## 560

### Take care of your steering column

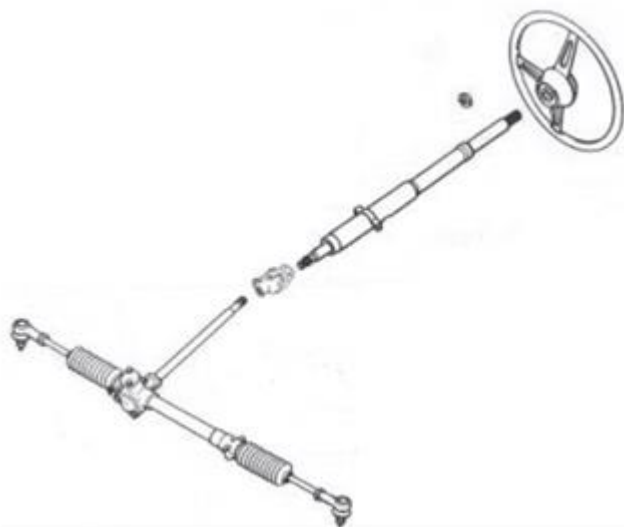
Nic Houslip highlights the space between the hollow and the solid shaft forming the collapsible column is injected with a resin based material through two holes in the hollow shaft, these forming a small cylindrical piece that acts as a "shear pin". Excessive force when removing or refitting the column can result in damage to those resin shear pins. Here he recommends care when handling the collapsible column. (Feb 19)

The outer shell of the column assembly is made of expanded metal or similarly manipulated sheet metal that is easily crushed. Inside the outer shell there is a more complicated assembly that enables the lower shaft, the part that carries the universal joint to slide axially outside the shaft attached to the steering wheel, enabling steering inputs to be transmitted to the steering rack. The column itself is mounted to the body by means of 3 diecast assemblies that also contain a shear pin mechanism that will allow the column assembly to move downward in the event the driver is thrown against the steering wheel.

It would seem a simple device, but to allow the necessary clearance for the two shafts to slide inside one another means it will probably rattle, so the designers came up with simple solution - the space between the hollow and the solid shaft is injected with a resin based material through two holes in the hollow shaft, these forming a small cylindrical piece that acts as a "shear pin".
