MGBGTV8 – readjusting the overdrive inhibitor switch (and a surprising discovery)

In his previous V8NOTE681 Jim Livingstone suggested that the cause of his V8's overdrive cycling in and out of engagement was low oil level in the gearbox caused by a leaking output shaft seal. This conclusion appeared to be confirmed by subsequent testing on local roads. However, the cycling returned on the first long run with extended use of overdrive. On revisiting the problem last month he discovered that adjustment of the inhibitor switch has proved more long lasting. He has recorded the procedure he adopted in this note.

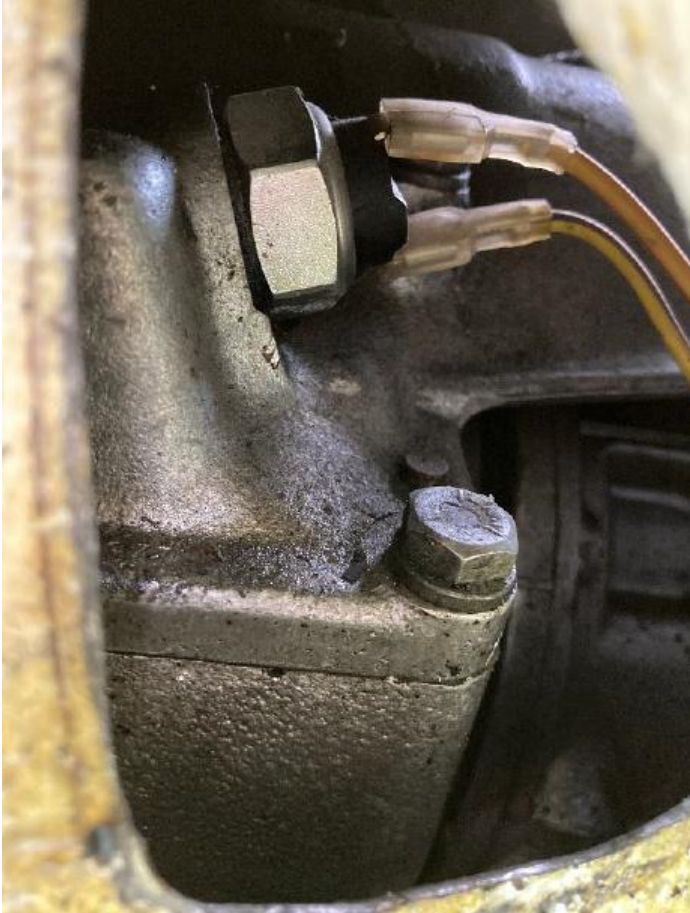
Figure 1 – inhibitor switch accessed by a rubber plug

car dealing with the previous oil leaks. There was no reference to this in the workshop manual or parts catalogue so I assumed this was not an original part of the car. Anxious not to spend any more hours on my back under the car I decided to investigate if this would be an easier route for the wiring or maybe even facilitate replacement of the switch should it prove faulty. **Figure 1**

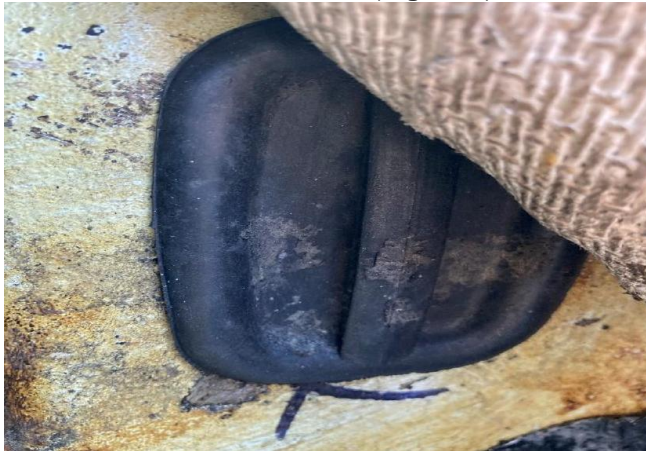
Figure 3 – rubber blanking plug

1. Remove the rubber blanking plug from the passenger side of the transmission tunnel (**Figure 3**).

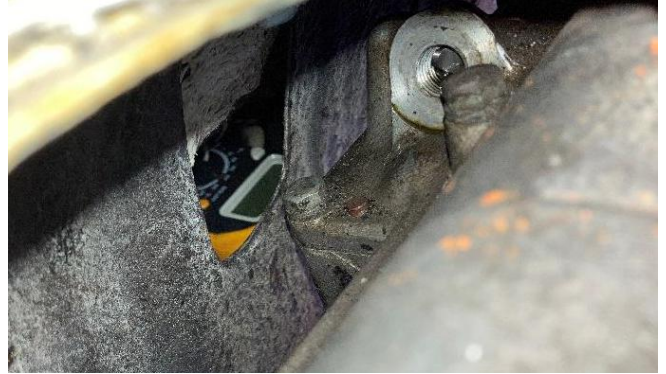
Figure 5

6. Examine the inhibitor pin in the gearbox and measure its depth from the flange in 3rd and 4th gear (**Figure 5**).

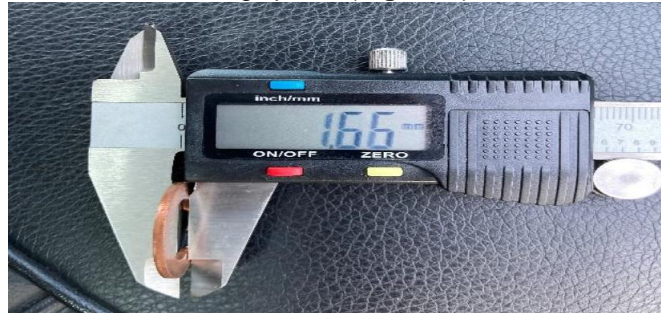
Figure 6

7. Measure the existing spacer (**Figure 6**).

8. Establish the thickness of spacer required to ensure overdrive engagement in 4th while inhibiting it in 3rd. I changed the thick original copper washer for a thinner fabric one.
9. Grease the switch plunger, reinsert and tighten.
10. Check the operation mechanically and electrically before reconnecting the spade terminals.
11. Refit all components removed on disassembly.
12. Test the operation of overdrive on the road.

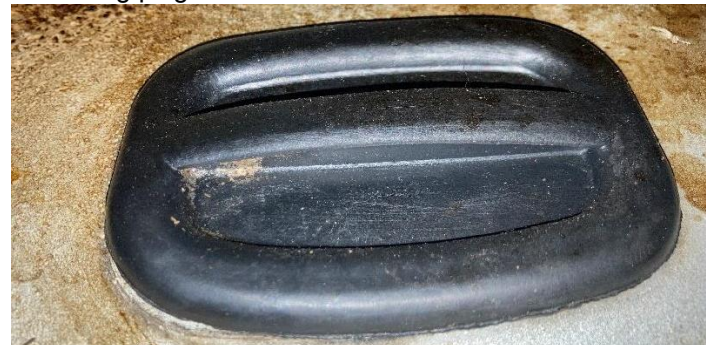
- Blanking plug 14B640

Remove the identical blanking plug from the engine bulkhead in front of the passenger seat and produce a

card template by tracing round the profile of its aperture. Establish the position of the inhibitor switch by drilling a small pilot hole. Position the template on the tunnel and mark the position of the aperture. Cut out the aperture with a Monodex or similar tool.
