What can the V8 badging reveal?

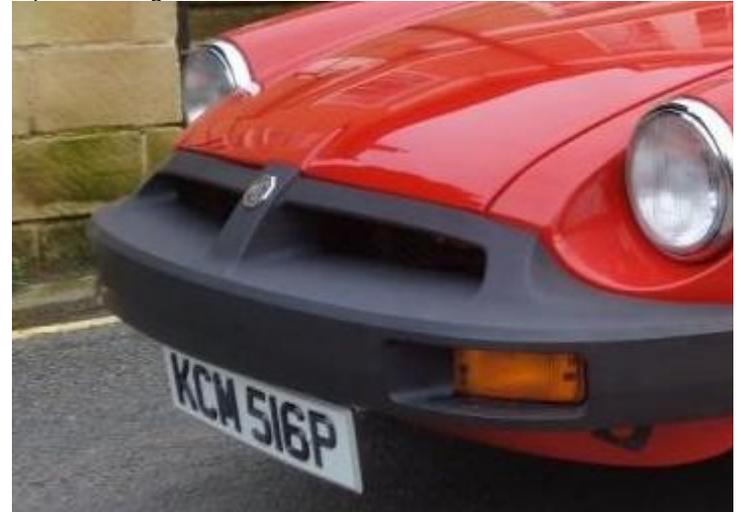
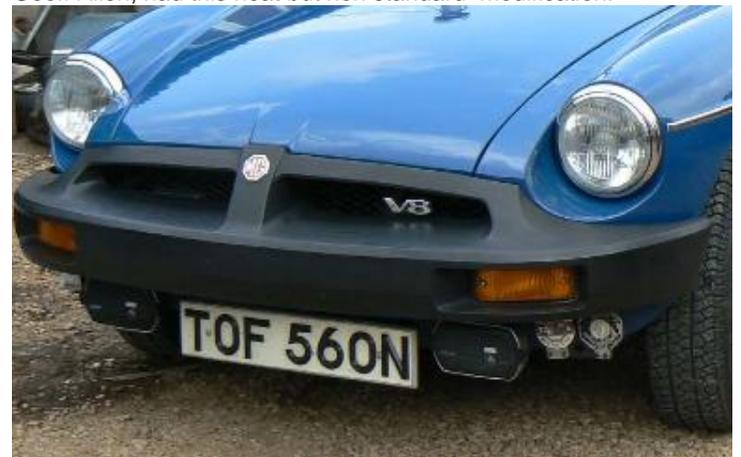
Some owners have fitted a V8 badge on a bracket attached to the mesh screen behind the rubber bumper so the badge is visible in the nearside opening of the rubber bumper. The first Factory rubber bumper MGBGT V8, Teal Blue 2101 formerly owned by the late Geoff Allen, had this neat but non standard modification.

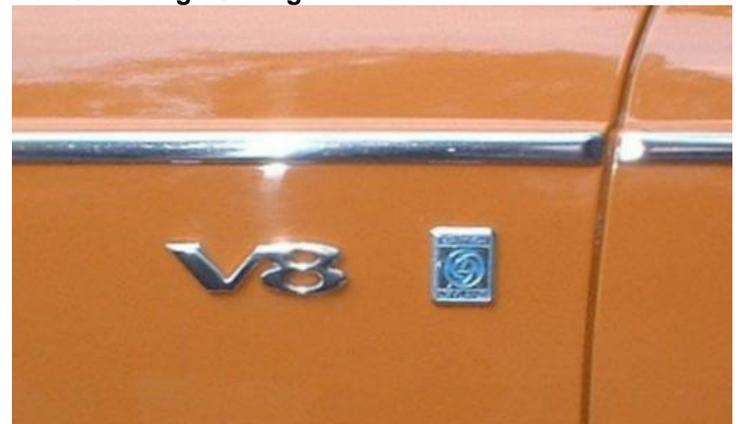
Nearside wing V8 badge

The nearside wing V8 badge was on both chrome and rubber bumpered Factory produced MGBGTV8s. The positioning of the badge is set out in [V8NOTE253](#) in Volume 7 of the V8 Workshop Notes series.

View of nearside wing between the rear of wheel arch and front edge of the door

There was **no badge on the offside wing** of Factory produced MGBGTV8s. Frequently you see restored V8s with badges on the offside wing.

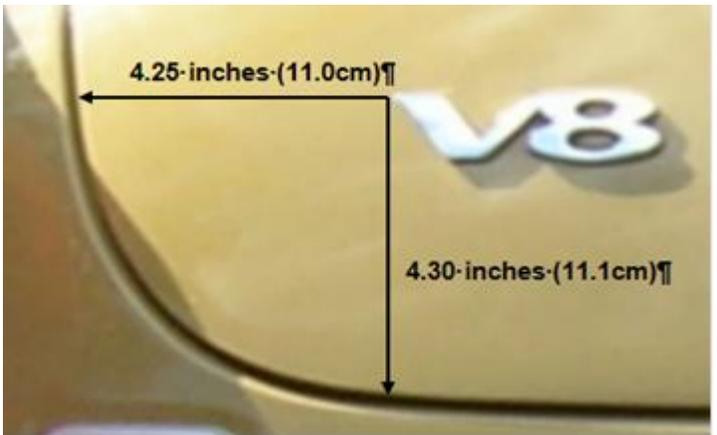
Tailgate V8 badge

It's located near the bottom edge of the tailgate on the nearside on both chrome and rubber bumpered Factory produced MGBGTV8s. The positioning of the badge is set out in [V8NOTE253](#) in Volume 7 of the V8 Workshop Notes series.

Often on restored MGBGTV8s badging is missing. Sometimes it is because the owner cannot find replacement badges but they are available but note that whilst the V8 badge for the nearside wing is flat, the badge for the tailgate is curved in both directions - sideways and top to bottom – to fit the rounded contours of the tailgate. The V8 badge for the grille mesh of the chrome bumper V8 is mounted on a backing bolted through the plastic mesh.

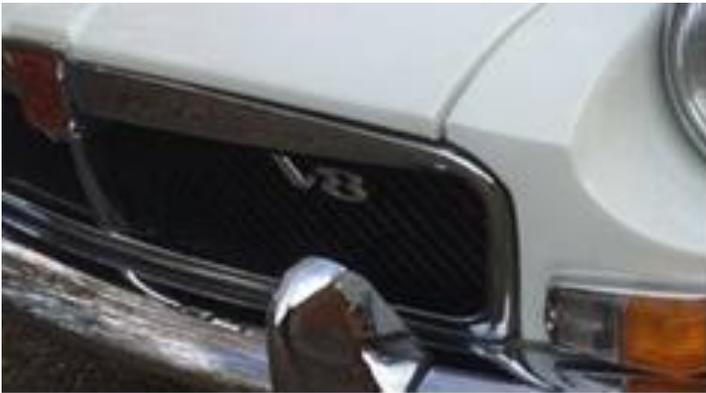
On this chrome bumper grille the **V8 badge is too high and too far to the nearside** of the grille. Note also the restorer has got the sidelight-indicator light unit the wrong way round too! The side light should be on the outside marking the edge of the front of the car and the indicator inside.

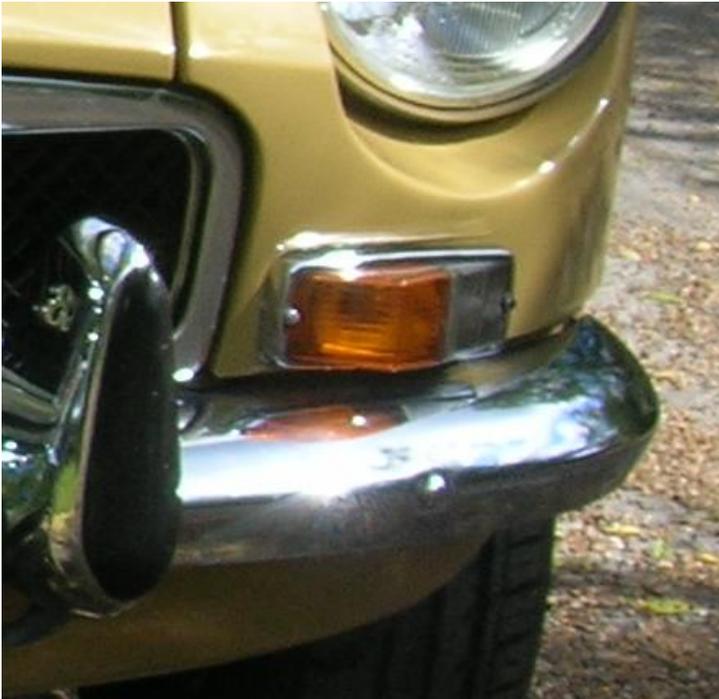
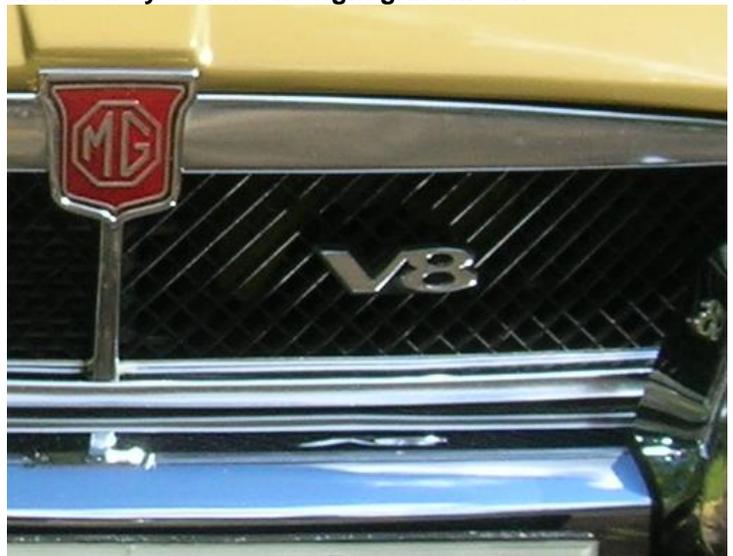
Make sure you have the right grille mesh!

An original grille mesh fitted to a chrome bumper MGBGTV8.

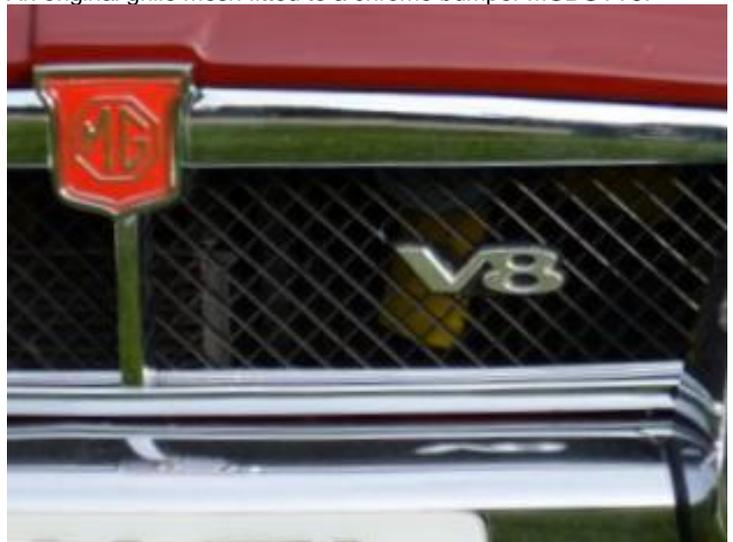
Reproduction grille mesh from the 1990s - you can see the bold feature on the mesh panel is reversed.
