Essential bonnet lock and safety catch servicing for an MGB and V8

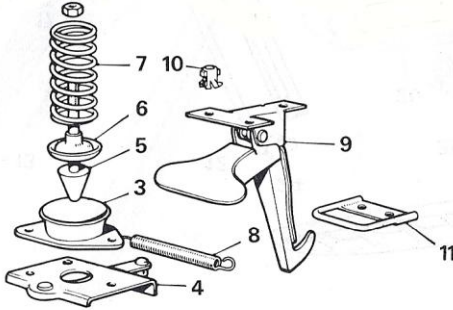
basis, removing all traces of road dirt, grit, old oil and grease. I prefer to use white spirit and a ½" paint brush. Then dry with rag waste or tissue. Then examine the release cable for freedom of movement and full return and check the Catch Plate Return Spring (8) which should be close coiled and free of corrosion, capable of 'snapping' the Catch Plate (4) back to its rest position. The Catch Plate should not have any appreciable wear on the underside where it engages with the Lock Pin (5). The same applies to the Lock Pin shoulder where it in turn engages with the Catch Plate. The Safety Catch Assembly (11) should move freely on its pivot, be sure the return spring is not damaged or broken.

When you are sure all the components are operating as they should and are corrosion free, the Lock Pin (5) should be adjusted to ensure the bonnet top surface lines up with the wings. The Bonnet Hinges and Cup-lock Locating (3) can be adjusted to equalise bonnet shut lines and alignment of the bonnet rear with the wings. Check to make sure the bonnet opens and closes freely without 'snagging'. The Safety Catch (9) must engage fully with the Bracket: Safety Catch (11). This may be achieved by moving the Safety Catch forward and aft on the bonnet under panel. Check by viewing through the gap when the bonnet is released. Most maintenance schedules
