RV8 boot lid lock and boot light switch

During a recent thread on the V8 Bulletin Board, Godfrey Dennis was able to solve two problems: first solving a problem with the switch forming part of the boot lock and second solving a missing tell-tale lamp on the dashboard switch for the boot lock. (Aug 12)

Faulty boot lamp switch

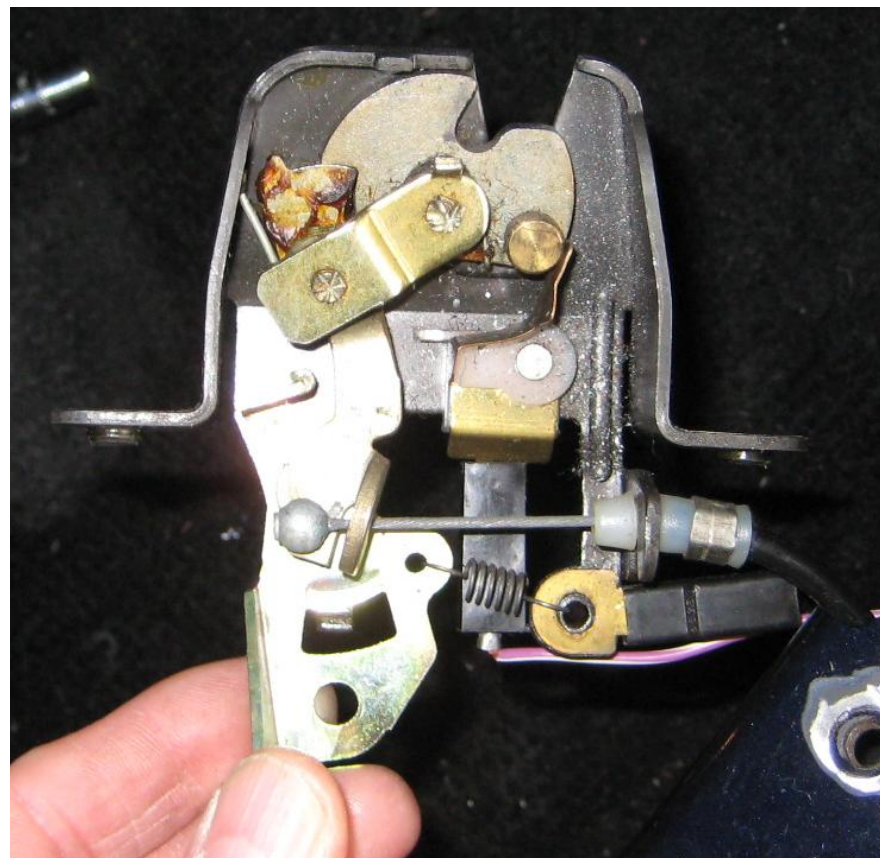
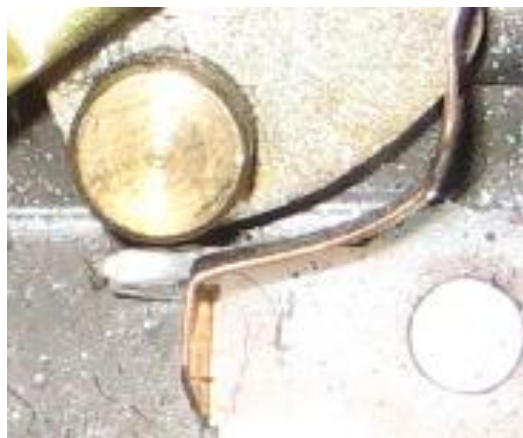
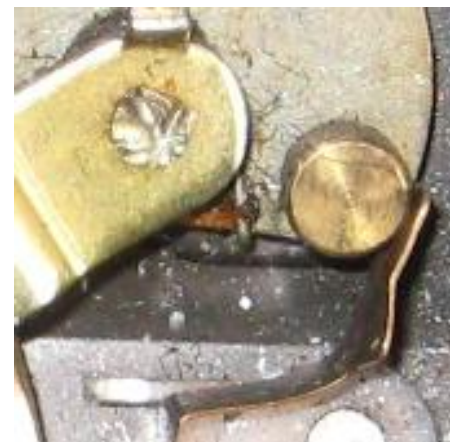
Godfrey Dennis has some useful pictures of the lock on the boot lid on his RV8 which he feels "should help to clarify the metal tab which acts as the switch mechanism for the interior boot lamp, particularly No. 013 (**top right** and enlarged to the right) which shows the position when the boot lid is open, and No. 014 (**top left** and enlarged to the left) the position when the boot lid is closed.

You can see a small round spindle in both pictures, and indeed in all of the set, but looking at Nos. 13 and 14 you can see in No 13 (right) where the metal tab contacts the spindle when the boot is open to complete the circuit and put the **light on** and in 14 (left) where it separates from the spindle, when the lid is closed, to break the circuit and keep the **light off.**"

You can see from the photos above, that it is possible to adjust the tab from the top by careful use of a screwdriver, although I think it's better to remove the unit fully for adjustment. It's not a big job.

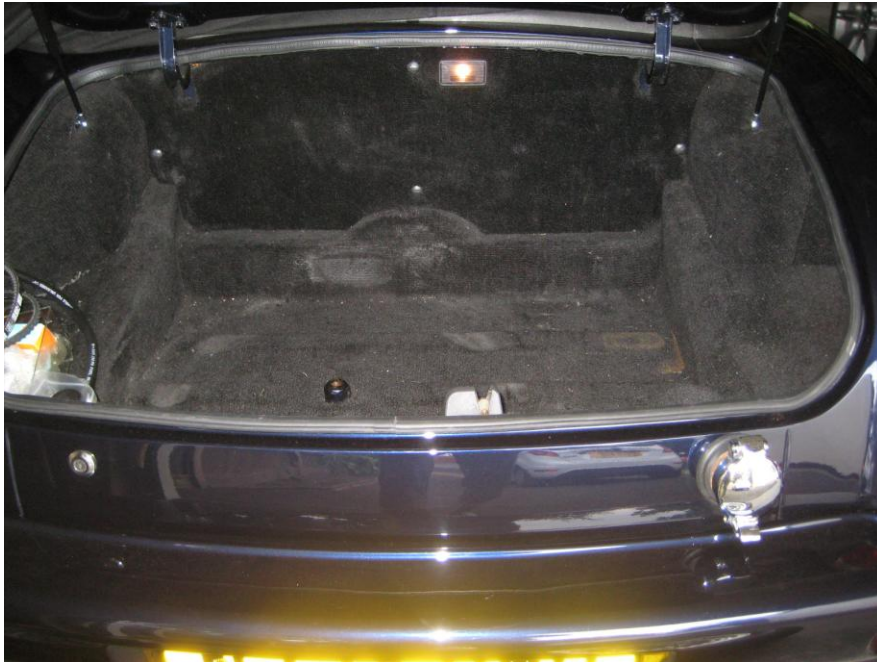
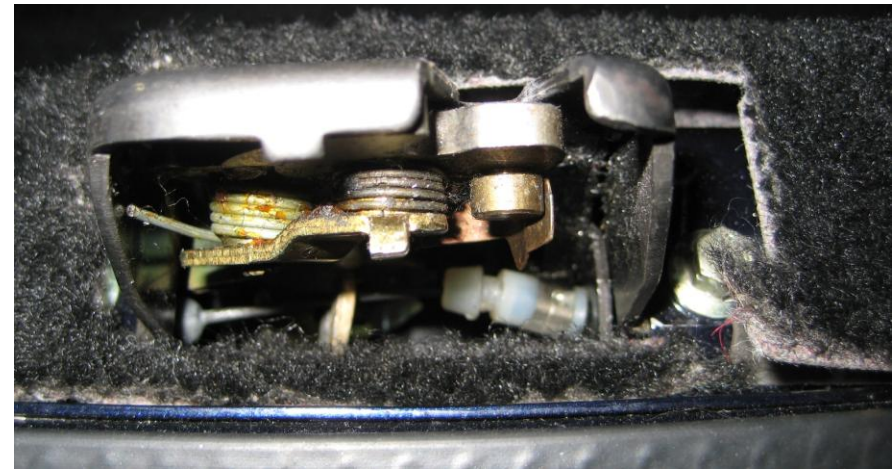
Boot lid is open - Photo 9 shows the position when the boot lid is open - you can see the tab in contact with the spindle, and therefore the interior light is on.

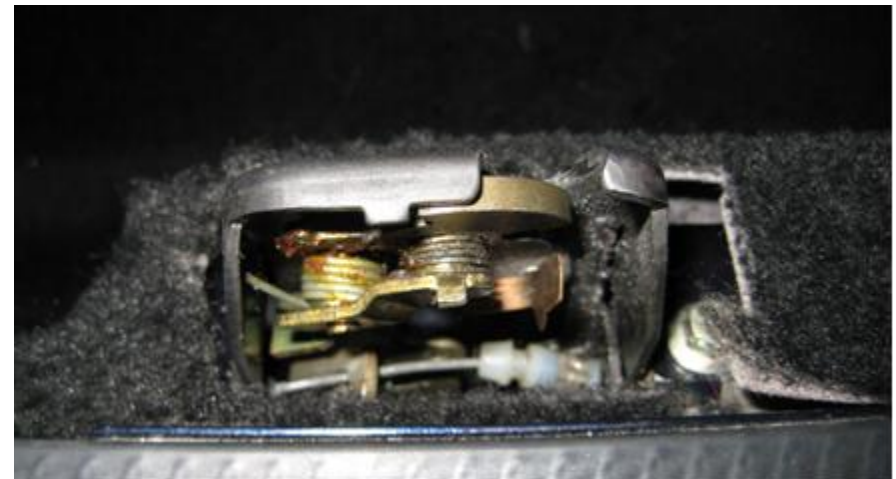
Boot lid is closed - Photo 10 shows the position when the lid is closed – the tab is not in contact with the spindle, the circuit is broken and the interior light goes off.

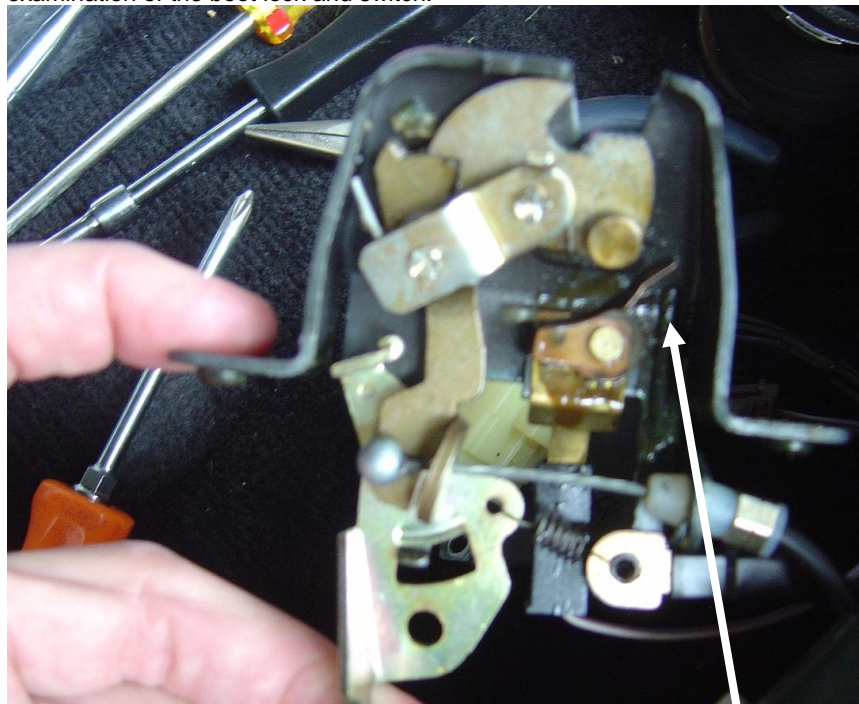
Metal tab shown was bent out of position causing the faulty boot light. (Simon Austin)

In the V8 Bulletin Board thread the query was why does the boot lamp fail to extinguish with the boot lid closed? Simon felt the problem was with the metal tab being bent out of position enough that it contacts the latch mechanism continuously, regardless of lid open or closed – see the photo above. Perhaps it just needs to be bent back to its original position? I'd think the chances of the latch mechanism being at fault are slim as it's a robust piece of equipment whereas the metal tab is rather fragile by comparison.

The good news is that the metal tab can be adjusted without removing the latch from the vehicle. If you look down into the mechanism, the tab should be visible and moving the latch should show how the complete system operates. One can use a screwdriver to replicate the boot lid's metal bracket engaging the latch

mechanism. With the lid open, force the latch into the closed position with the screwdriver and confirm how the metal ground tab contacts the knob on the latch. Adjust as required. To release the latch, just insert key as normal and the latch will spring to the open position. I had to remove the latch mechanism in order to determine how the system operated but as mentioned, one should be able to adjust the metal tab without removal of the mechanism. If that doesn't work, removal may be necessary and the RV8 Repair Manual is very good at describing the procedure.
