RV8 cooling fan modification so the fan can run after the ignition has been turned off

Wiring modification which allows the fans to run when the ignition is off

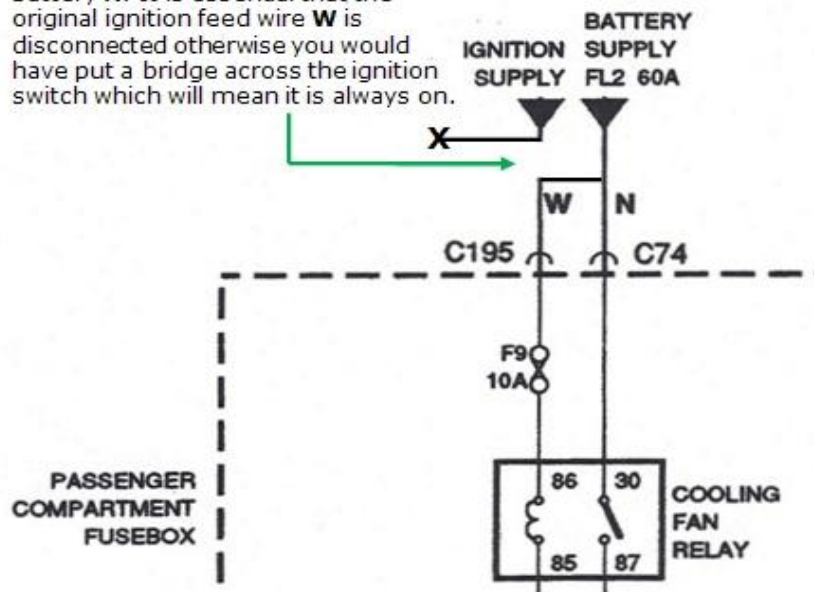
The modification to the wiring is shown alongside as a mark-up on a copy of the wiring diagram in the RV8 Repair Manual – see a page with the heading "Cooling fan" which is page 5 in the Wiring Diagrams section at the back of that manual.

Bosch joined up **W** (the feed to the relay coil) to the live feed from the battery **N**. It is essential that the original ignition feed wire **W** is disconnected otherwise you would have put a bridge across the ignition switch which will mean it is always on.

When Bosch made the wiring modification they joined up **W** (the feed to the relay coil) to the live feed from the battery **N**. This ensures permanent power to the fan so that it does not necessarily switch off when the ignition switch is turned off. It is essential that the original ignition feed wire **W** is disconnected otherwise you would have put a bridge across the ignition switch which will mean it is always on.

In reviewing Peter's report of this useful modification, Bob Owen notes "the feed to the relay coil – **W** in the mark up diagram above - should be **transferred** to the live feed. It is essential that the original ignition feed wire **W** is disconnected (as shown above) otherwise you would have put a bridge across the ignition switch which will mean it is always on." You can see a full page copy of the original wiring diagram on page 3 below.

Bob Owen notes "the essence of this modification is the wiring change which allows the cooling fan to run regardless of the state of the ignition switch. The 12V supply to the fan relay on the RV8 is originally fed from the ignition switched supply so the fans cannot run if the ignition is off, even if the temperature sensor switch closes as a result of heat in the block after the engine is stopped. The key feature of this modification is to transfer the feed to the relay coil to a non-ignition switched supply, which is the modification done by the Bosch engineers for Peter Garton and is drawn on the wiring diagram above. Ideally the physical wiring should also be drawn or photographed as the purpose of a wiring diagram is to show the essence of the wiring in a simple form when the physical reality of the position of the wiring is often far from clear. Hopefully later we will be able to get a set of photos to provide an additional illustration of the wiring changes.

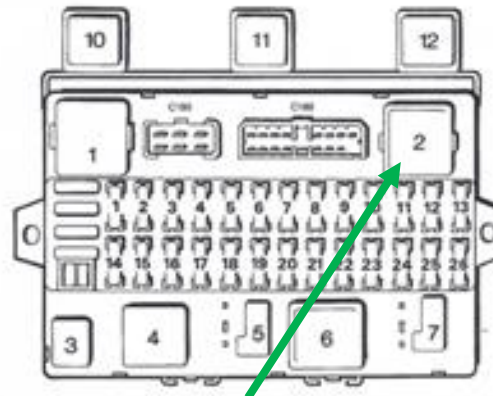
Relay 2 for the cooling fan

The RV8 coolant temperature sensor switch closes when the coolant has reached the "fan-on" temperature activating the cooling fan motor via a relay because the fan motor draws a relatively heavy current. The relay allows a large load, such as the cooling fan motor, to be controlled by a switch with a much smaller current rating. The switch may be mechanical or electronic. The traditional relay comprises an electromagnet (a coil with a soft iron core) plus an armature connected to physical electrical contacts. A current through the electromagnet attracts the armature which moves to physically close (or open) the contacts. A **delay relay** will have some electronics which causes the coil current to continue to flow for some time after the initial stimulus is removed. This is useful for example for courtesy lights. Moreover the physical contacts may themselves be replaced by an electronic device which can either be caused to switch on/off like contacts or whose resistance may be controllable so allowing a dimming action.

Typical relay above

Peter heard from the Bosch engineer who carried out the work that relay number 2 on his RV8 was replaced with a Bosch 30amp relay part number **0332 209 151** which is a standard part available from several sources. This relay is a standard relay and does not have a delay feature. To the extent the fans can run on after the ignition has been turned off, that delay in their turning off is achieved by the wiring modification and controlled by the thermostat switch and not by a "delay" feature in the relay itself.

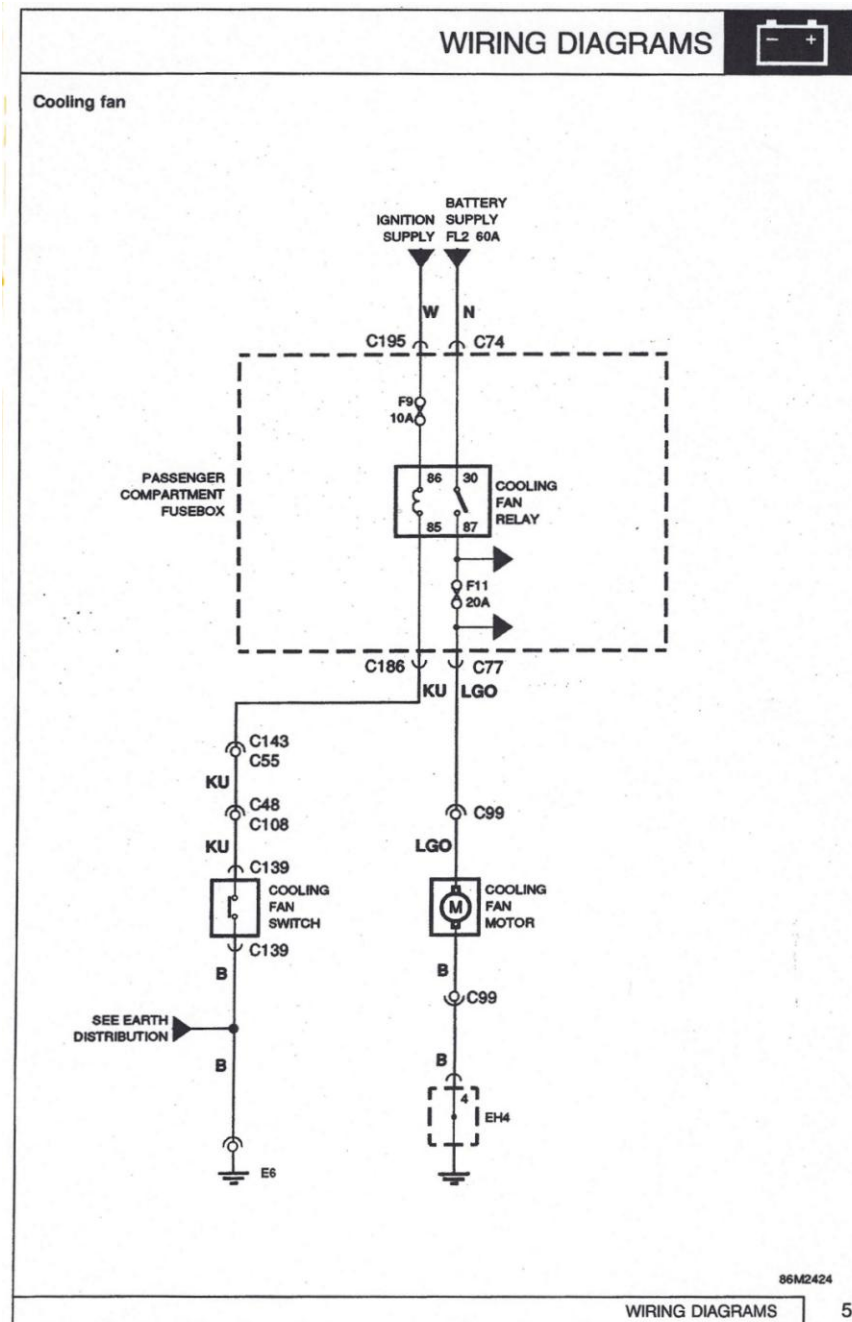
Wiring diagram

Left, the original wiring arrangement.

Source: diagrams are from the Wiring Diagrams section at the back of the RV8 Repair Manual AKM 7153ENG:

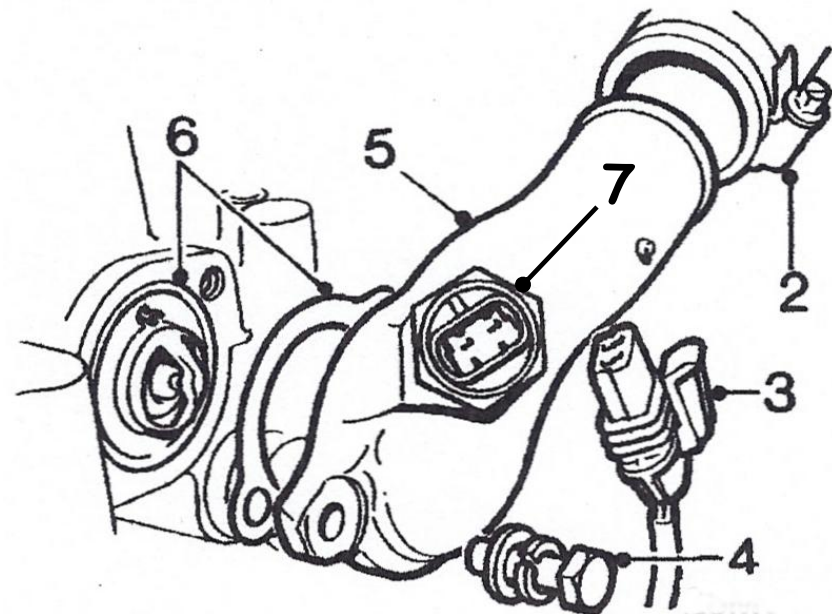
Thermostat and thermostat switch fitted to the RV8

- 2 - hose clip
- 3 - multiplug from thermostatic switch
- 4 - bolts, plain and springs washer securing thermostat housing cover
- 5 - thermostat housing cover
- 6 - thermostat and gasket
- 7 - thermostatic switch
