## STEERING RACK COMPONENTS

### RV8 steering rack

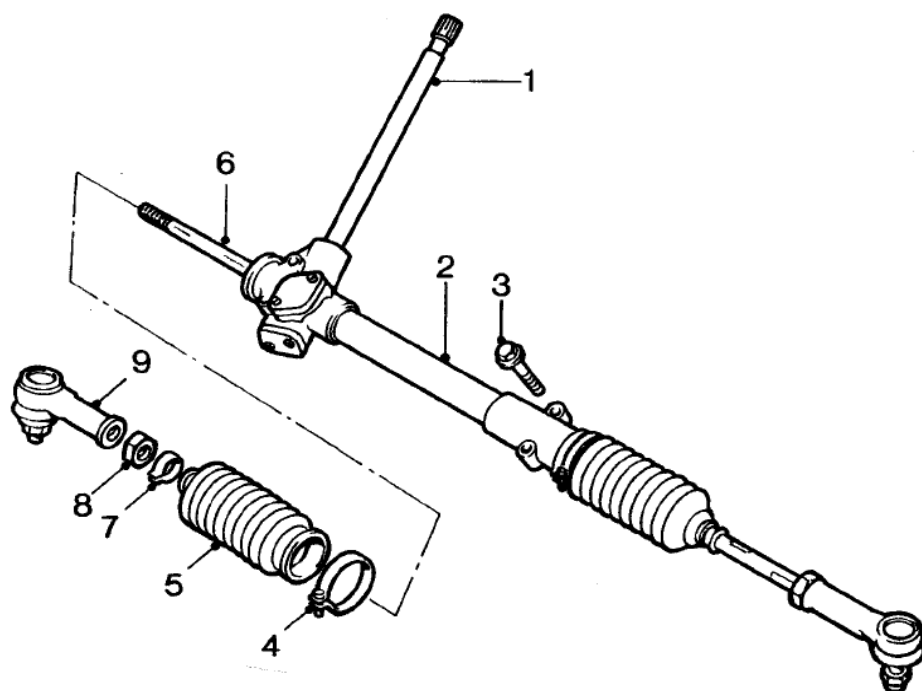
| 1. Pinion | 6. Track rod |
| 2. Steering rack | 7. Clip - gaiter to track rod |
| 3. Bolt - steering rack to mounting | 8. Locknut - track rod end |
| 4. Clip - gaiter to steering rack | 9. Track rod end |
| 5. Gaiter | |

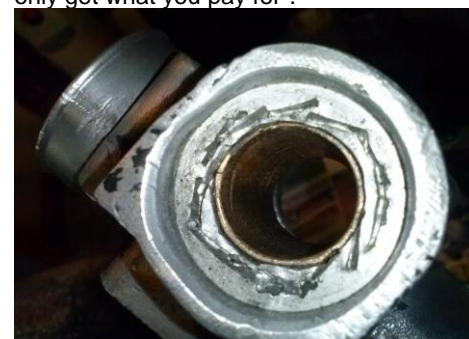
Poor quality work with the pinion there and seal inside.

Clive has serious concerns over some cheap reconditioned racks which are available from some parts suppliers. His two photos below show a rack has a casting at one end and a steel tube linking to a casting at the other end. The photos show a poorly repaired rack bar which was supplied by a "so called reconditioner" who had chiselled the ends of the bushes over with a cold chisel to take up any slack. Clive says that in this situation the old cliché applies – "you only get what you pay for".

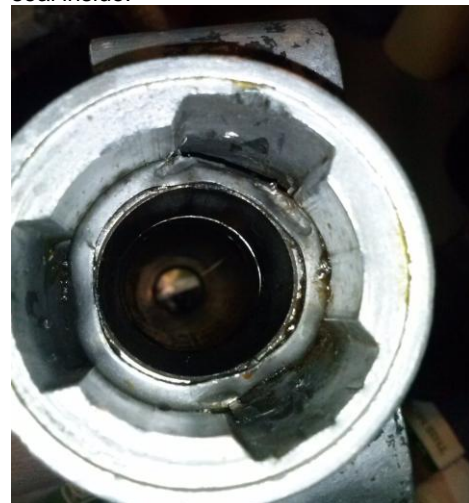
View at the rack bar end on the nearside.
