### Check your plastic breather pipe is not missing

Derek Squires highlights a check worth making on your RV8 back axle.

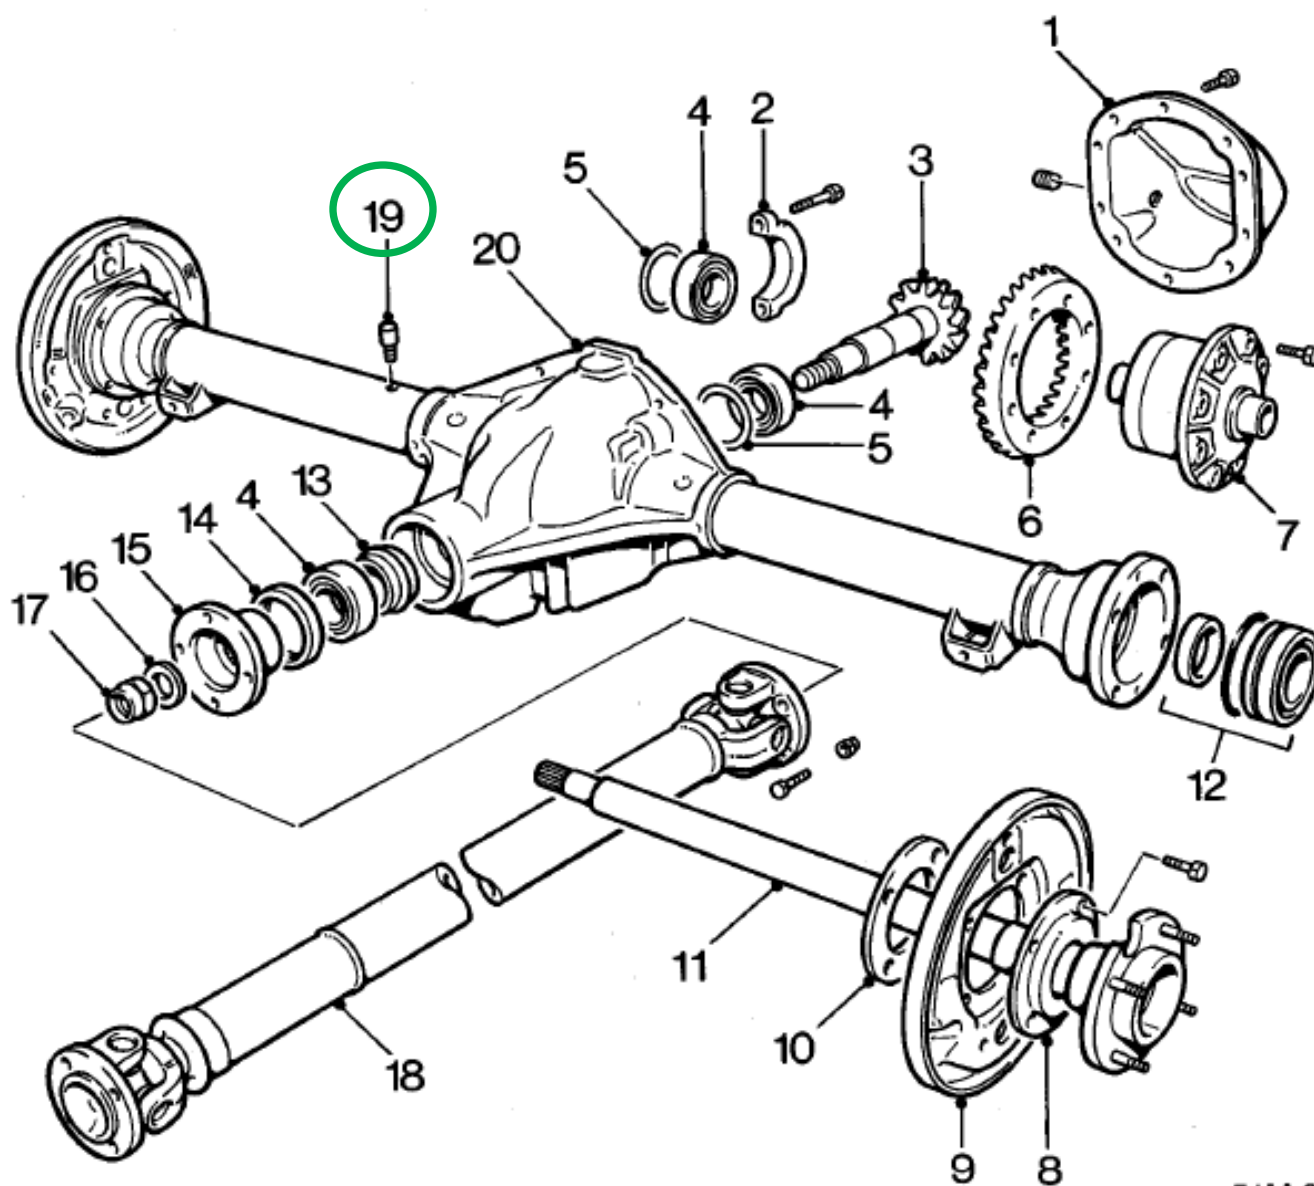
Diagram: RV8 Repair Manual AKM7144ENG

Went into my garage a couple of weeks ago and saw something lying on the floor under the back of the RV8. Turned out to be the plastic rear axle breather (19), which had sheared off at the top of the short threaded section that holds it into the axle, and so I now have an open hole of about 7mm diameter in the top of the axle to let in water and grit! Readily obtainable, but if it had fallen off on the road, I'd never have noticed that it was missing. My RV8-owner friend here in southern Spain has just crawled under his car, and his is missing as

well.

Might be worth a check that you still have one on your RV8! You can find it on top of the axle, right-hand side, just outboard of the differential.

The replacement parts are listed by Brown & Gammons as **ZXC5726** for the RV8 and **21H6060** for the GTV8.
