RV8 aircon heater cut-off flap vacuum actuator

Extracts from the RV8 Repair Manual AKM7144ENG

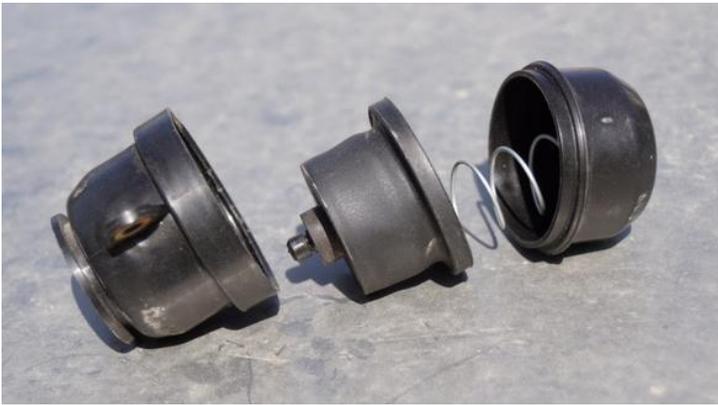
Dismantled plastic vacuum actuator. The outer ridge on the smaller part on the right just snap-fits into the inner groove on the larger part on the left that has the attachment lugs moulded on it, so it's just brute force to separate them! (Photos: Derek Squires)

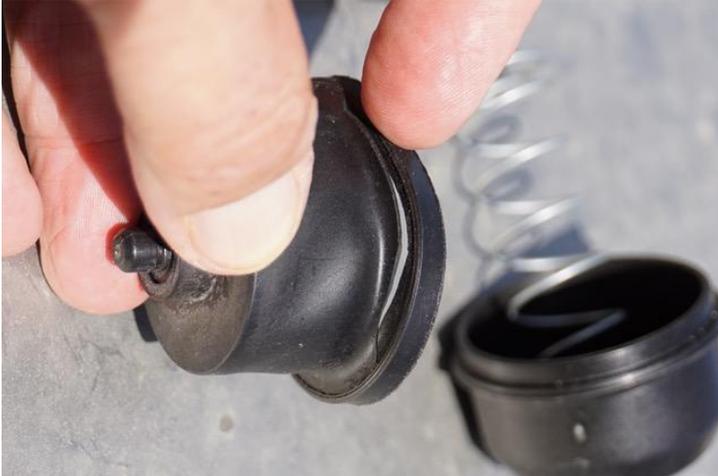
You can see here the **rubber diaphragm splits along the edge**. Using Superglue would only be a temporary fix.

Nic Houslip added "I do feel that trying to repair the vacuum valve diaphragm will only produce a very short-term solution. The diaphragm is under considerable stress when subject to manifold vacuum, with atmosphere on the other side. The diaphragm flexes every time it is operated and there is probably no adhesive that will stand the flexing that causes the diaphragm to split in the first place. Air leakage here will possibly affect the engine idle speed and perhaps the mixture".

Derek Squires later mentioned that to avoid confusion, as there are three vacuum valves in the system, it is the plastic **Heater Cut-Off Flap Vacuum Actuator** that can be replaced with the **RTC 6696** unit, and this does not require any dismantling of the heater box or fascia. As he was over in the UK at the time he mentioned that on returning home to Spain he would send some photos of his old unit dismantled so fellow members could see how it fits together and can be opened for repairing the rubber diaphragm. The useful photos alongside were subsequently sent in by Derek.

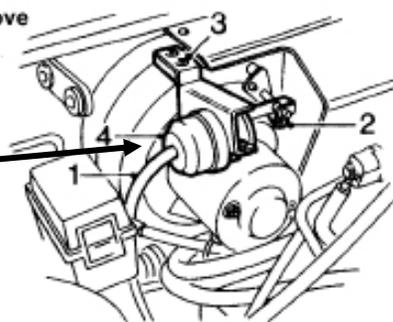
HEATER CUT - OFF FLAP VACUUM ACTUATOR

Remove

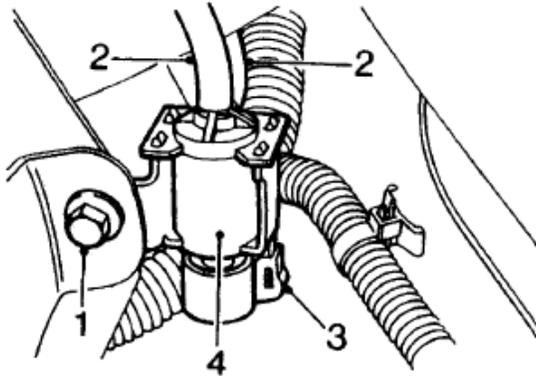
82M0137

1. Remove bolt securing vacuum solenoid valve to expansion tank bracket.
2. Disconnect 2 vacuum hoses from valve.
3. Disconnect multiplug.
4. Remove valve.

1. Position valve; connect multiplug and 2 vacuum hoses.
2. Align valve to expansion tank bracket; fit and tighten bolt.

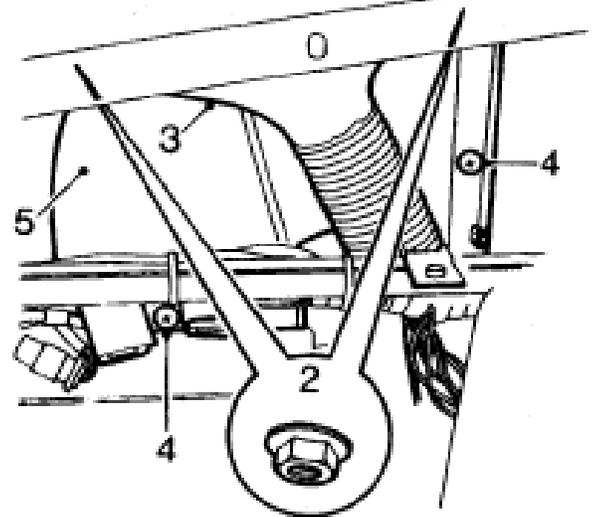
82M0138

2. Remove 2 nuts securing L.H. heater duct.
3. Remove duct.
4. Remove 2 scrivet fasteners securing air duct; evaporator to distribution box.

5. Remove air duct.

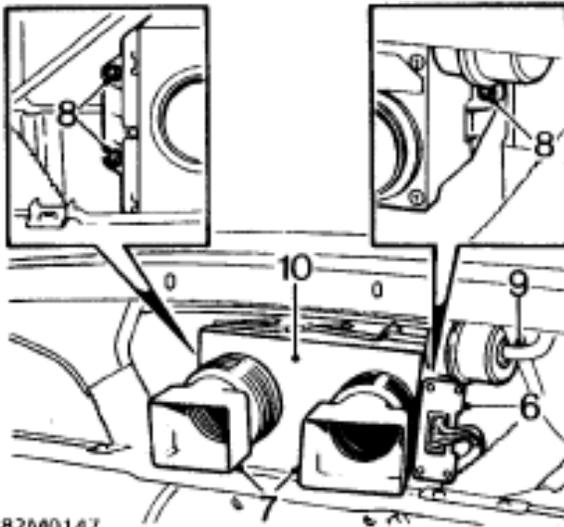
82M0147

6. Release engine immobiliser control unit from distribution box.
7. Remove 2 hoses; distribution box to fascia
8. Remove 3 nuts securing distribution box to body.
9. Disconnect vacuum hose from vacuum actuator.
10. Remove distribution box and vacuum actuator assembly.

1. Fit distribution box to body; fit and tighten 3 nuts.
2. Connect vacuum hose to vacuum actuator.
3. Fit 2 hoses; fascia to distribution box.
4. Secure engine immobiliser control unit to distribution box.
5. Fit air duct; evaporator to distribution box and secure with 2 scrivers.
6. Fit L.H. heater duct; fit and tighten 2 nuts.
7. Refit fascia assembly, see **BODY**

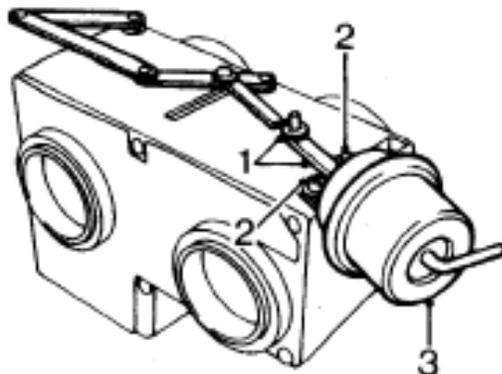
82M0140

1. Remove clip securing vacuum actuator link rod to flap lever; disconnect rod.
2. Remove 2 bolts securing vacuum actuator to distribution box.
3. Remove vacuum actuator.
4. Fit vacuum actuator to distribution box; fit and tighten 2 bolts.
5. Connect vacuum actuator link rod to flap lever; fit clip.

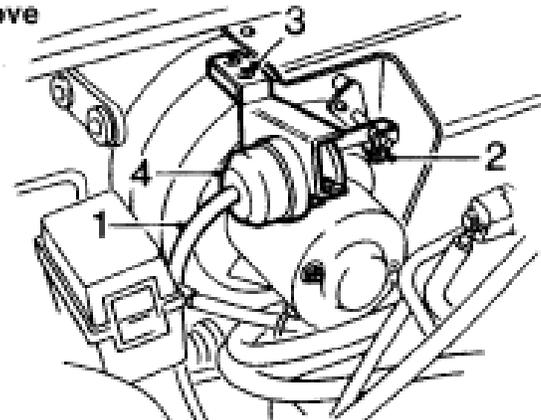
82M0155

1. Disconnect vacuum hose
2. Remove clip securing vacuum actuator to flap lever.
3. Remove 2 screws securing vacuum actuator.
4. Remove vacuum actuator.

1. Fit actuator and connect link.
2. Fit and tighten 2 screws securing actuator.
3. Fit clip securing actuator to flap lever and connect vacuum hose.
