Improving the air con flow to RV8 driver's feet

RV8 owner John Anthistle had always been unimpressed with the airflow from the Air Conditioning to the driver's foot well and decided to investigate further. He has devised a simple improvement that can be easily reversed.

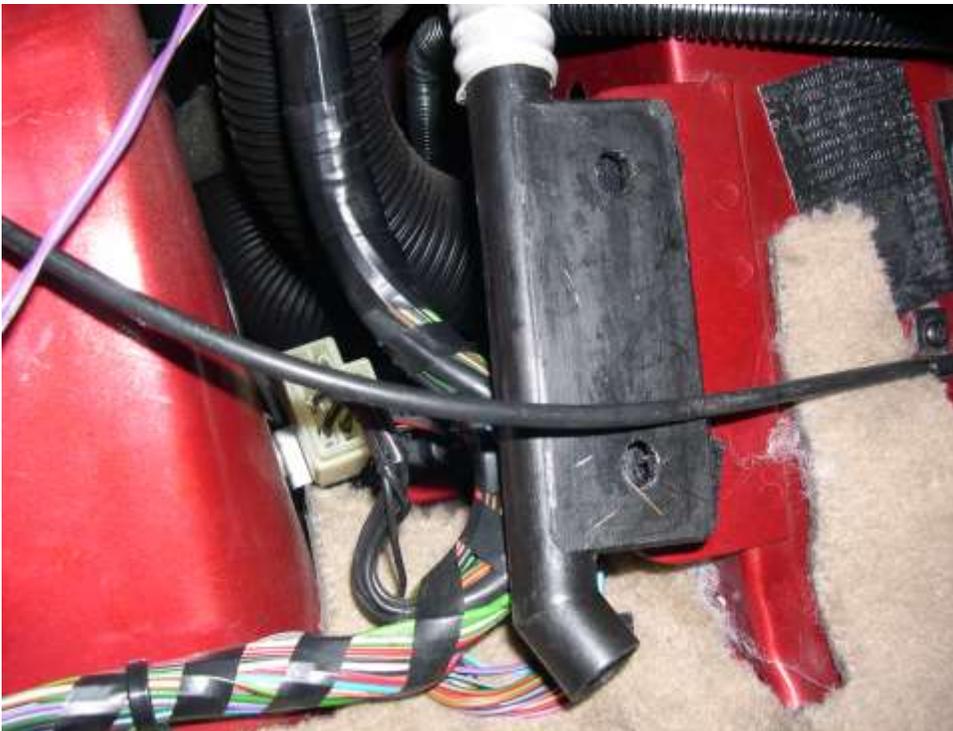
This takes the form of a neat black plastic moulding tucked behind the transmission

tunnel kick-panel (the one with the interior light) which not only reduces the effective hose diameter but additionally forces the air to deviate considerably. This moulding is a push fit into the light-grey cross-facia hose and also onto its mountings - the backs of the pads that carry the Velcro-like fasteners for the forward end of the kick-panel.

< Original Outlet – pulled from its mountings for clarity

Removing the moulding certainly produces an increased flow from the hose and it is a simple matter to push a short extension hose – about 90mm in length - over the existing one. I used a 25mm inside diameter plastic hose from a garden water-barrel feed.

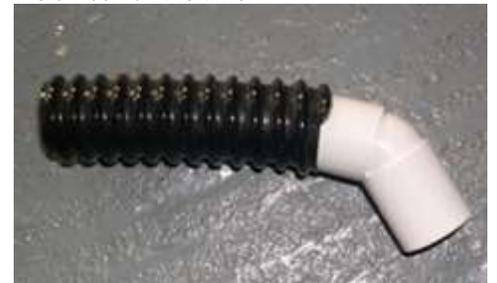
New Extension Hose and Elbow

This hose can then be terminated with a 135 deg plastic 'elbow' as used on small diameter, solvent-fix domestic plumbing pipework, positioned by the steering column and pointed at the driver's ankles. As it rests on the top of the kick-panel it does not require additional securing. The flow is still not fantastic but a considerable improvement, plus it emerges in a better position and its precise direction can be adjusted by twisting the extension hose".
