Cure for "sloppy" gear lever

Replacing the bushes

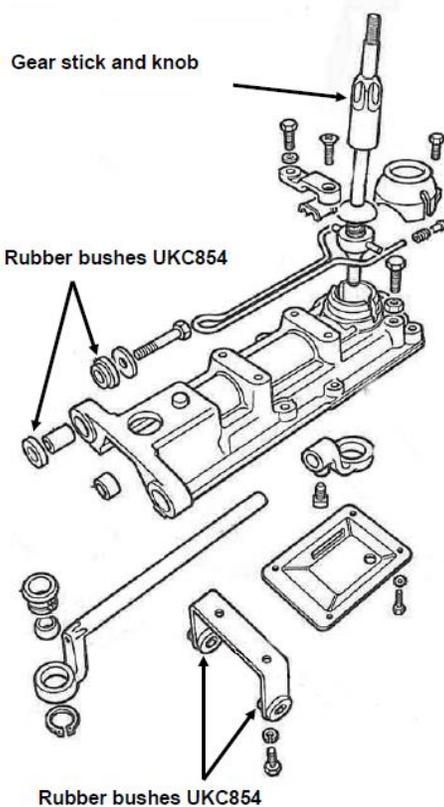
Rubber bushes UKC854

See an article contributed by Peter Varley in 2013 following his initial query posted on the V8BB in 2012. Over time the rubber bushes **UKC854** on the bolts that connect the remote gear change housing to the gearbox (TKC3821 or FRC7102) rot and then the remote housing becomes loose on those bolts. That can lead to gear selection difficulties because as you try to move the gear lever to select a gear, the remote housing moves on those bolts and then selecting a gear become difficult – you may hear a crunching sound when you change gears and then it may soon become impossible. So those rubber bushes have to be replaced, preferably with the polyurethane version **UKC854POLY** as they will last a great deal longer than the standard rubber parts which typically will last between 5 and 20 years depending on the extent of the contamination on the rubber bushes leading to their rotting.

There are 8 rubber bushes **UKC854** in total – they are used in pairs to make a "bush". Two pairs (4 bushes) are used on the bolts between the gear change housing and the gearbox and another two pairs (4 bushes) on the "U" shaped bracket under the gear change housing. [More](#)

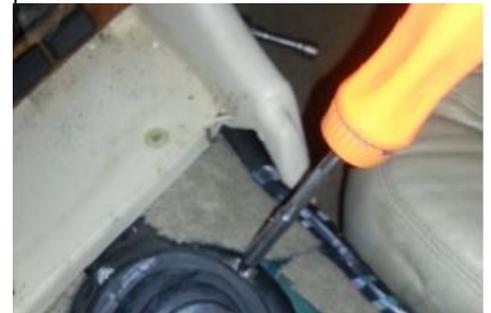
Forward of the gear lever opening in the RV8 transmission tunnel is a second closing panel held down with screws. This panel can be removed to allow access to the gearlever extension casting and its mountings. To gain access to this panel the long centre consol needs to be removed along with either the whole radio console or

the lower part of it by carefully cutting through the bottom flat plastic moulding. I did the latter as taking the radio and heater controls out is a real bore! Careful positioning of the cuts allows them to be covered by the removable lower flat trim panel when refitted.

If your hands are large, like mine, then widening the hole exposed by the forward access panel can be achieved by two sideways saw cuts to the right and bending up a flap of the transmission tunnel metal. The gear lever extension housing mounting bolts can be removed with various spanners sockets/extensions, etc.

I replaced the bushes with poly bushes, a set of eight slim washers/stepped washers from eBay - **Superflex Gearbox Selector Bush Kit SF376-0355-8K** for Triumph TR7/8. They are also available from some MG parts suppliers.

When all is back together and tested to your satisfaction the tunnel flap can be hammered back down, the closing plate refitted and all sealed with some mastic. The trim and centre console can then be refitted.
