### Expansion tank bracket corrosion

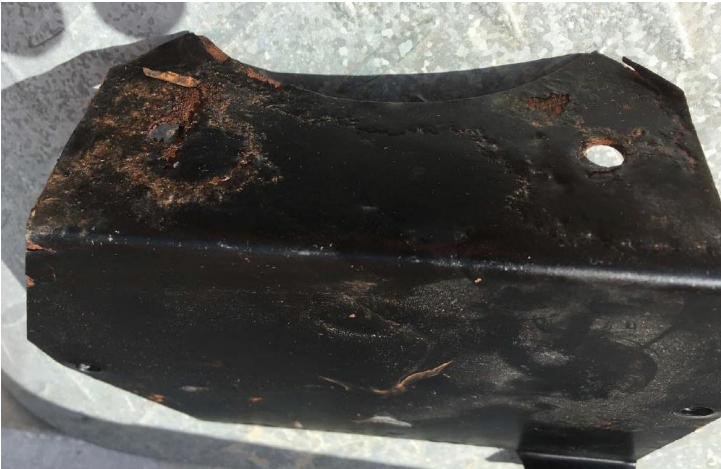
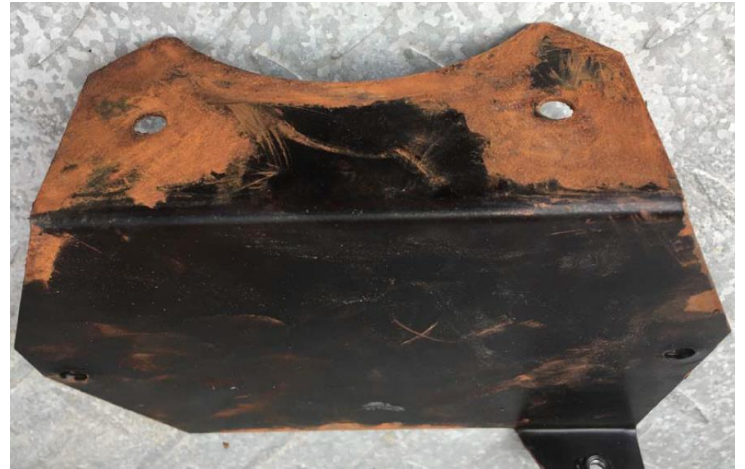
Jim Dolbel provided some photos of the corroded bracket before the paint was removed showing the extent of the corrosion found

(Left) Expansion tank bracket removed, all these rusted areas were completely hidden by the expansion tank and the windscreen washer reservoir. (Above) rust hidden under the painted surface.

The removal of the expansion tank is straightforward. Next was the removal of the windscreen washer tank which was not difficult and after a bit of wiggling it came out of the securing bracket. However the removal of the expansion tank bracket was more difficult and the two 10mm nuts securing this bracket to the firewall were difficult to access, they were also covered by the wiring harness. Both the nuts were rusted and needed WD40 to help with the removal. The bracket was then totally stripped back to bare metal, the areas of corrosion treated with a rust converter, primed and repainted. Fitting the refurbished parts is the reverse of the removal procedure.

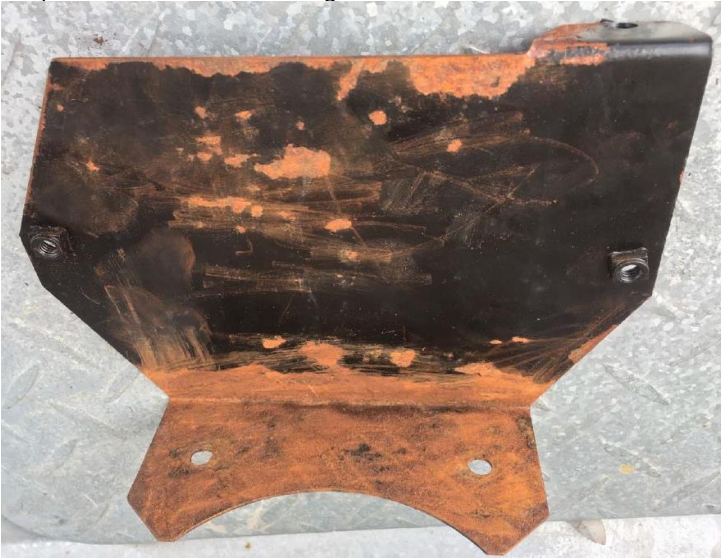
The other side of the expansion tank bracket once the paint was removed.

under the paint. He notes none of the rust was visible until the bracket was removed.

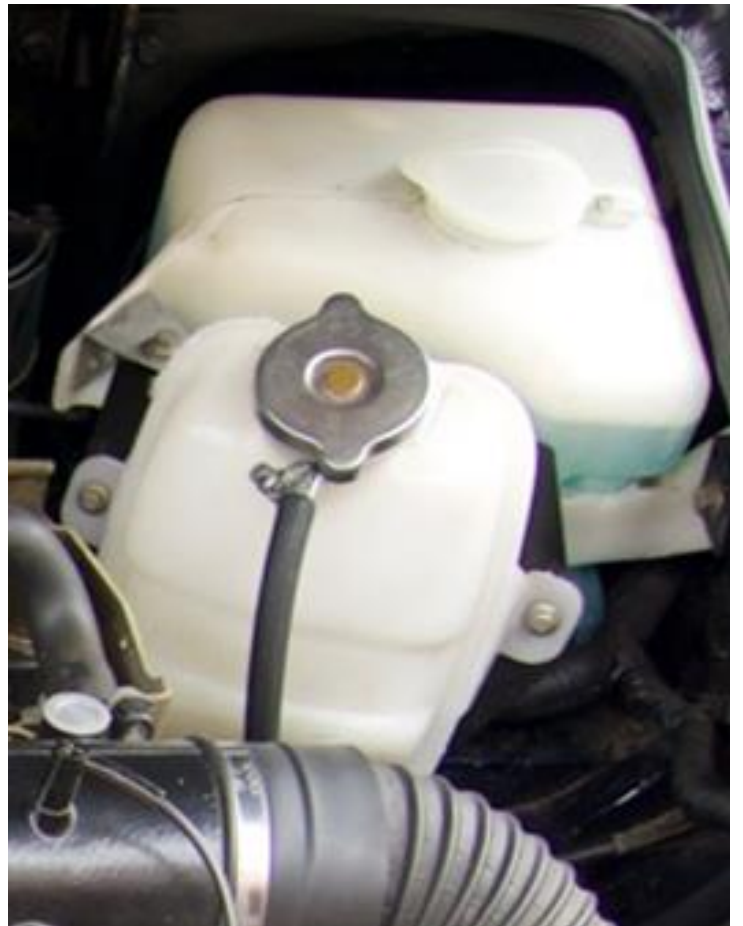
Coolant expansion tank close to the windscreen washer tank.
