Replacement radio amplifier

Julian Drew needed a replacement for his faulty amplifier and placed a wanted advert on the V8 Spares for Sale webpage on the V8 Website. Here he reports how he made the replacement.

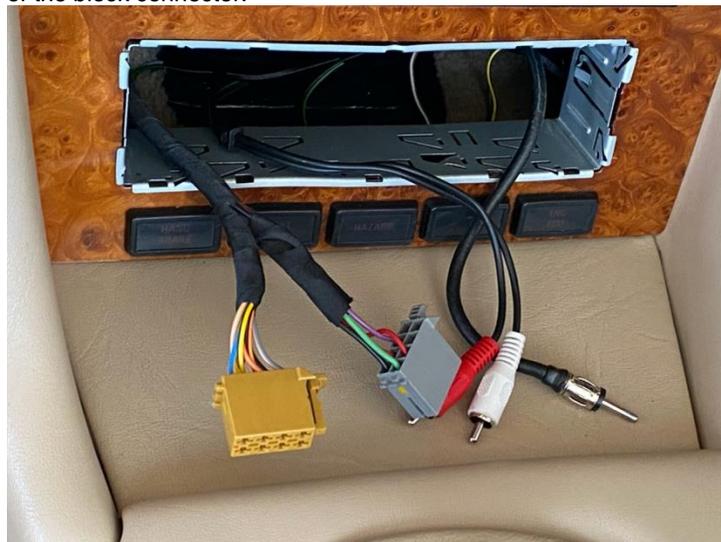
Image 1: Standard IOS plugs Grey and Tan, with additional amp trigger wire fitted to grey plug next to green power supply, additional Red and White RCA (Radio Corporation of America plugs) that will connect directly to the amp

You can see in the photo above I have used a red and black wire as the additional pin in the ISO connector which I already had, then soldered this to the vehicle harness light green wire. This then gives you the supply and trigger to the amplifier - for the earth use

For my electrical installation, I retained the fused power supply which powered the original amplifier and enabled a trigger feed from the head unit adapting the original facia radio harness by removing the small PCB (printed circuit board, about 100mm up the harness from the radio ISO plugs) and utilising the light green wire (which was the original trigger supply) to take the replacement head units trigger supply to the rear. Most replacement head units use the ISO connectors, the grey and tan coloured plugs which we already have, but without the trigger supply pin fitted in the plug. I was able to add an additional pin to the grey plug that allowed connection to the new radio head unit trigger supply (normally detailed within your radio wiring details but is often the pin next to the radio supply pin). Our ISO connectors on the RV8 do not have a pin allocated to this position, but you can quite simply purchase the ISO block connector pins (female) from the internet, then solder it to your trigger wire (light green vehicle harness) then simply plug the pin into the back of the block connector.

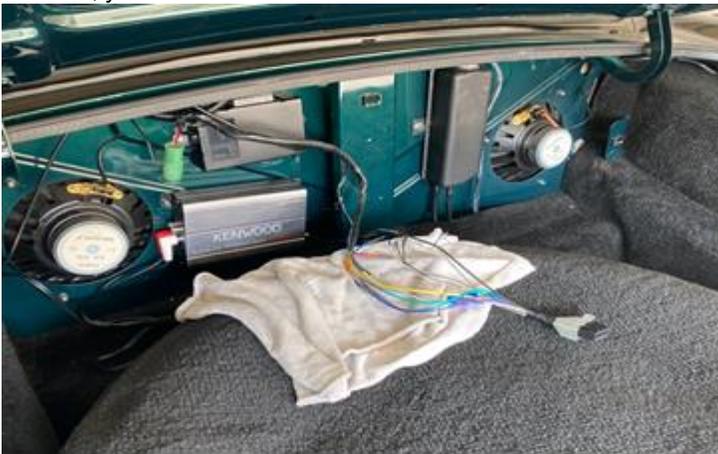
Image 2: Detailing adjustment to vehicle loom and new Kenwood amplifier plug now incorporated into harness

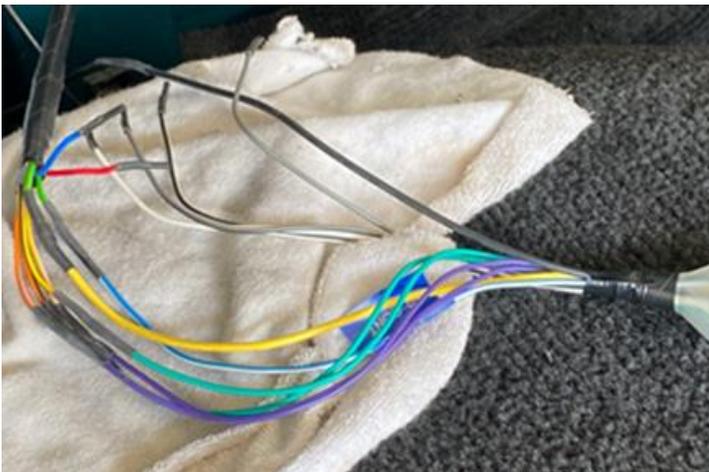
Image 3: You can see here I have removed the original vehicle plugs for the speaker connections and amp connections and soldered the Kenwood supplied loom to the two speaker outputs (orange & yellow wires), the fused power which is already in the boot (dark green) the amp trigger which is coming from the radio ISO plug (light green) as detailed in image 1 and finally the earth black wire, to the original harness that resides in the boot

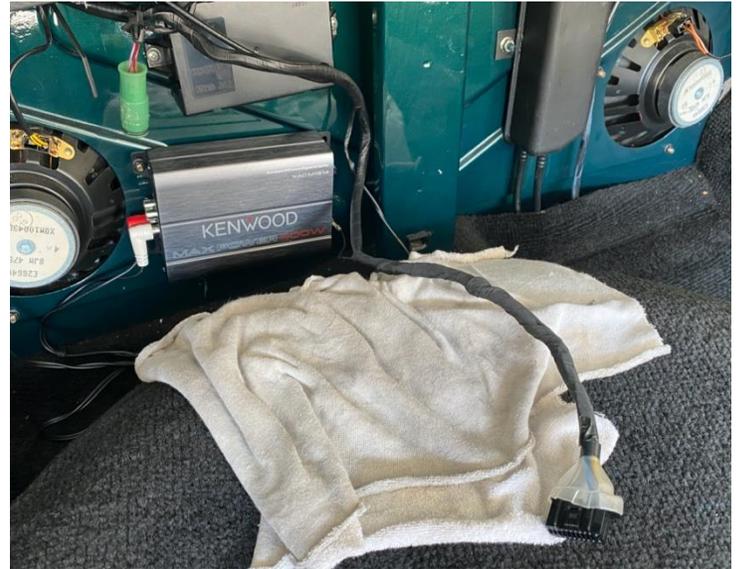
Image 4: Boot wire harness now complete with loom tape applied

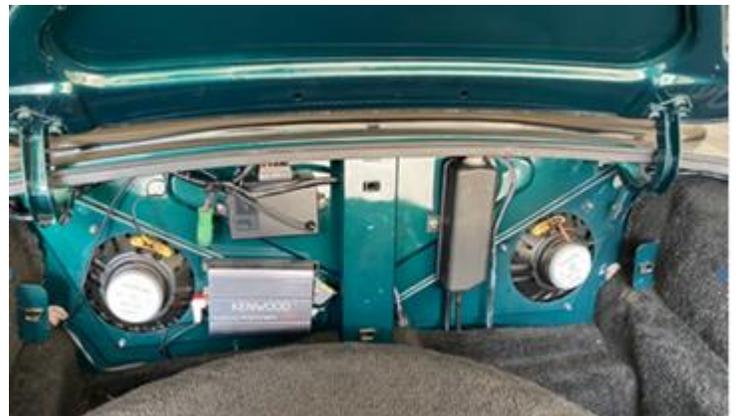
Image 5: Kenwood amp fitted in place of original amplifier using one speaker fixing and one original amp fixing, loom/harness now tucked behind central pillar, Red & White RCA plugs coming up from the carpet to connect to the amp via the small hole that exists within the rear panel towards the bottom left.

I found a company in London called "**Dynamic Sounds**" who had stock and were able to confirm its suitability for my application. The unit itself will fit quite conveniently where the old unit resided and can use one of the original amplifier's screw fixings along with one of the speaker fixing points. Albeit this leaves the amplifier at an angle, but this is only a cosmetic issue and will not impair performance as the amplifier does not require any particular fitting position. This does also avoid the need for any drilling or adapting to enable a suitable fixing retainer.

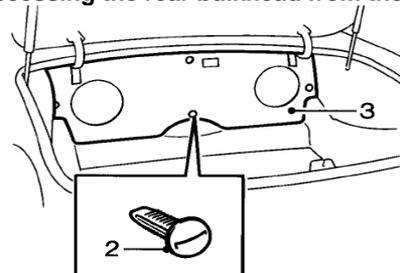
Accessing the rear bulkhead from the boot

Turn the 4 studs (2) 90 degrees and release from the retainers. Remove the carpet from the rear bulkhead (3). Position carpet on the rear bulkhead and engage the 4 studs.
