## RV8 gear lever rubber gaiter replacement

Richard Wood (Caribbean Blue 0370) from Lancashire found help from a fellow member via the V8 Bulletin Board on this occasional service item. (Sep 10)

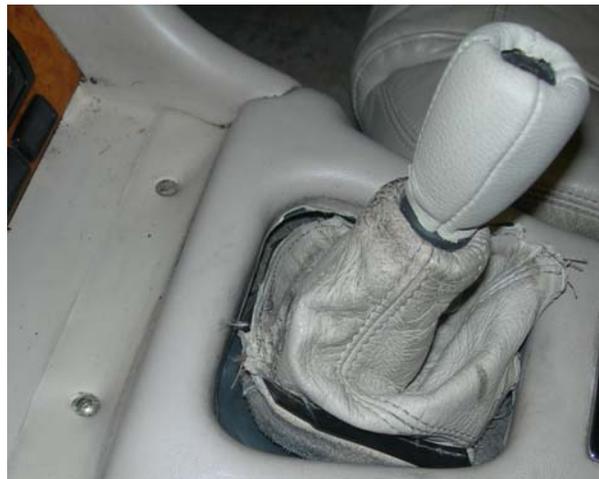
Richard recalled that he decided to tackle the worn gearknob and leather gaiter only to find that the bottom rubber gaiter had completely perished. He had a new gear knob, leather gaiter and rubber gaiter on order but wondered whether anyone had any tips on how to get new rubber gaiter over the "bulge" in the gear lever. At that stage he thought five minutes in hot water might make it more

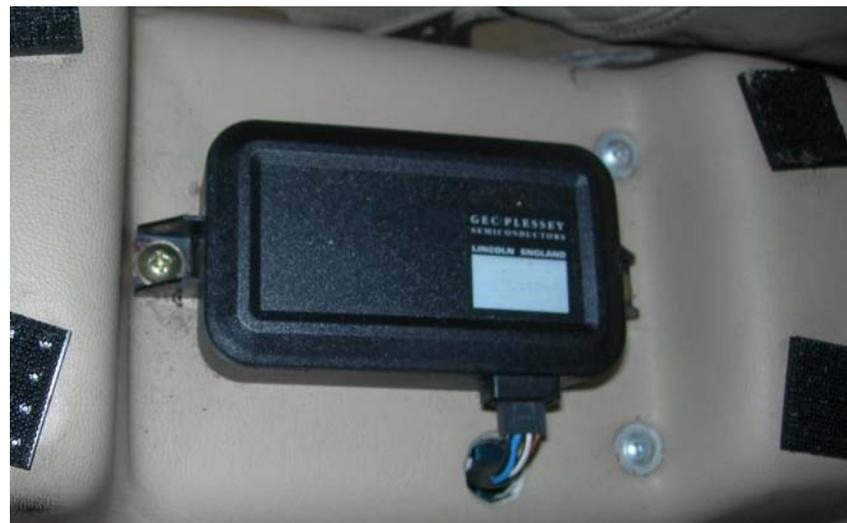
- Remove (lift off) the alarm cover from centre console and four screws are revealed. - see photo above right.
- Remove the leather covered console cover strip from in front of radio - two screws will be revealed. See photo above.
- Take a piece of string or flexible wire and attach to the alarm connector. Remove the plug from side of alarm box - centre console.

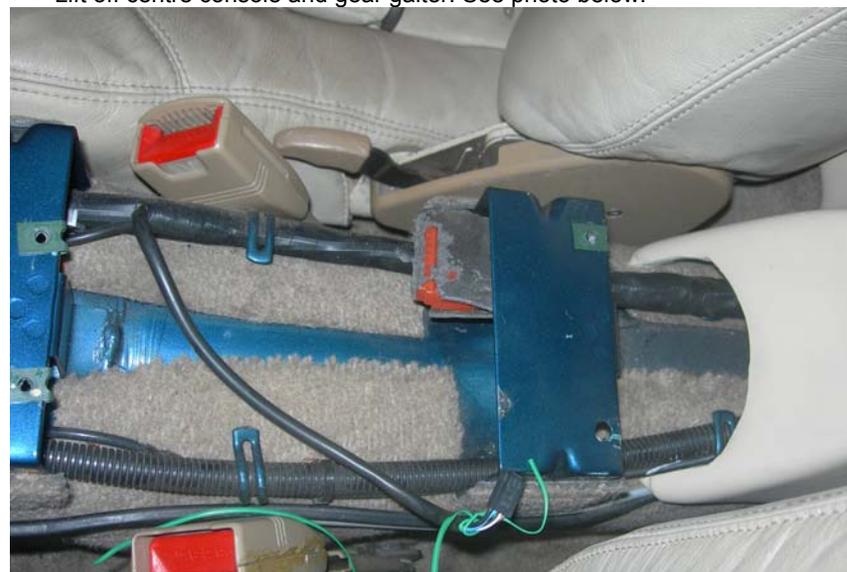
- Unscrew the two rear screws - these were longer than the middle and front ones. I also unscrewed the alarm box but this is not necessary.
- Remove gear knob - it takes a lot of unscrewing due to a long thread.
- Lift off centre console and gear gaiter. See photo below.

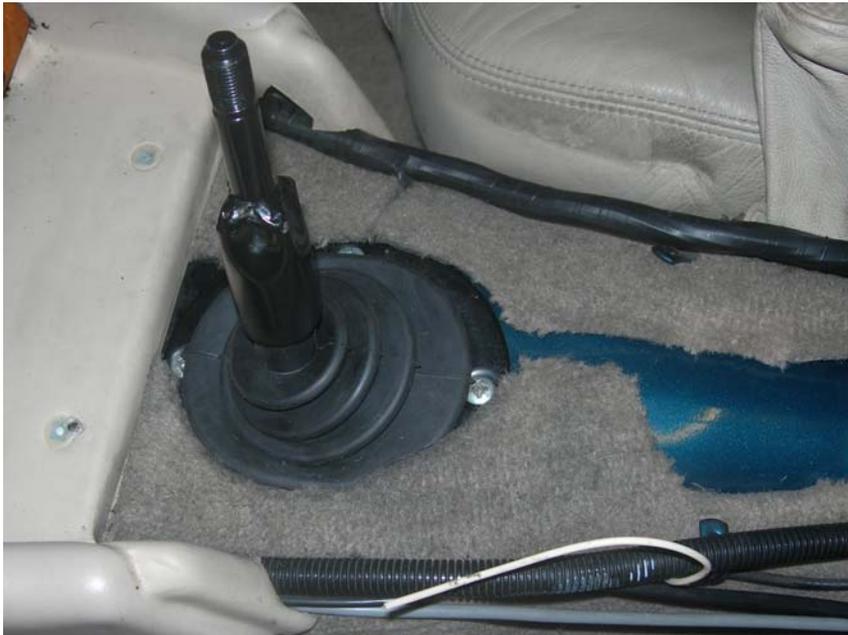
- To remove the bottom perished rubber you will need to remove a metal holding ring, this has four large crosshead screws/bolts, they fix to the car so don't worry there are no nuts to lose. Photos on the left side of page 2.

- Take off the old and perished rubber, check everything is clean and then spray the gearstick liberally with WD40 or a similar water dispersant as suggested in per Graeme's tip. Slide the rubber gaiter over. Replace the metal holding ring

and four screws and check that the gearstick will still select all gears! Mine did although the movement into second is a little tighter.

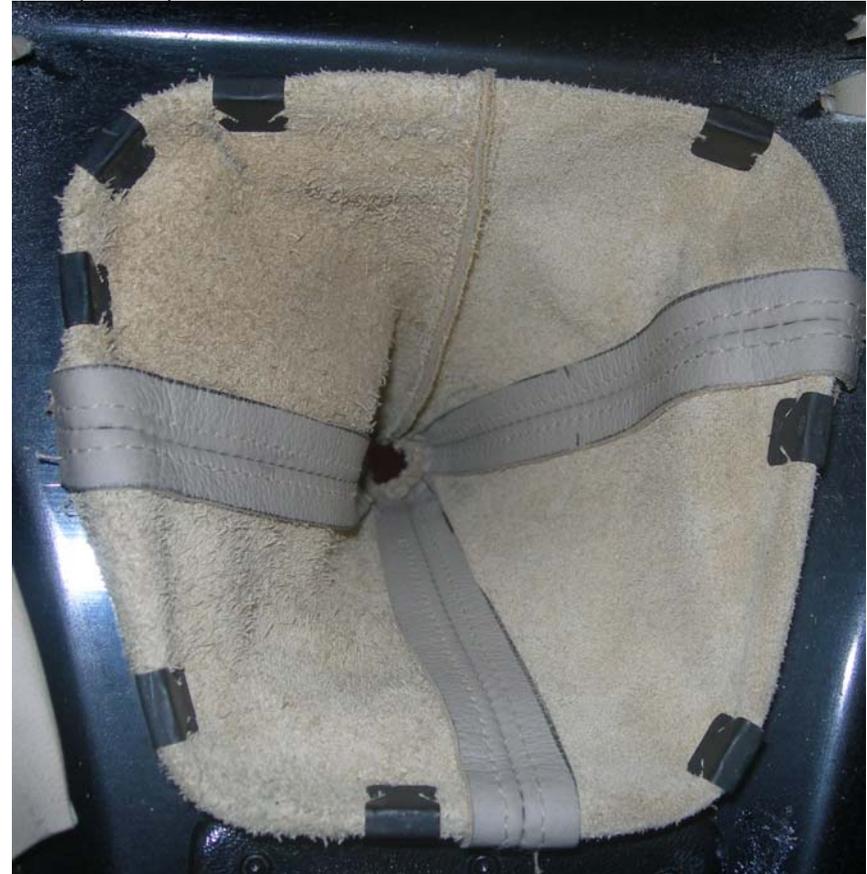
- If you are replacing the leather gaiter, it is secured to the console with metal clips. See photo below.

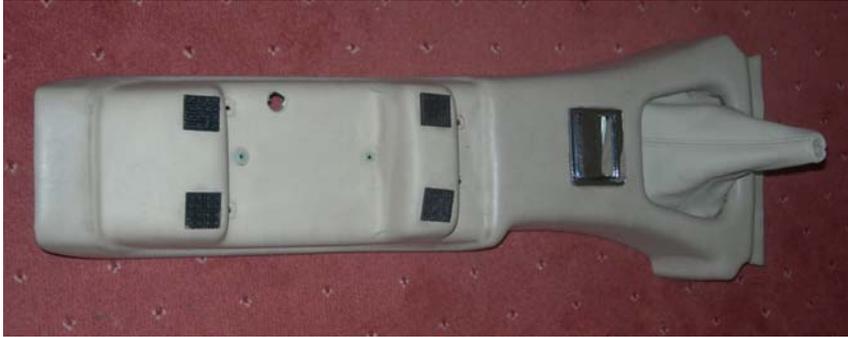
- Photo on page 3 shows complete console ready to refit, this is where the string or wire attached to the alarm plug helps!
- Refit the console, the longer screws at the rear.
- Again check that you have movement to all gears.
- Replace the gearknob.
- Replace the leather cover in front of the radio. Connect the plug to the alarm - this will need the customary three presses of the fob to synchronise when you next lock the car. Replace the alarm cover.
- The gearknob replacement comes with a lovely enamelled diagram of the later gearbox. Since I don't have that gearbox and I have yet to adjust fully to this one (as it has a different position for reverse), I removed the metal insert from

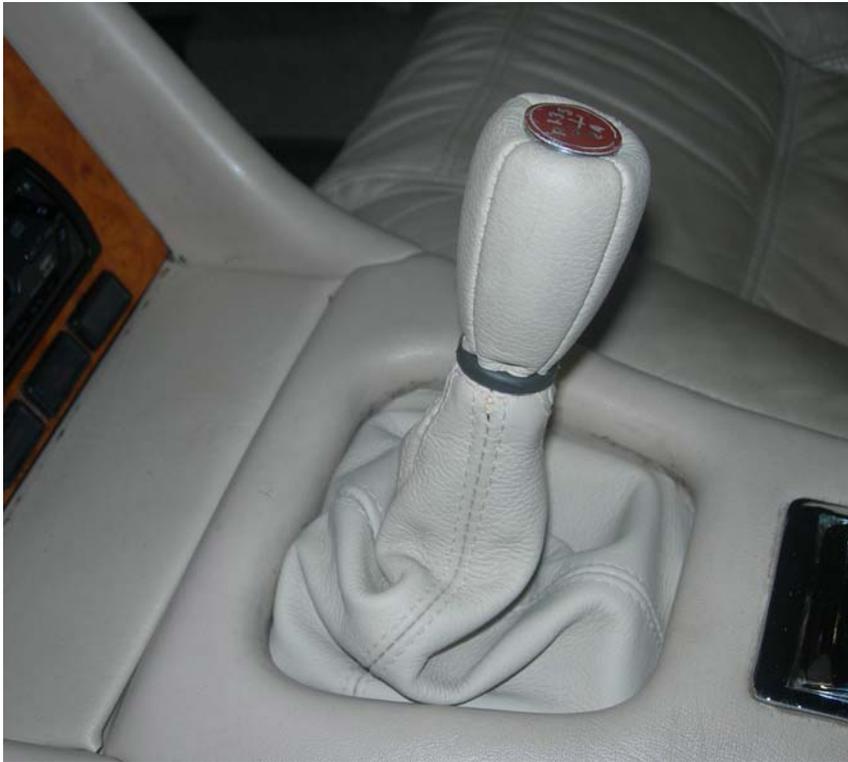
my original gearknob and glued it over the new one and completed with two coats of clear nail varnish (borrowed from the other half!). See the photo below.

Some of you may say that the position of the seams on the leather gaiter is incorrect but I like it this way. An important benefit of replacing the rubber gaiter is there is a noticeable reduction in heat leaking out the area around the gearstick.
