## Heater blower not working – RV8NOTE336

Richard Wood posted a note on the V8 Bulletin Board seeking help with a heater blower that would not work. An RV8 enthusiast in Germany, Peter Garton, spotted a possible solution which solved the problem.

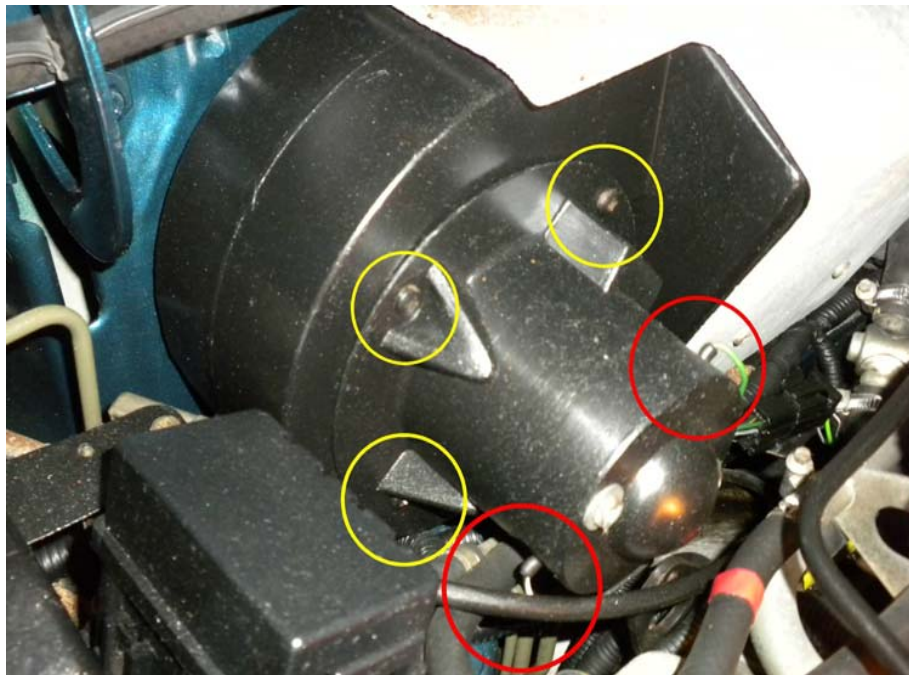
It arrived promptly and I set about fitting it which involved adapting the housing to fit. First I removed the old unit and popped a label on the two motor wires (red circles around position) and removed the four (fairly accessible) screws - three of them are shown with yellow circles around them in the photo. They hold the motor in and once removed the unit comes away very easily. The new motor needs to be fitted into the external casing of the original unit. The contacts for the wires are in a slightly different position, but nothing that a torch and a Dremel (or similar) multitool cannot resolve. The picture below shows the original (yellow) and the new (red) wire positions.
