RV8NOTE352

Refurbishing the seats on an RV8

Olav Jansen found the seats on the ex Japanese spec RV8 he bought were rather dirty and the iron frame was somewhat rusty, so he took out the seats to carry out a refurbishment. (Sep 11)

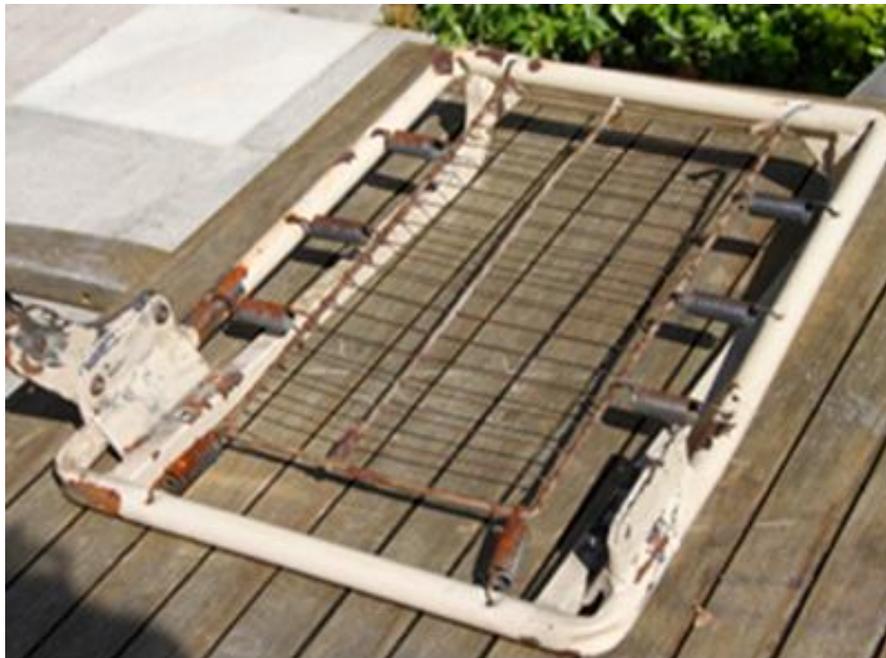
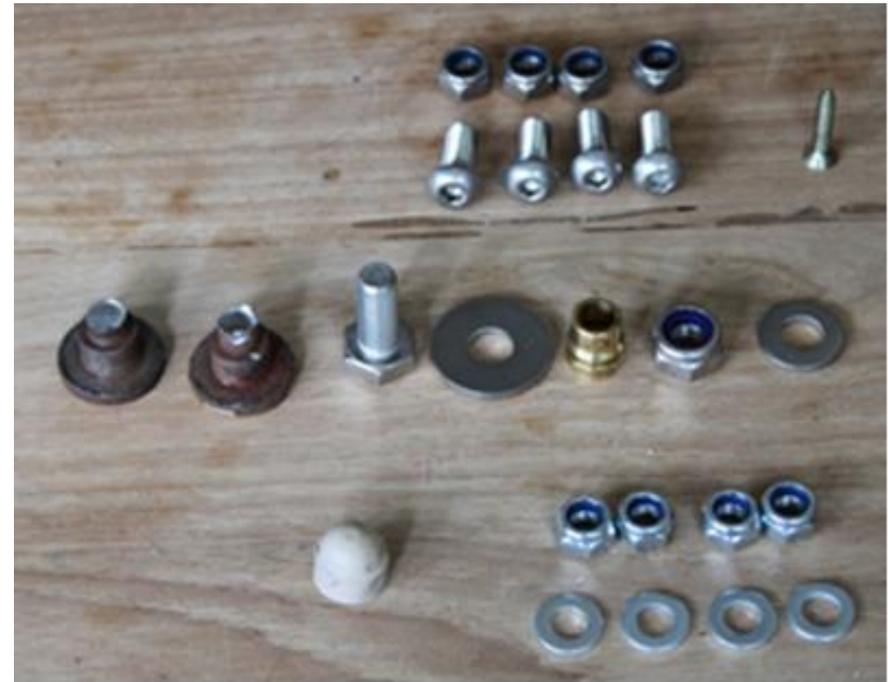
Top: four Allen key bolts to join back rest to the seat

Middle left: two original pivot axles

Middle right: replacement with yellow sleeve being the collar to make bolt fit in the pivot hole

Bottom: four self-locking nuts and washers to bolt the seat frame to rails.

You can see all the hardware needed to put the two parts of the seat back together again in the photo above. The pivot bolt that was welded to the seat exists of 3 stages with 3 different diameters. You need to find a collar for the big bolt with an inner diameter to fit nicely over the bolt without any play and with an outer diameter to fit neatly into the slot of the seatback. I found something in the plumbing department of a well equipped hardware store but you will have to be inventive. From here it is all straightforward. The total cost for refurbishing two seats was €250 or approximately £218.
