Fitting a V8 Register grille badge to an RV8

John Anthistle says he hasn't fitted an MG Car Club badge to his RV8 and it sounds a bit different. He did however fit a V8 Register grille badge (see above) some time ago and decided this was most

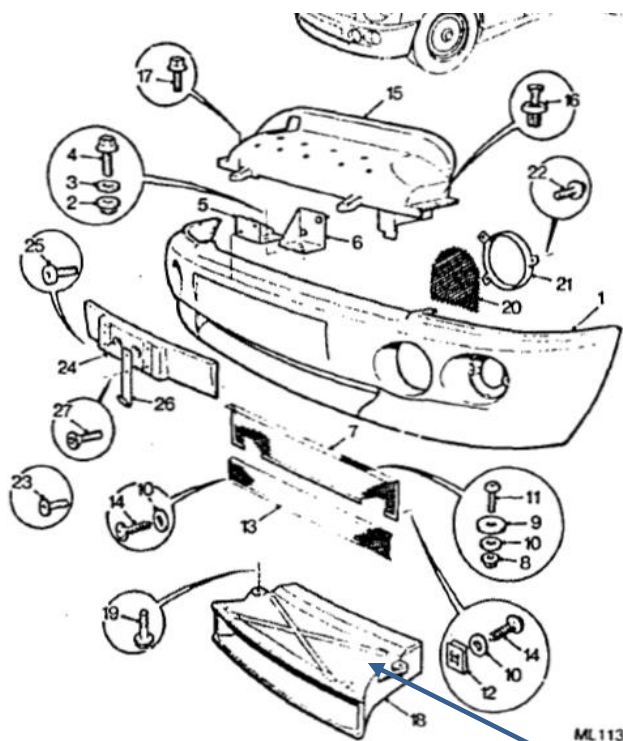
RV8 Parts Fiche, Section O 02, Item 18 is ZKC6634 Duct – lower radiator

Locating the duct for removal for hand access behind the grille mesh

John says "to get an idea of the part to which I am referring, have a look at the RV8 Repair Manual AKM7153ENG section 'Body Repairs' page 2 - the duct is there referred to as an '**under cowl**''. It is more clearly illustrated on the RV8 Parts Fiche, Section O 02 Item 18 where it is referred to as a '**duct**'".

John adds that despite what the Repair Manual says, you can remove the under cowl and gain access behind the grille mesh with the vehicle on the ground so avoiding the need to raise the car.

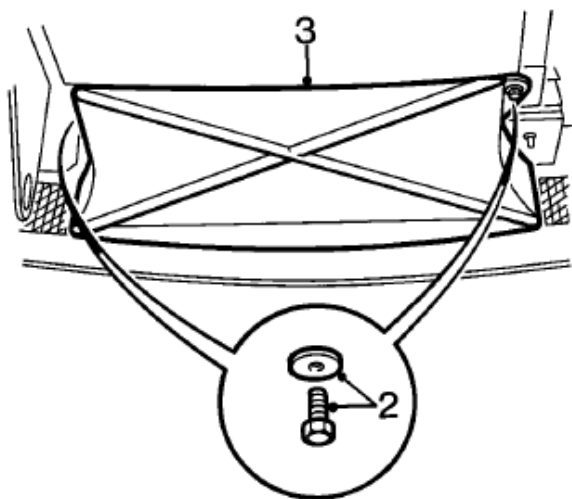
RV8 Repair Manual AKM7153 section Body Repairs page 2

UNDER COWLING

Service Repair No. 76.10.50

Remove

1. Raise front of vehicle.

WARNING: Support on safety stands.

2. Remove 2 bolts with plain washers securing under cowl to body.
3. Remove under cowl.
