MGB V8 Roadster restoration project – Report 13

Wednesday 25th February 2015

Attacking the rust on the floor pan

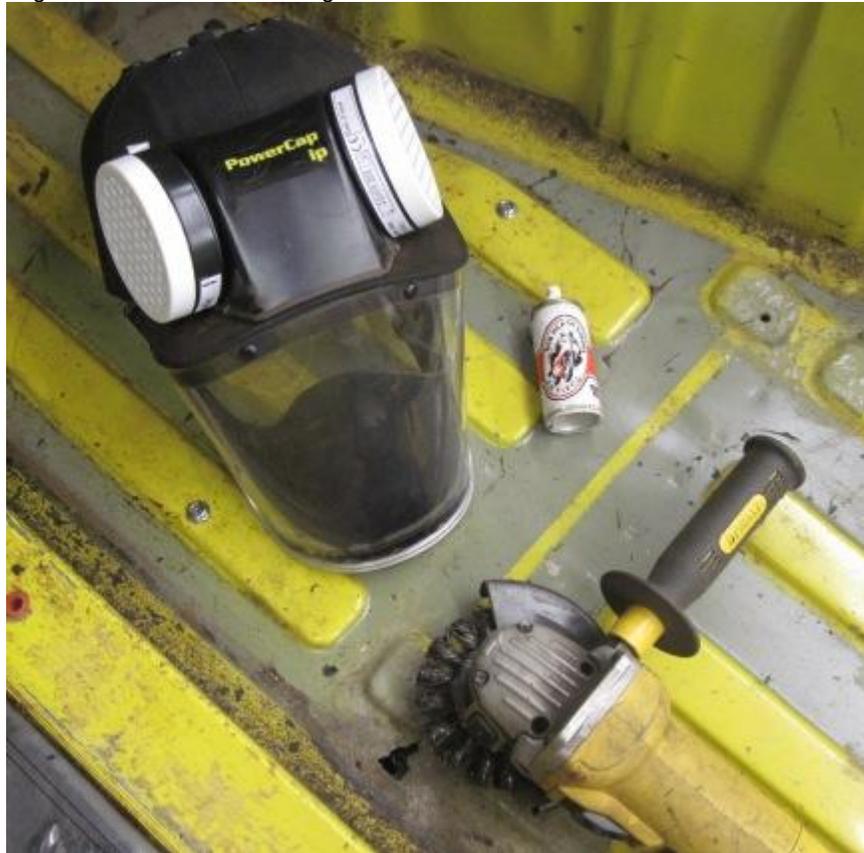
Instead of the engine work I decided to attack the passenger's floor pan. I suspected some rust under the raised parts of the floor that were between the original black sound deadening material.

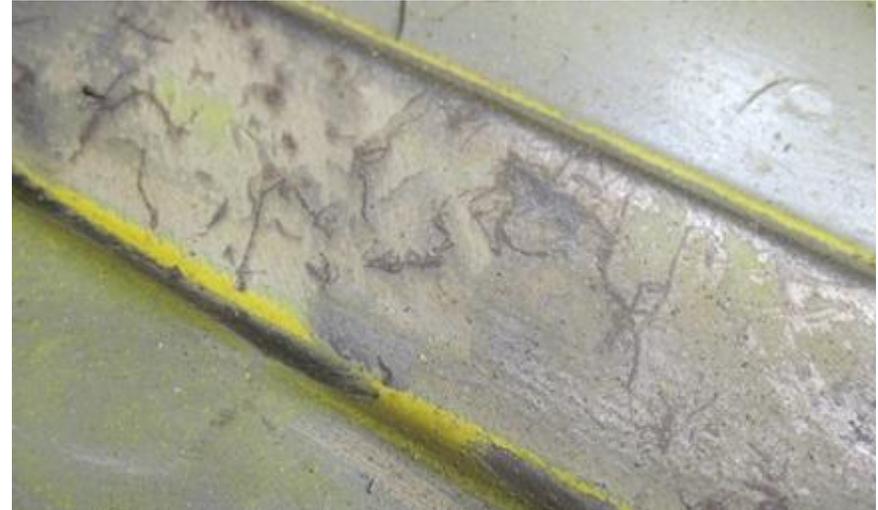
First of all I used a knotted wire brush on my De-Walt angle grinder to remove the British Leyland tar that they used as seam sealer. Also it stripped the paint off the suspect bits of floor and uncovered the spiders webs of rust that you seem to get with BL cars of the 70s. The knotted wire brush seems to vaporise the tar so it can easily be swept up. As you get a lot of dust, I use a Power Cap mask that filters the air into the mask. The aerosol next to it is a visor cleaner for motorcycle helmets.

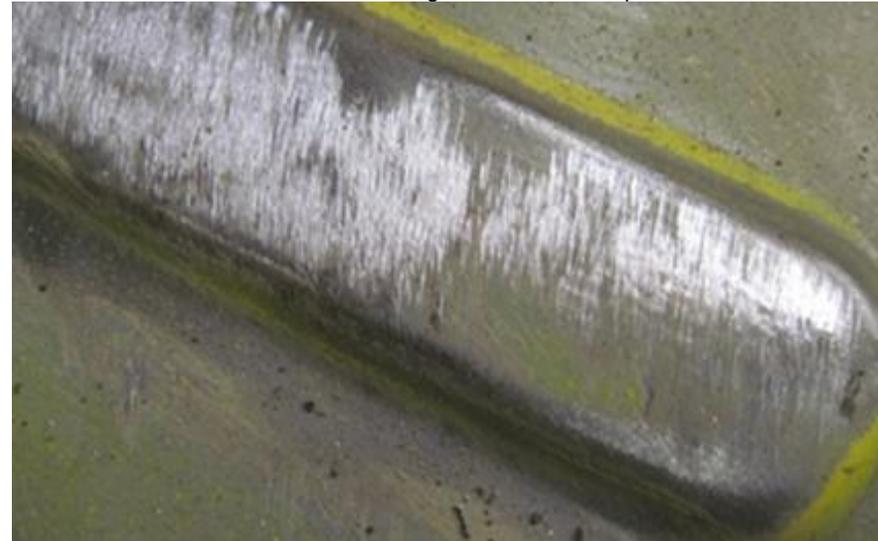
Sure enough under the paint were the **rust spiders**. Next I used the reversible drill with the "mule skinner" attached to grind out the rust spiders.

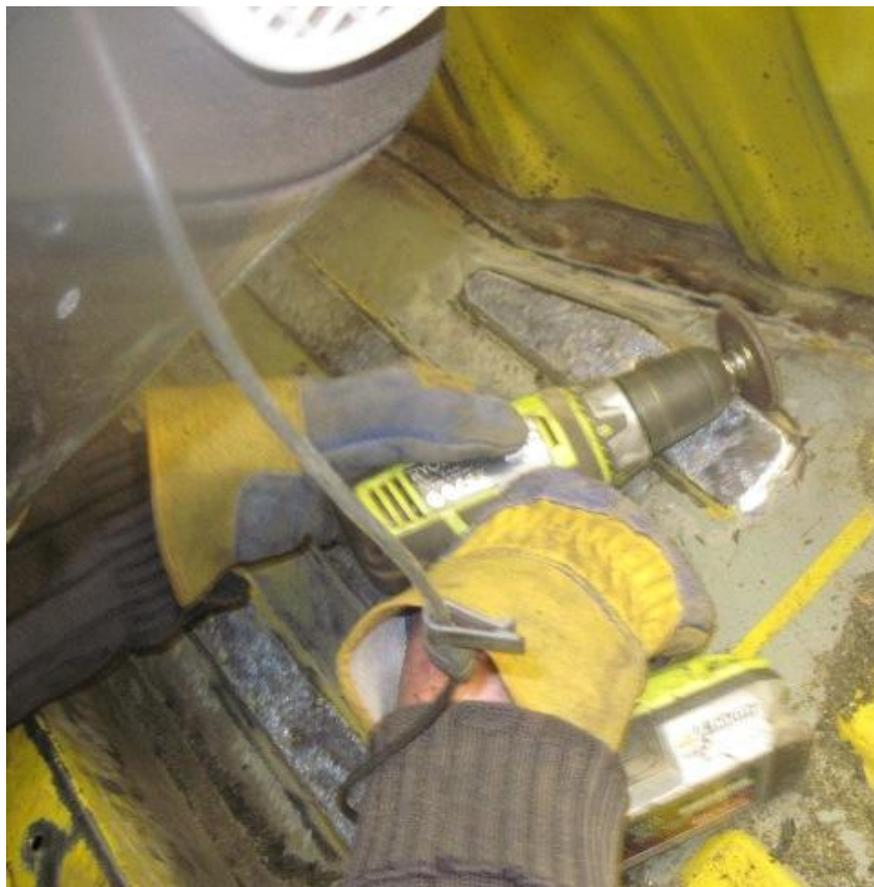
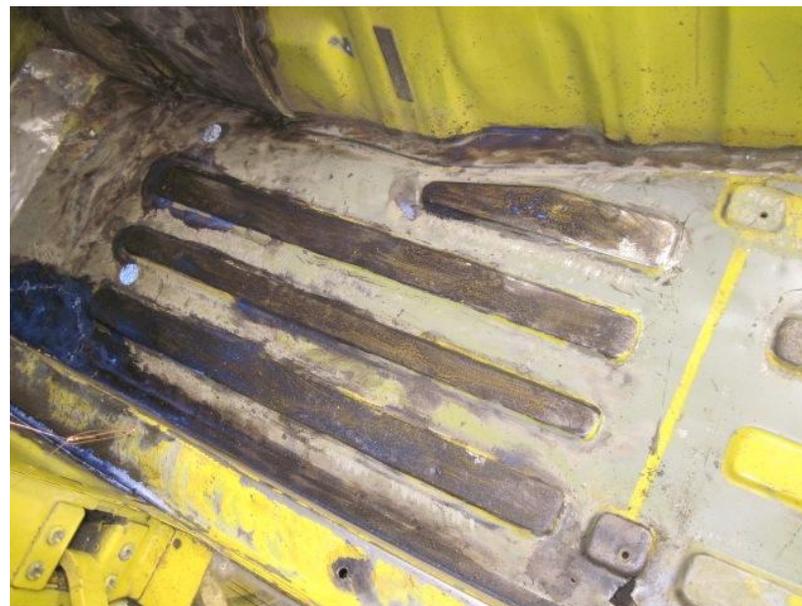
Rust spiders ground out.
