Replacement clutch master cylinder on an MGBGTV8

David Brown, with a rubber bumpered V8 Roadster Conversion carried out by David Franklin using a late 1980 MGB with a five speed gearbox, posted a query on fitting a replacement clutch master cylinder saying "having replaced the clutch slave cylinder, I set about replacing the clutch master cylinder too with part number GMC 1011 (plastic reservoir type). But I've found the plastic cap can't be undone as the cap fits under the pedal box recess on the bulkhead with insufficient clearance. I have stripped out that replacement unit and put back the old master cylinder. What do I need to do to make the replacement and what part number do I need? The clutch pedal was pretty heavy compared to the Factory MGBGTV8 we have but this has always been the case with this car.

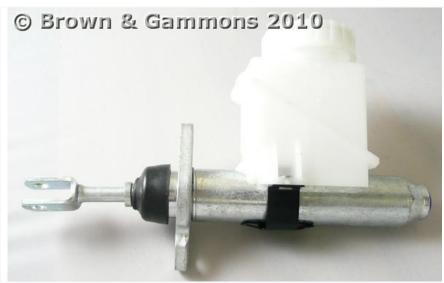
GMC 1011 replacement V8 clutch master cylinder (B&G website)

Geoff King, with a V8 Roadster built on a Heritage shell, responded saying "you are not the first to discover that **GMC 1011** with the plastic reservoir doesn't fit but it can be made to fit by removing the reservoir from the master cylinder and refitting it the other way round.

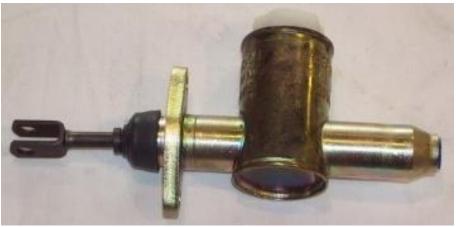
GMC 1011 V8 clutch master cylinder for an MGBGTV8 (1973-76) is shown on offer from Leacy Classics

In a subsequent posting Geoff King highlighted the **Leacy Classics** at Perry Bar Birmingham have a **GMC 1011** (metal reservoir type) on their website: www.leacyclassics.com/gmc1011.html

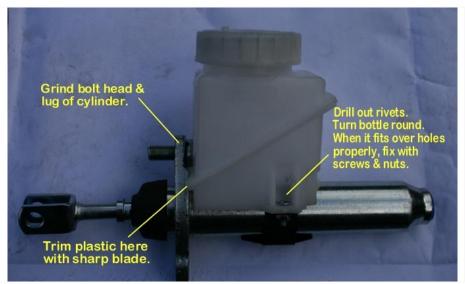
Modified GMC 1011 V8 clutch master cylinder (Mike Howlett)

Mike Howlett added "I have fitted the plastic reservoir clutch master cylinder by turning around the reservoir. It isn't too difficult but does need a little ingenuity to make it work. I have a couple of photos I can email to illustrate the change." The photos Mike provided are included in this note. Mike then added "I bought **GMC 1011** from a well-known supplier and when I found it didn't fit, I contacted them and they were completely unhelpful saying they had never come across this before. There seemed to be no alternative but to swap the reservoir round, so that's what I did. I have had three year's use so far with no problem."

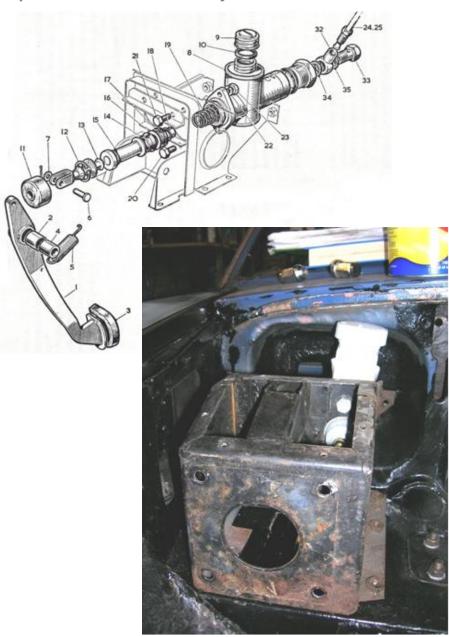
Left: Diagram of the MGB pedal box and clutch master cylinder (MGB Workshop Manual, page E6 AKD3259). Right: a later MGB pedal box (Mike Howlett)

Mike Howlett later highlighted what may well be an explanation for the difficulty experienced by David Brown by saying "from memory, and from looking at my photo of my pedal box (see below) I think it was more than the cap size that prevented me from using the replacement clutch master cylinder without modification. I really wonder if it is only a problem with the very late MGB pedal box which I used and I believe David is also using. The Factory MGBGTV8s used single line brakes with remote servo didn't they? If so, the pedal box is quite different (see the diagram below reproduced from the workshop manual) to the later one designed for the in-line brake servo and dual circuit master cylinder. Have a look at my photo and see what you think."
