## MGBGTV8 - door seal sill retaining strip

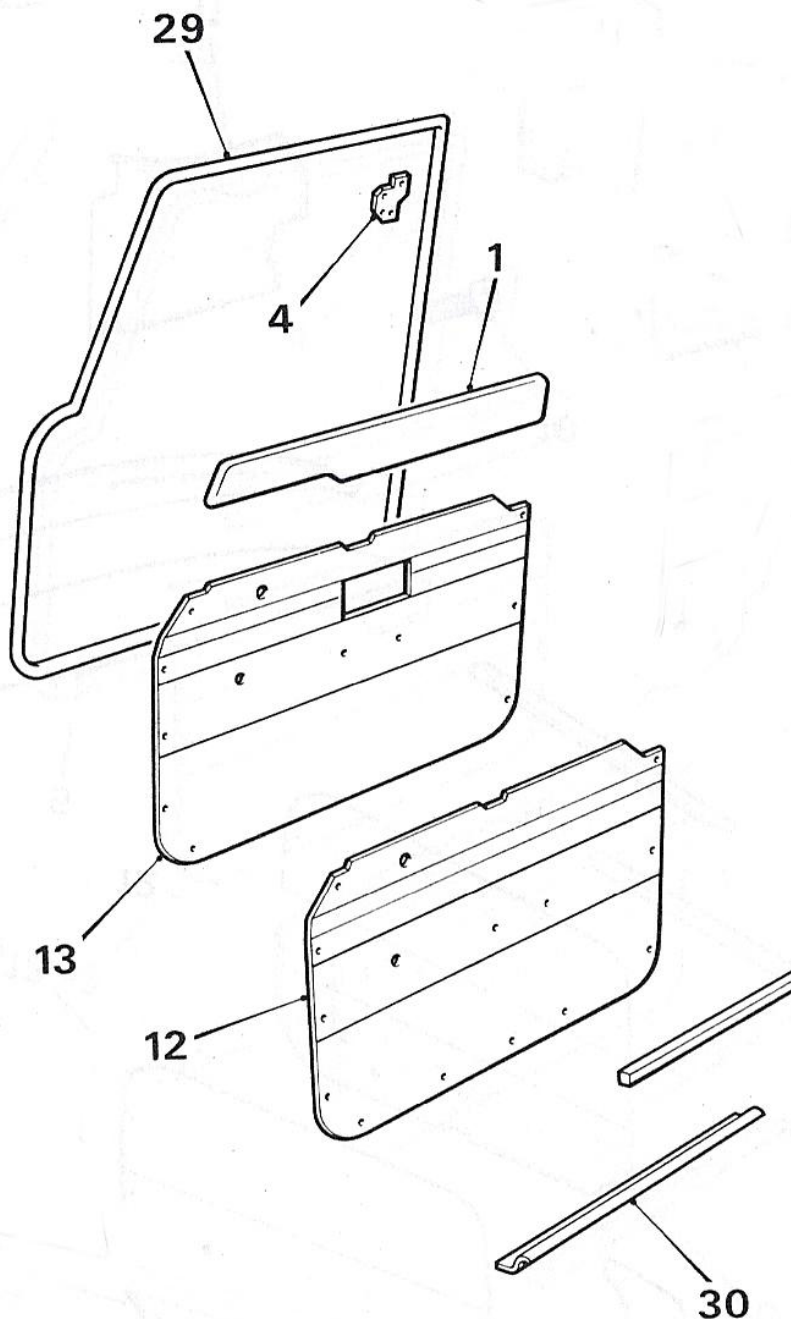
The part is a metal strip (item 30 alongside and above) to retain, or more likely protect, the sill section of the rubber door seal (item 29 alongside). It is fixed to the rubber mat sill. See item 30 above, part number **AHH7768**. See pages 108-O 29 & 108-O 30 in the parts manual AKM0039.

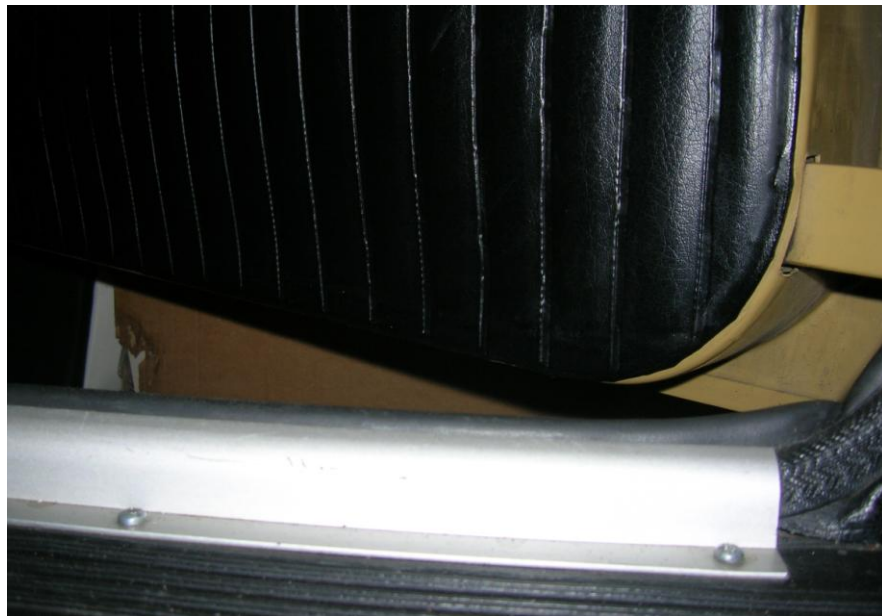
**Left:** view from passenger legwell to the door seal sill retaining strip showing it has a profile like a number **2**.

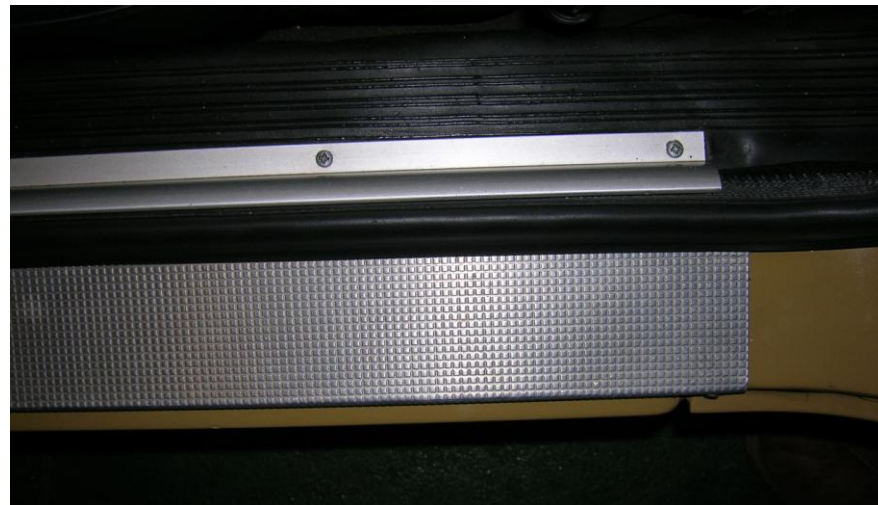
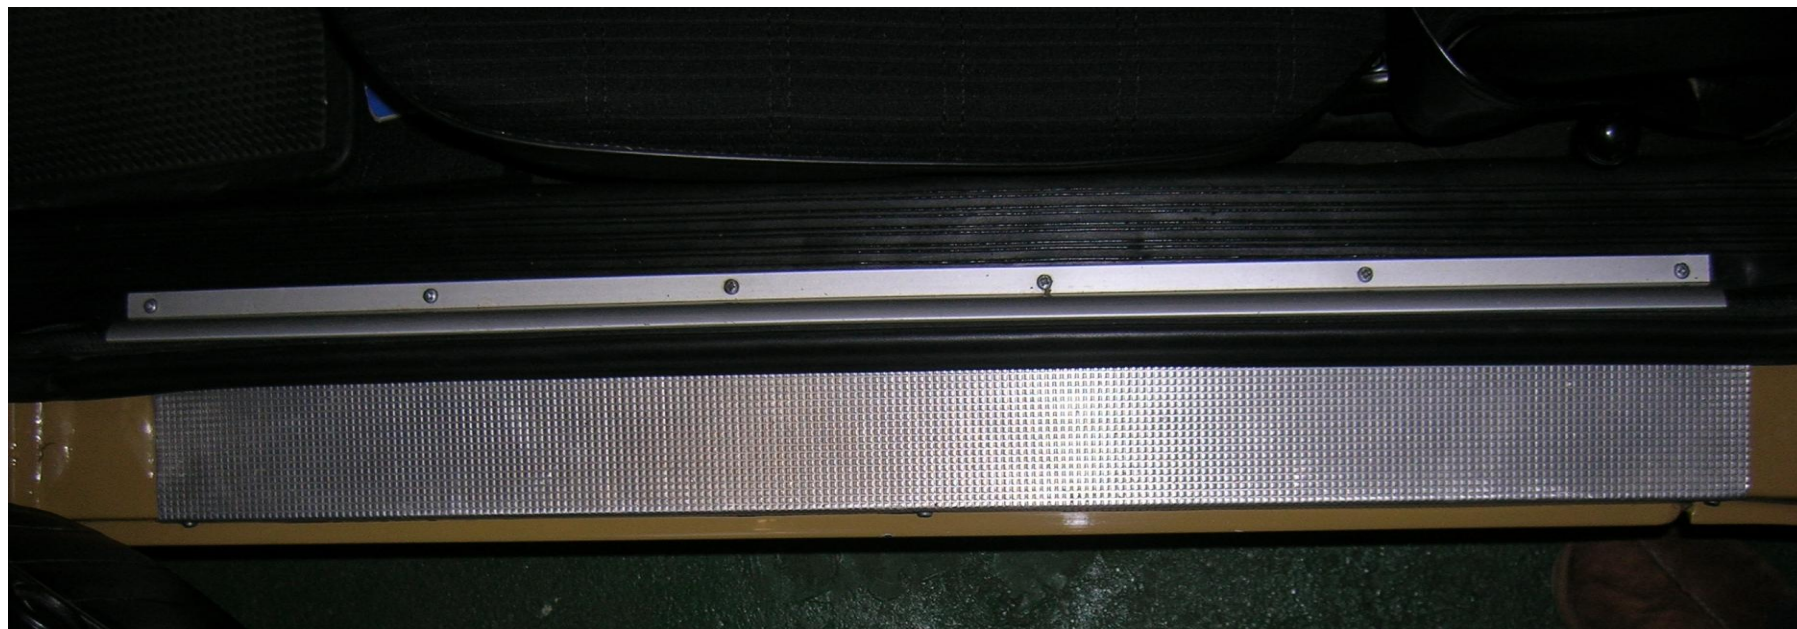
**Above and below,** the strip is fitted over the rubber mat sill with six fixings.
