## Tracing a puzzling misfire on a Factory MGBGTV8 and finding replacement wiring harness clips

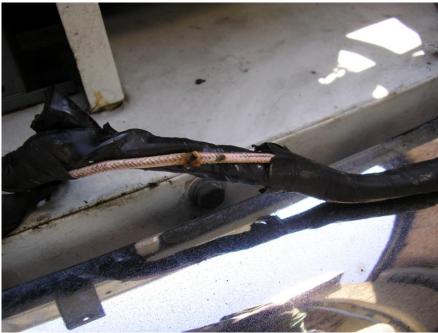
Looking very carefully around the engine bay I then noticed the front wiring loom was damaged; it had been fouling on the bonnet catch and of course, the catch had worn through the loom. Thankfully the problem was finally solved and was temporarily fixed with some tape.

I imagine that when the car was resprayed by a previous owner, they discarded the wiring harness clips which go on the panel above the oil cooler (the bonnet lock platform) and in their place put in "P" clips neatly underneath. The original MGB loom would have gone through the hole in the brace panel below but the v8 loom is too thick so the Factory introduced clips, which the rubber bumper cars also use, to fix it to the front of the panel well away from the bonnet catch. Imagine my relief at solving this one. (Ignore the white wire in the photo (top right) as this was for the old electronic ignition and redundant.)"

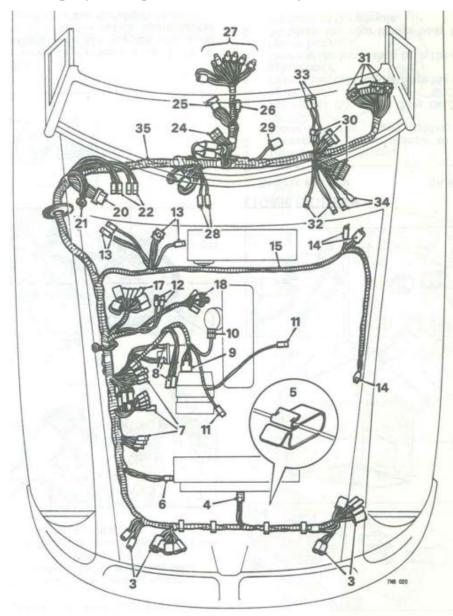
lan Ailes enquired "do you know if these clips are available anywhere? – see item 5 on the diagram of the main wiring harness above. I cannot find a part number anywhere but they are mentioned alongside the diagram as the harness retaining clips on the bonnet lock platform."

Peter Beadle responded saying "there are two sizes of this clip - BHA4232 the smaller clip is designed to support two cable bundles up to 1/4"dia each and BHA4233, the larger clip which is designed to support two cable bundles up to 5/16"dia each. Both sizes were used on MG Midgets whereas the MGB Parts Catalogue AKM0039 only lists BHA4233 Clip –edge on page 108-H 50. I think that both Moss Europe and Brown & Gammons supersede the two part numbers above to a "similar" clip, BHA4473, which performs the same function and still looks correct. They both currently have a stock of BHA4473 (Wiring Edge Clip) at approximately 60p each."

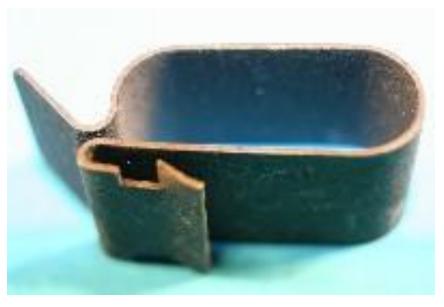
When you look up BHA4233 on the Moss Europe website it says it has been superseded and directs you to **BHA4473** as Peter says:

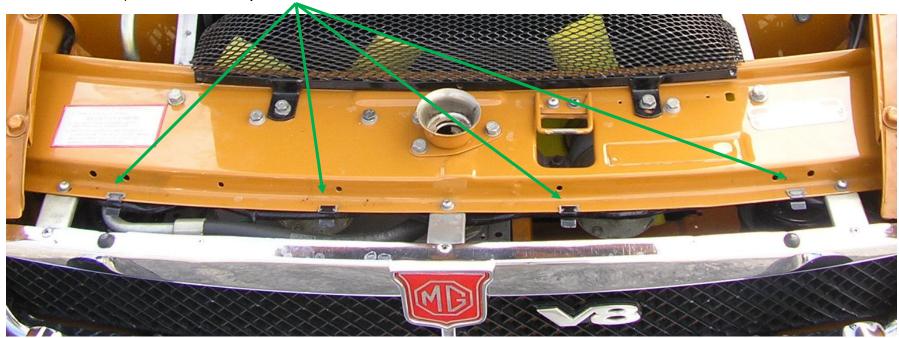
**Peter Beadle** provided this photo of the clip used to secure the wiring harness under the bonnet lock panel – see the **four clips below**.

He added that he had checked on his MGBGTV8 and "all 4 clips are the same and designed to accept up to two bundles of 5/16"dia cables. I also checked on my late 1979 MGBGT and found the same. I assume they were used right up to the last MGB off the line in late 1979."
