Replacing the spring on the tailgate stay assembly

Mike Russell sought help with replacing the spring on the tailgate stay assembly with a posting on the V8 Bulletin Board. The response was useful.

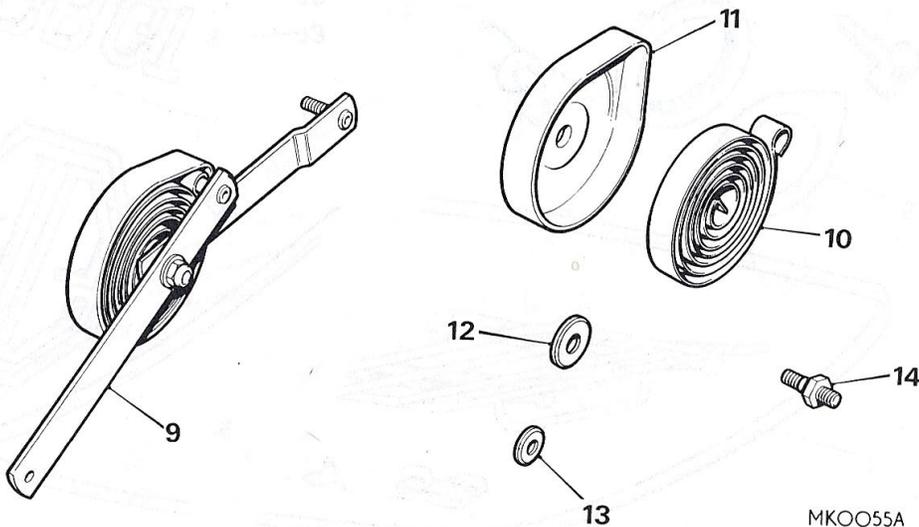
Left, tailgate stay assembly – 9 tailgate stay assembly RH (AHH7900) and LH (AHH7901), 11 spring cover (AHH7899), 10 spring (AHH8049), 12 cap cover large (AHH7578), 13 cap cover small (AHH7579) and 14 pivot stay stud (AHH7575).

Changing the spring is not too difficult, can be done with well gloved hands. Pushing on the two caps is fiddly, they are easily dented. Adjust the positions of the two lower mounting studs so that both stays 'lock' evenly when the tailgate is up. Actually I get the feeling that the unchanged stay now has a weaker spring, so I might replace that spring with the other one from the eBay stay."

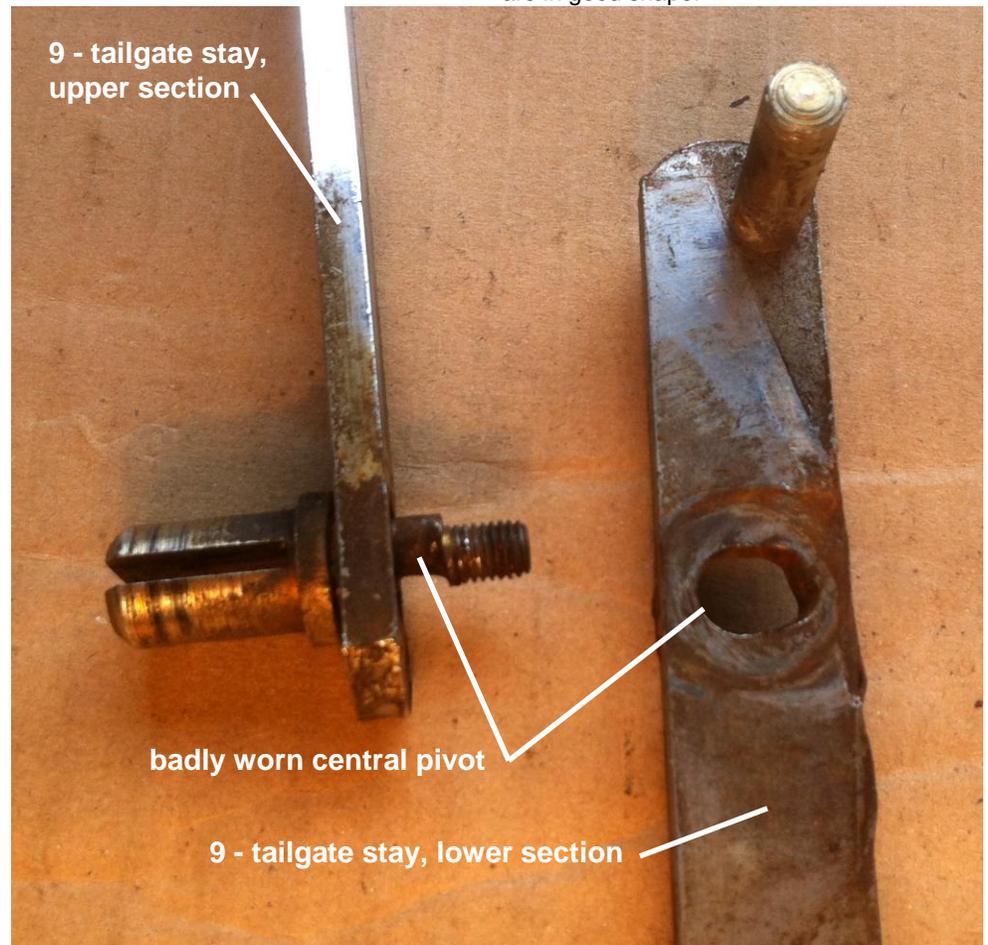
they were rough looking was not a problem. But, nobody would have wanted to risk them on a car. The pivot pin and the corresponding hole in the lower arm were seriously worn (see below). Probably something we should be looking at on a well used BGT.

Below: scary picture of the worn pivot pin on Jim Gibson's second hand parts. The pivots on his V8 get a drop of oil now and then and are in good shape.
