Changing the differential thrust washers on an MGBGT V8

Dugald MacNeill went up to Norfolk recently to visit his old friend Mike Macartney and while he was there Mike very kindly offered to help Dugald change the differential thrust washers on his Factory MGB GT V8. The car had been comprehensively restored four years ago but there had been a back axle clunk for some time and Dugald had been working himself up to fixing it. Dugald took photos during the work and explains how the job was done.

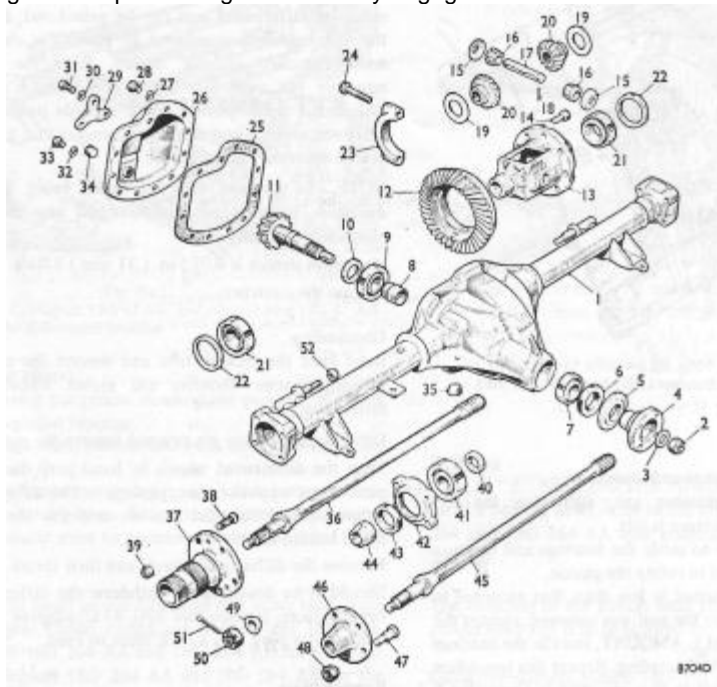
If you look at the photo below of the differential assembly in conjunction with the page from the workshop manual on the right, you will see that there are four bevel gears meshed together and all are contained within the differential cage. The two small gears (differential pinions **16**) are mounted on the pinion pin **17** and the two large gears (differential wheels **20**) are mounted on the splined inner ends of the two half-shafts **45**. Behind each differential pinion **16** is a bronze spheroidal thrust washer **15** and behind each differential wheel **16** is a flat fibre washer **19**. When power is applied most of the force from the engine is transmitted via the crown wheel and differential to the two drive half-shafts. But some of the force between the bevel gears is transmitted axially outwards on to the thrust washers – this force is trying to push the four bevel gears apart, thrusting them on to the thrust washers. That is why the washers are called thrust washers.

These washers do two things: they reduce the wear between the

gears and the cage and they act as shims to ensure that the bevel gears are pushed together and fully engaged.

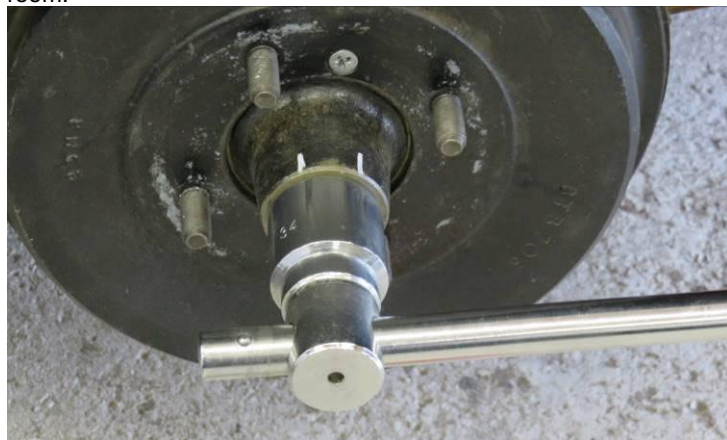
First thing to do was to jack the car up onto stands which were placed under the front spring hangers to give ourselves plenty of room.

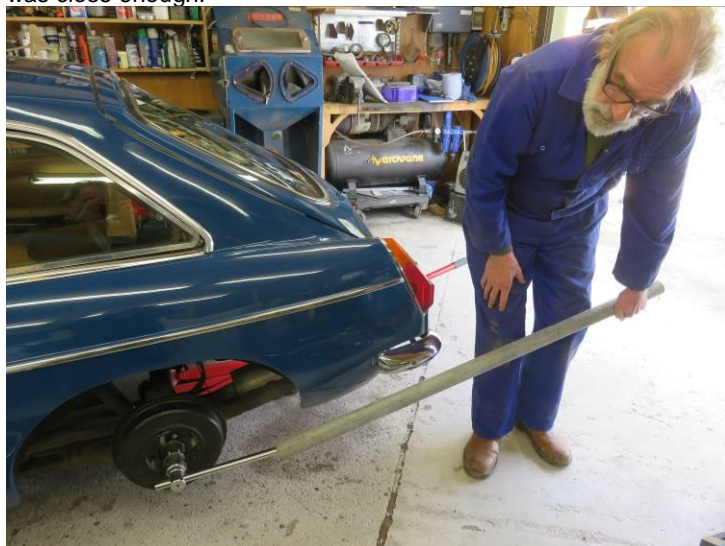
We needed to withdraw one of the axle half-shafts by a couple of inches to remove the two larger bevel gears (pinion wheels) from the cage. We decided to withdraw the left one which is on the crown wheel side. We had to get the drive shaft nut off, first marking its position on the hub for reassembly. Mike couldn't find his 1-5/16" socket and I forgot to bring mine so he used a 34mm socket which was close enough.

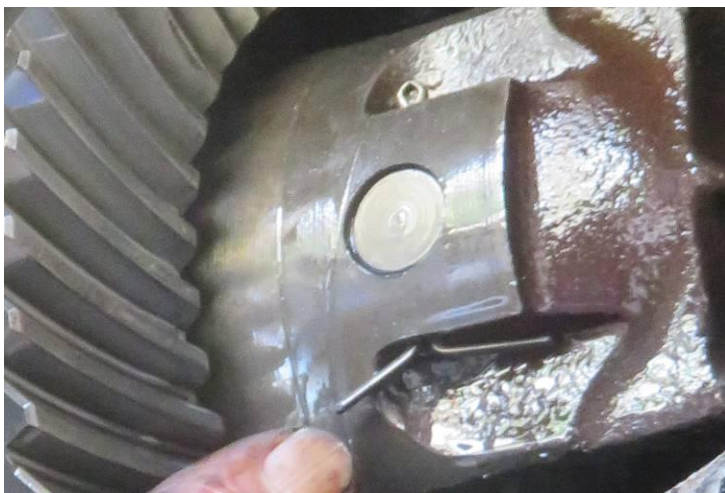
Interestingly, when we removed the rear cover we found that a split pin had been fitted inside the roll pin that retains the pinion pin. This is not a standard fitting and was not put in by Mike when he restored the car. I presume that it was put in by the previous owner before I first acquired the car in 1983. I had intended to fit one anyway while replacing the thrust washers. The split pin is supposed to prevent the roll pin from falling out. The modification was first proposed many years ago back in the 1980s and it provoked a lot of debate at the time. For a discussion, see Peter Laidler's [V8 Workshop Note 98](#).

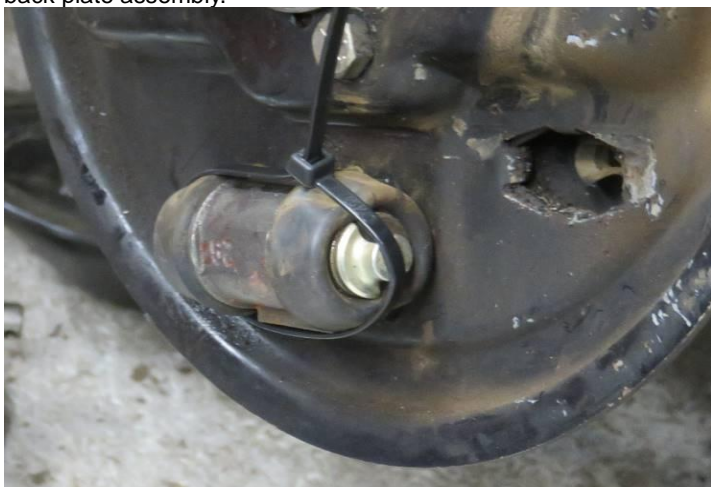
After taking off the brake drum, wheel hub and brake shoes, Mike put a cable tie around the pistons to retain them within the brake cylinder. We didn't want to disconnect the cylinder from the hydraulic system and have to bleed the brake cylinder afterwards. The copper hydraulic brake pipe was carefully unmounted from the axle. The brake cylinder was left attached to the brake back plate which was unbolted from the flange at the end of the axle and then carefully suspended on wire from a rebound strap mounting with the hydraulic pipe still attached.

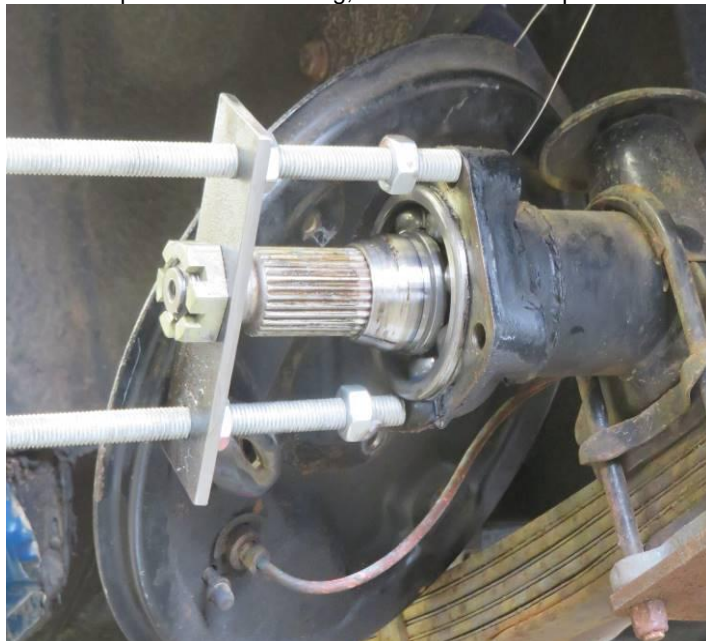
Now we went on to pulling out the half-shaft. Mike made up a tool from a couple of bits of studding, several nuts and a plate.

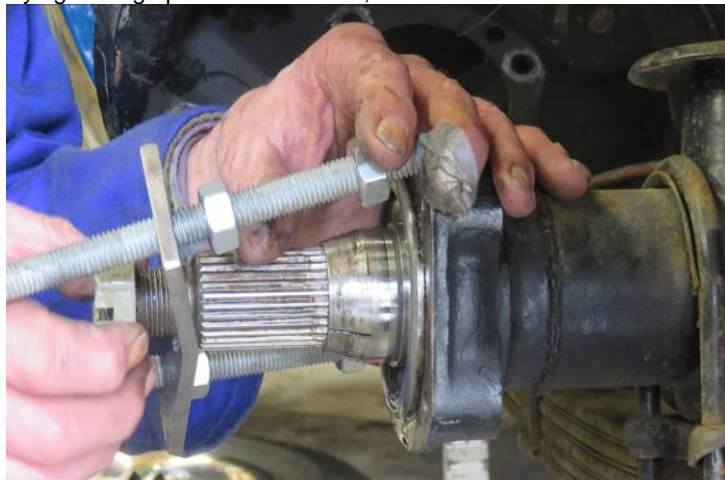
By tightening up the hub shaft nut, the half-shaft should come out.

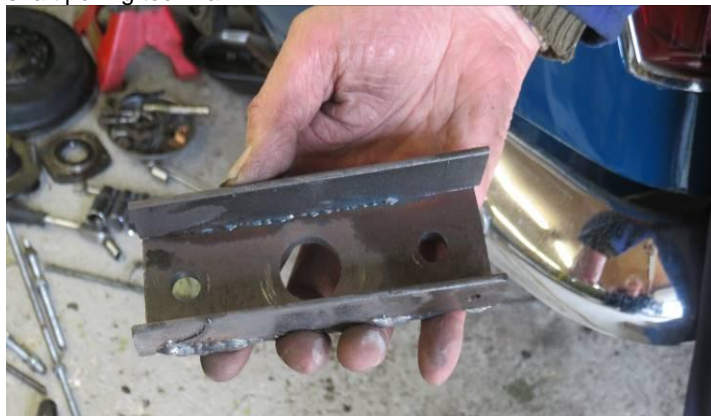
Oh dear, the plate has bent - it wasn't strong enough! On to half shaft pulling tool Mark 2.

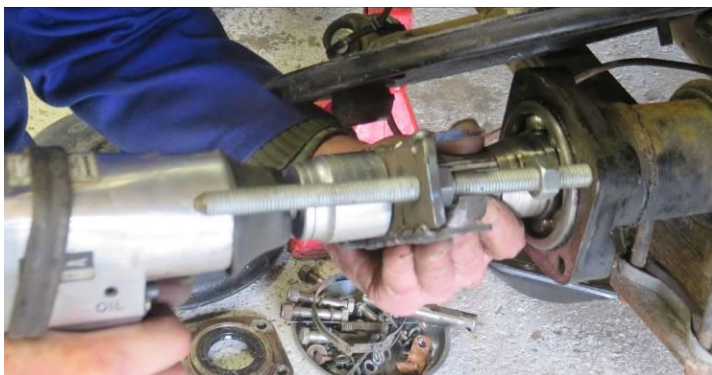
Mike straightened out the plate and strengthened it by welding on a couple of side flanges.

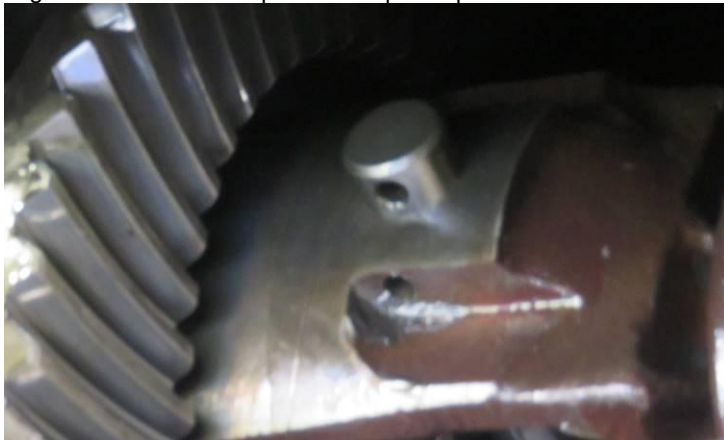
First Mike pulled out the split pin from the roll pin and then drifted out the roll pin with a pin punch. Note the paper towel positioned to catch the roll pin when it was knocked through.

Next Mike removed the pinion pin. He pulled the cage around until the opposite end to the roll pin end was facing him. The pinion pin was tapped out **JUST ENOUGH FOR THE ROLL PIN HOLE OF THE PINION PIN TO CLEAR THE CAGE**. Tap it too far and the cage can't be rotated to pull out the pinion pin from the other side.

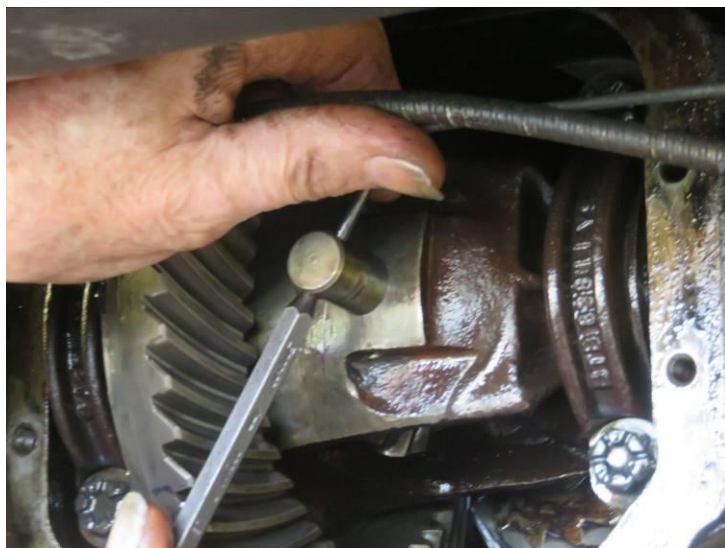
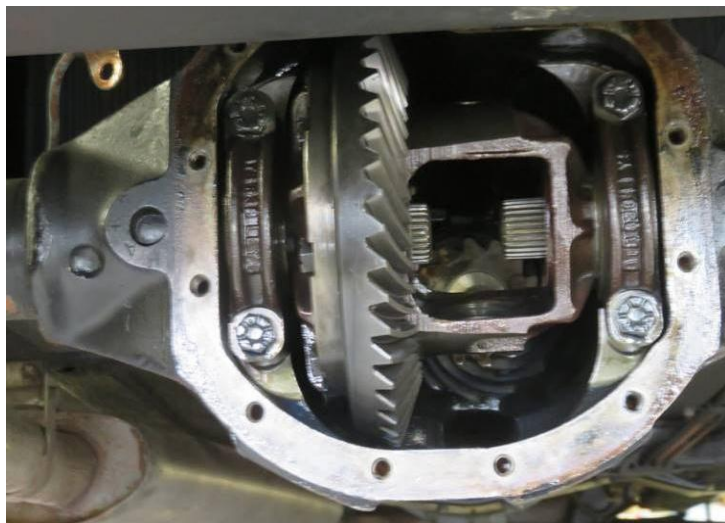
The roll pin hole has just cleared the outside of the cage and the pinion pin can be pulled out using a suitable screwdriver or pin punch.

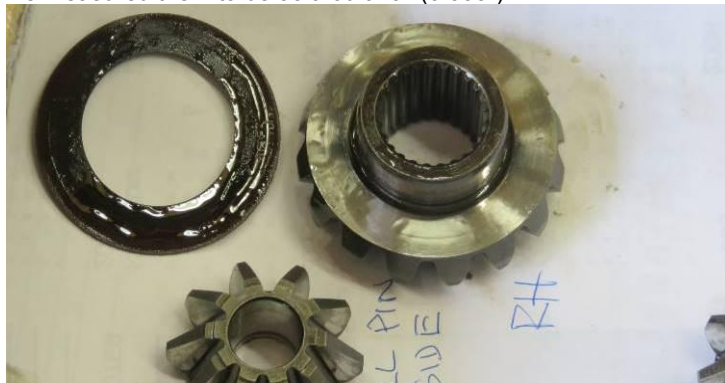
We examined the washers. The fibre washers appeared OK and we measured them to be 35 thou thick (0.035").

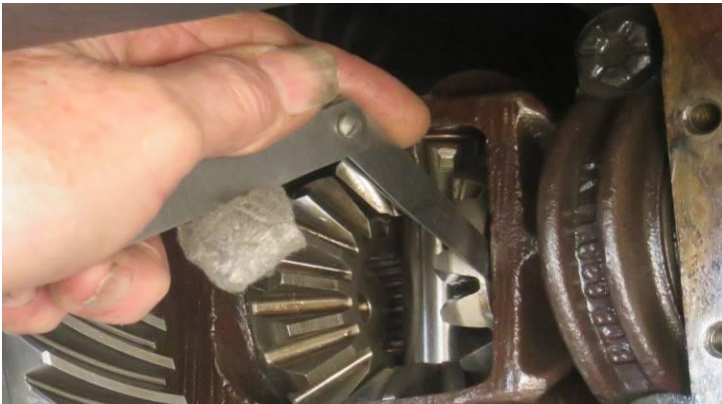
This tallied with the end float of the differential wheels when we did a trial assembly without one of the fibre washers. The washers were also the same thickness as the new replacements.

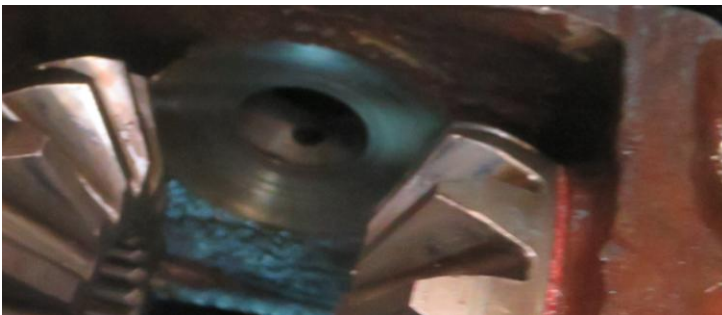
The bronze thrust washers, however, were rather heavily scored.

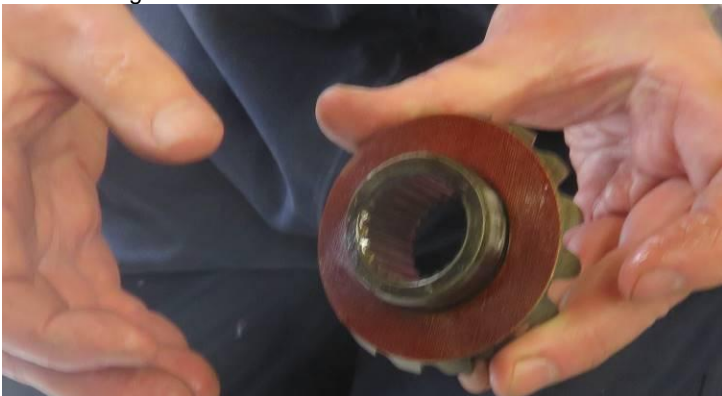
This seemed to be because their seats in the cage were also scored. We don't know why the cage seats for the bronze washers were scored. Perhaps the cage was poorly machined when it was originally manufactured or the seats had been damaged in the distant past through a lack of lubrication or from excessively worn or even missing washers.

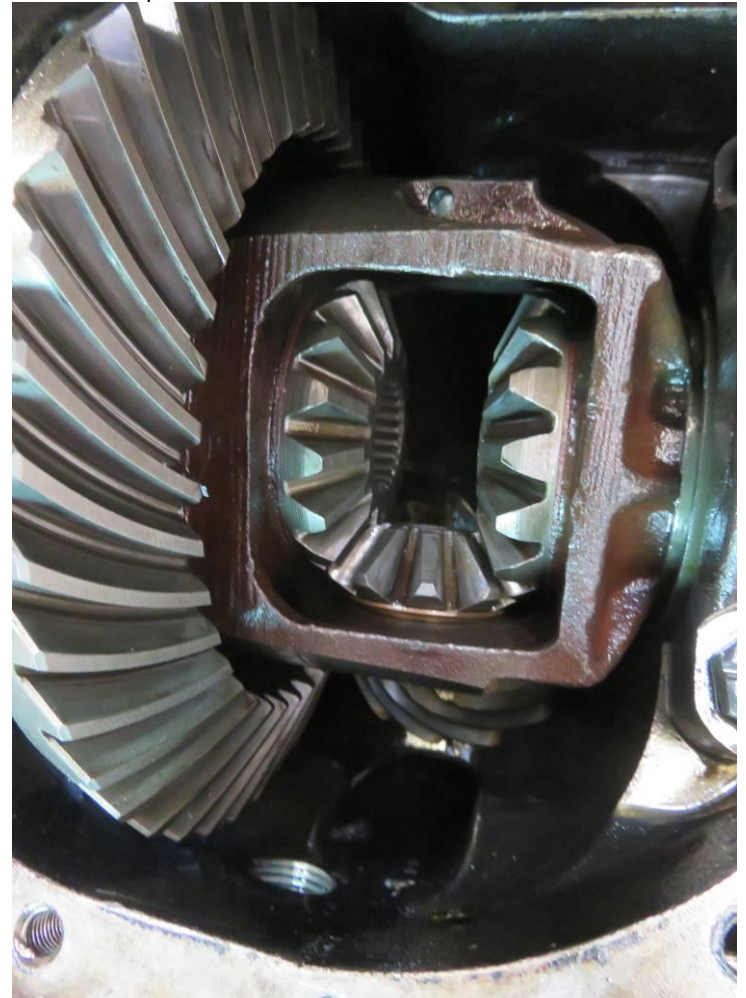
Then I slipped the pinion wheels onto the half shafts inside the cage and put in the first of the smaller bevel gears and its bronze washer which I had also lubricated.
