Mystery of a missing bellhousing cover plate

In a V8BB posting David Worthington sought fellow members' help with a missing bellhousing cover plate. (May 17)

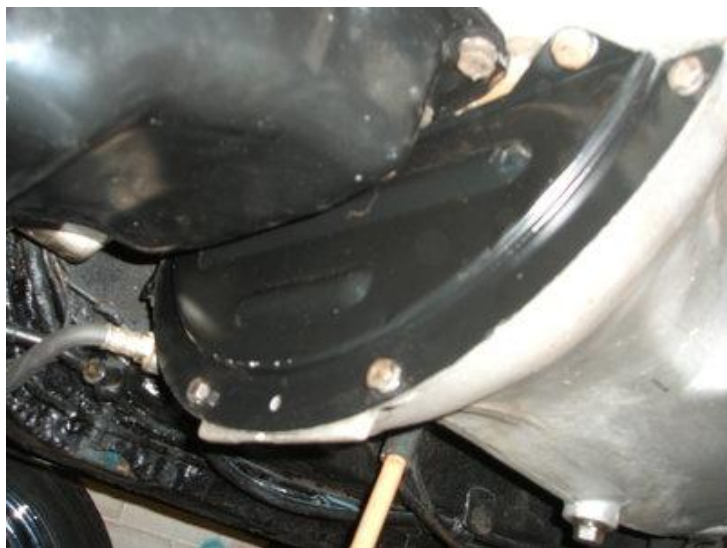
Michael O'Leary then posted a note saying "my car is currently on axle stands so took a photo of the cover plate in situ". Photo above.

- The **four horizontal bolts** are **1/4" U.N.C x 1/2" long** and require a 7/16" spanner.
- The **two vertical bolts** are **5/16" U.N.C x 5/8" long** and require a 1/2" spanner.

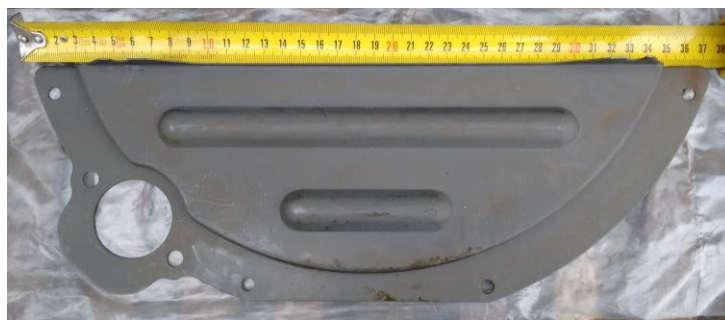
FRC142L from John Craddock.

Arnie Skirrow posted a note saying "I just got one of these from John Craddock part number **FRC142L**, total price including delivery was £23.59. Rimmer Bros also sell these. Hope this helps". On contacting Arnie he promptly took a photo of the cover plate and sent it in for release on the V8BB thread (see a copy alongside).

The link to the cover plate on the John Craddock website is:
www.johncraddockltd.co.uk/land-rover-parts/frc142l-cover-plate.html

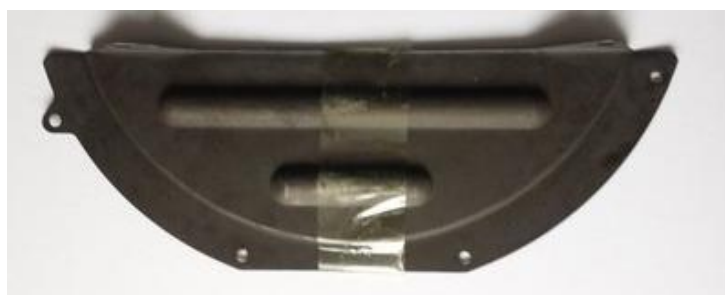
FRC145 from Rimmer Bros.

David Worthington then posted saying "thanks for the replies to my original posting. I decided after a couple of days with no leads to do some searching and after a few phone calls I discovered that Rimmer Bros did something that looked suitable. I ordered it and it arrived yesterday. Having offered it up to the bellhousing today, it looks suitable and very similar if not identical to the one in Michael's photograph. It looks to be an original Rover part, number **FRC145**. It cost a total of £16.48 including postage. Five of the six holes in the plate line up perfectly. The hole that is set in a lug outside the main curve of the plate does not line up with anything. There is a threaded hole in the bellhousing just above where this lug is that should take a bolt. I will possibly drill a hole in the plate at that position to fix it completely".

On the Rimmer Bros webpage for FRC145 it notes "this part may have multiple applications. If you need additional information or clarification on this part, please select your car model from below to see specific application information – and there is says 'Rover SD1 Gearbox Unit (Auto)'. Part No FRC145 is not listed on the John Craddock website.

The link to the cover plate on the Rimmer Bros website is:
www.rimmerbros.co.uk/item--i-FRC145

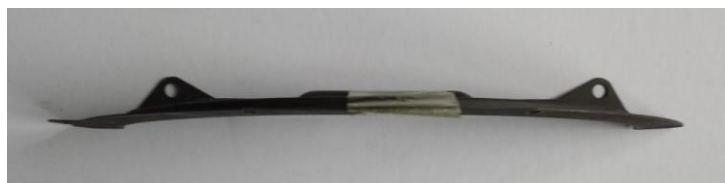
Side view of **FRC145**.

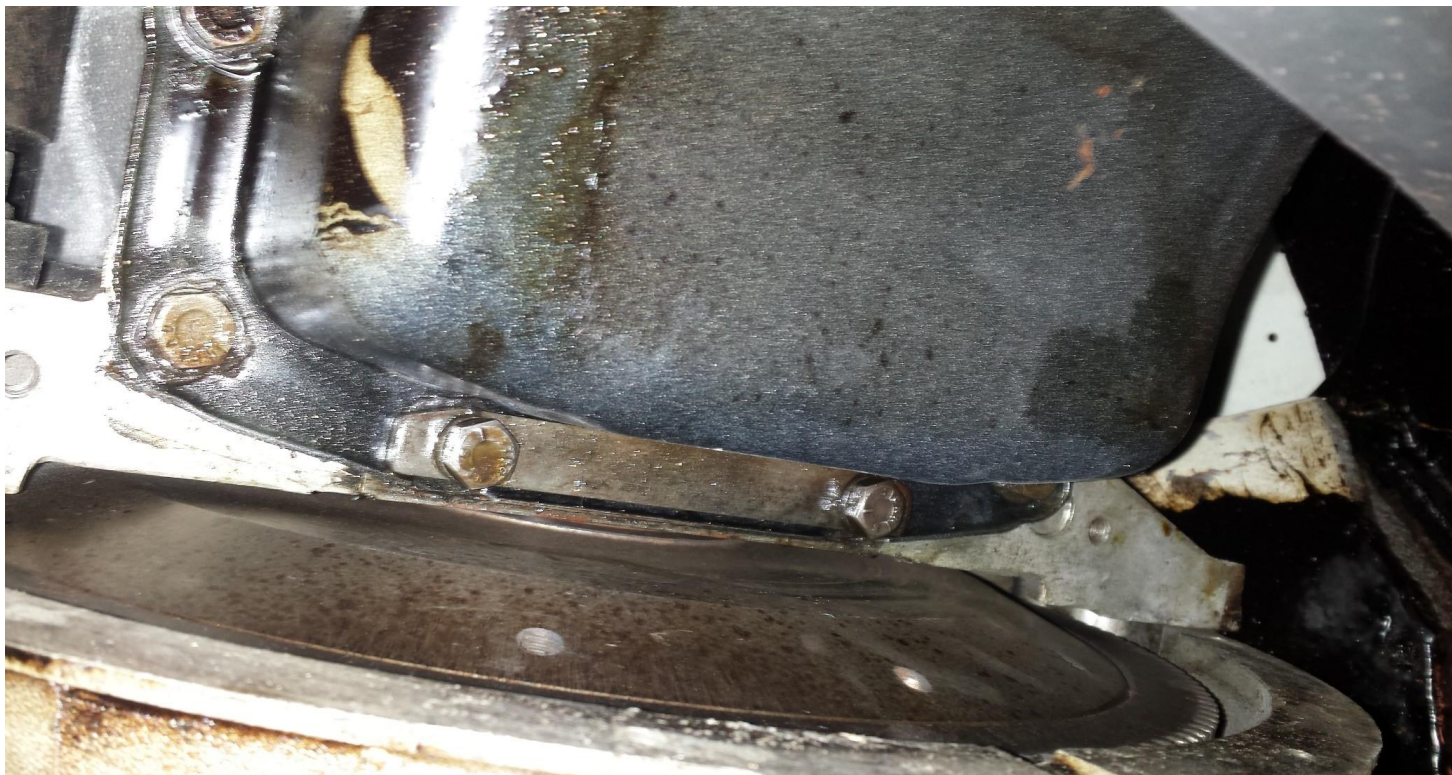
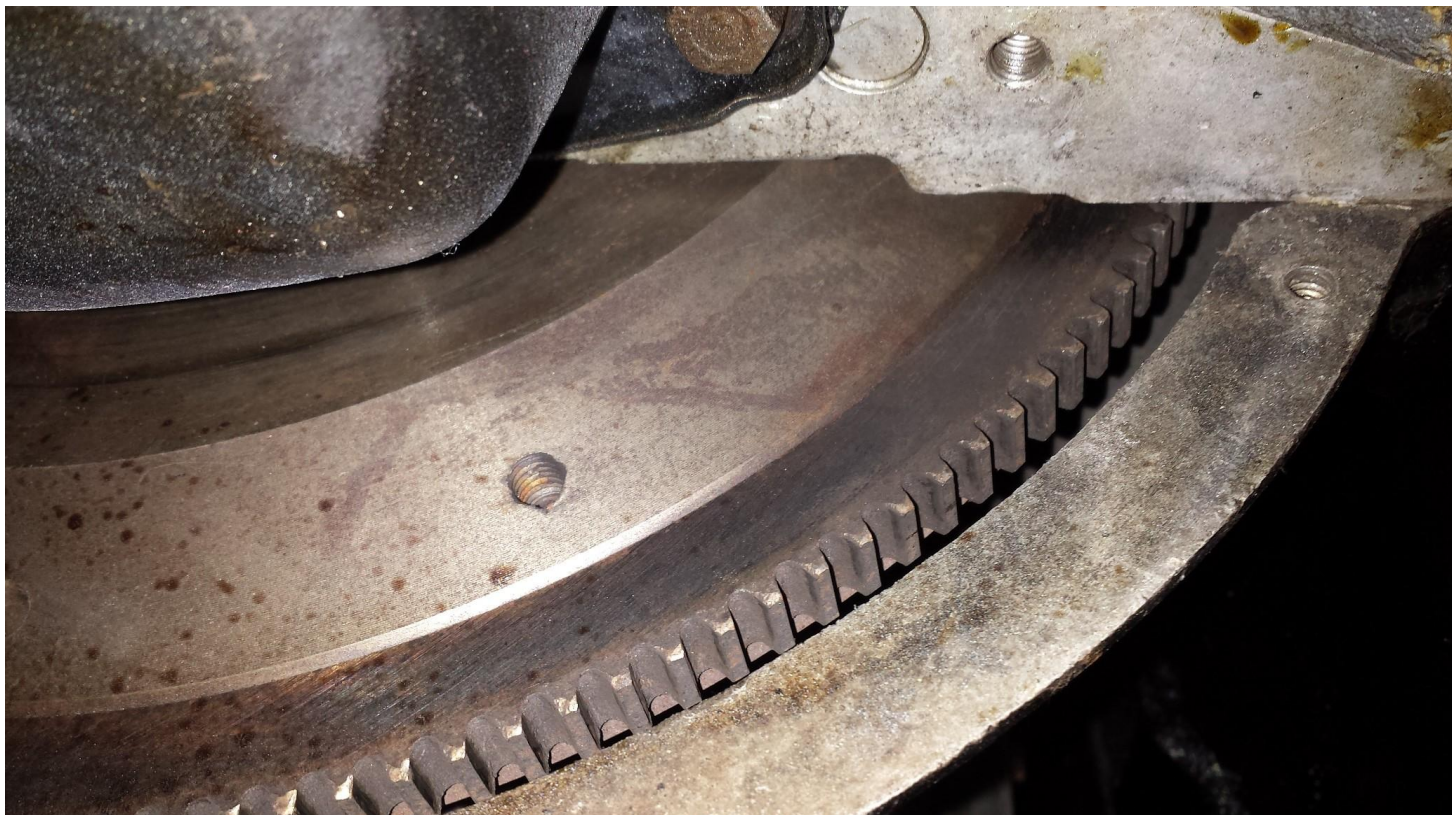
David Worthington says "two photos of the bellhousing without the cover plate which is what first alerted me to the problem".

David Worthington said "having bought my MGBGT V8 a couple of years ago, I now discover that the plate covering the lower section of the bellhousing is missing. I think this plate is also called the flywheel housing dust plate. The engine had been rebuilt before I bought the car and I now suspect that this plate was not reattached when the engine was mated with the gearbox. I can see the 6 threaded holes that attach the plate. My questions are: does anyone have a photo of what this plate looks like? How essential is it to have one fitted? Does anyone have one that they no longer need that I can buy? I cannot see one listed in the catalogues of the usual suppliers. Any help would be gratefully received".
