Fitting power steering to an MGBGT V8

Jim Livingstone acquired his MGBGT V8 (Glacier White 1810) from Dr Chris Ward who had had the car [restored](#) by a specialist in Northumberland. Jim has since carried out several modifications and here he sets out a detailed note on his choice and then the installation of a power steering upgrade on the car.

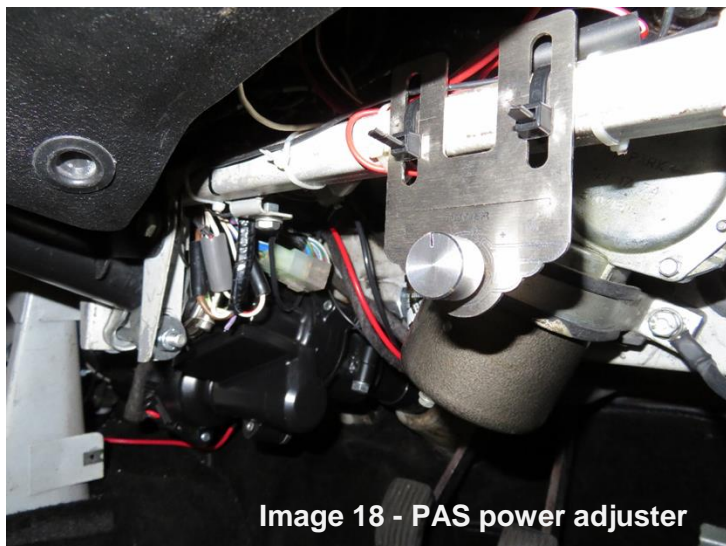
Image 18 - PAS power adjuster

29. Select a convenient position for the power adjustment unit and fix securely. The right end of the steering column support tube (the square tube joining the door hinge panels) provides a suitable location to attach the unit using plastic ties. See **Image 18** (see page 1).

34. Centralise the steering, refit the steering wheel and tighten the shaft nut. Refit the horn push.
35. Reconnect the battery.
36. Recheck that all fasteners are secure and lower the car.
37. Road test to establish the best setting of the **power adjuster**.

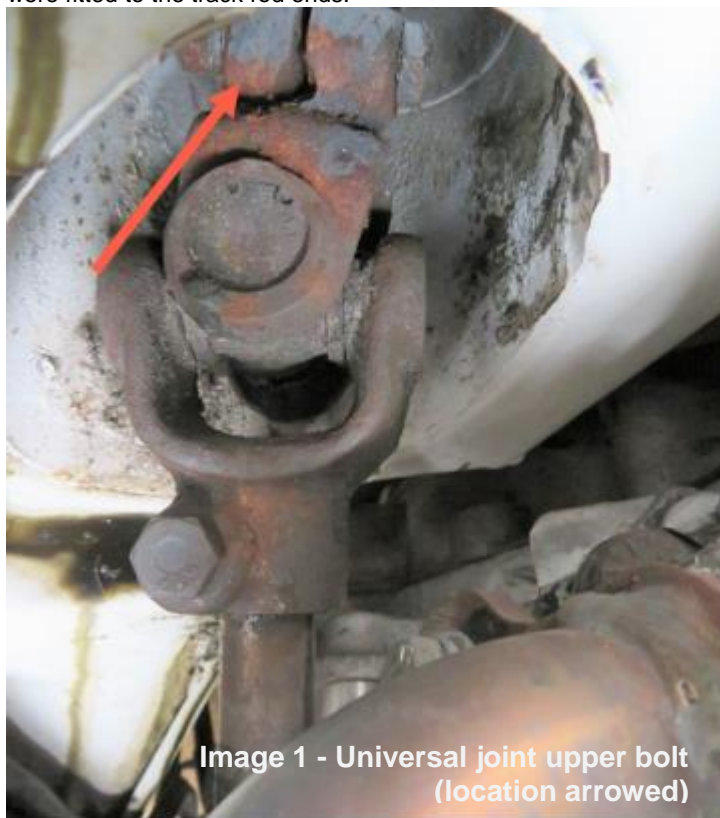
Image 1 - Universal joint upper bolt (location arrowed)

When the new column arrived from EZ in Holland it was examined carefully for interchangeability. There are several versions of the MGB steering column and it is important that the correct EZ kit is ordered. An additional complication which I believe is unique to the MGB V8 is that the upper clamp bolt of the **steering column universal joint is buried deep in the bulkhead tunnel** resulting in difficult access to this critical fastener. See **Image 1**. In the original column the inner shaft is free axially and the bolt can be accessed

once the shaft is freed from the rack input and the steering wheel and turn indicator striker are removed. The EZ inner column is fixed axially to the outer column necessitating a different approach.

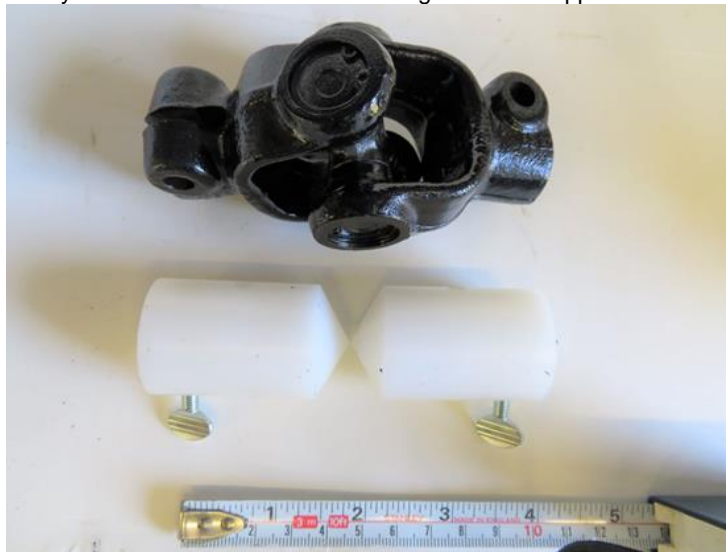
Image 2: - Column alignment tool

To facilitate accurate alignment of the upper and lower steering shafts the Moss (www.moss-europe.co.uk) **alignment kit** (part number 453-622) was purchased. The kit comprises two nylon sleeves which replicate the halves of the universal joint and two screws which simulate the clamp bolts. **See Image 2.** When the points on the sleeves are aligned the shafts will articulate about the centre of the universal joint spider resulting in lower stresses in the column and rack.

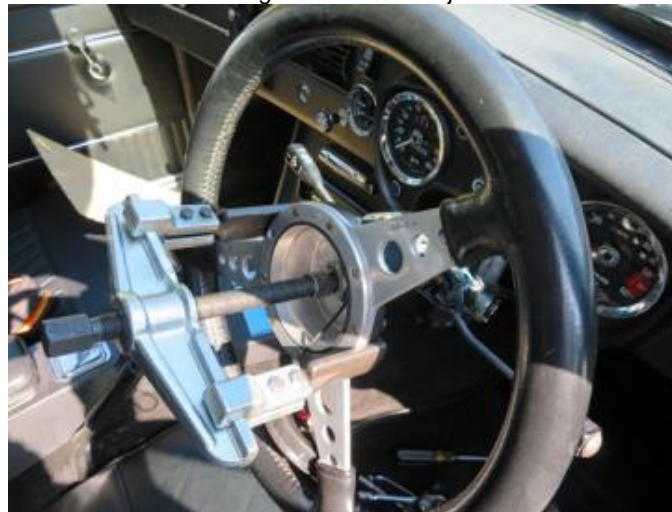
Image 3 – puller to remove the steering wheel safely

3. Prize out the horn push and remove the steering wheel by loosening the centre nut and with a suitable puller to break the taper between the wheel and shaft. **See Image 3.**

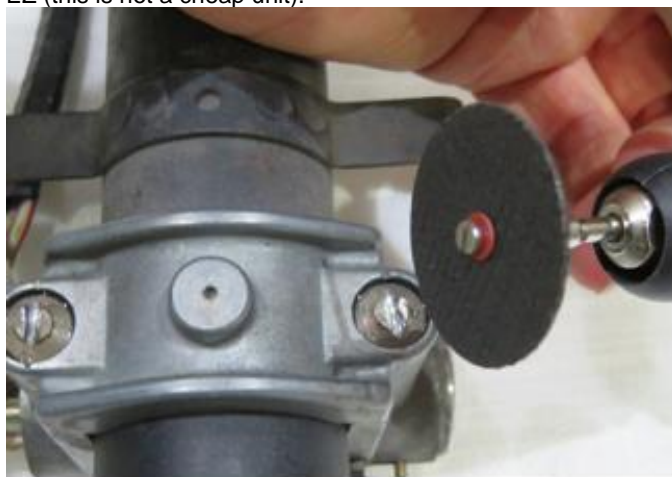
Image 5 – removing security bolts

14. The combined column lock and ignition switch must now be removed from the original column. It is possible to drill out the bolts but a simpler alternative is to grind screwdriver slots in the protruding stumps using a small (25mm) cutting disc. The bolts are then unscrewed using an impact driver and slotted attachment. See **Image 5**.

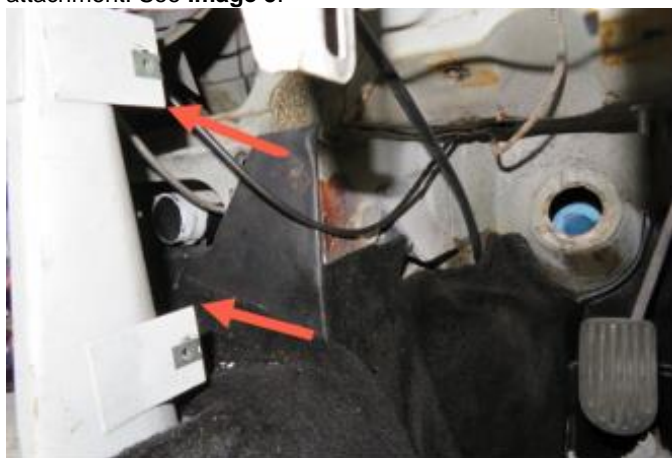
Image 6 – Radio console support brackets

Note: The brackets on the radio console support have sharp corners which should be ground to a radius to prevent personal injury and cosmetic damage to the motor unit. See **Image 6**.

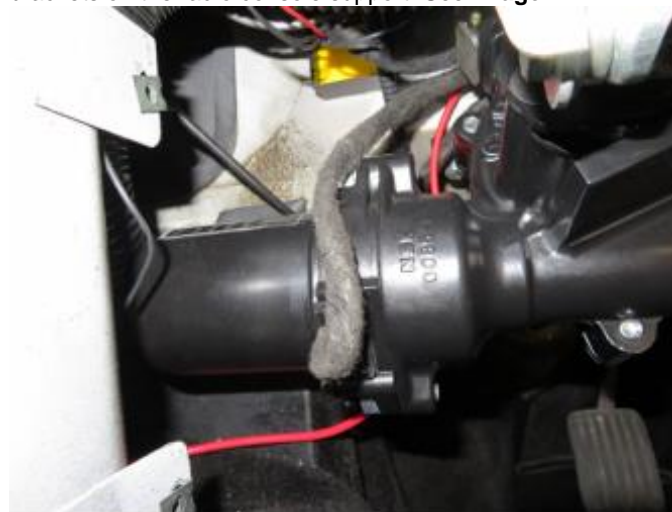
Image 7 – Motor unit in position

16. Fit the bulkhead seal to the bottom end of the new column assembly, thread the shaft through the hole on the bulkhead

and manoeuvre the motor unit into position between the brackets on the radio console support. See **Image 7**.

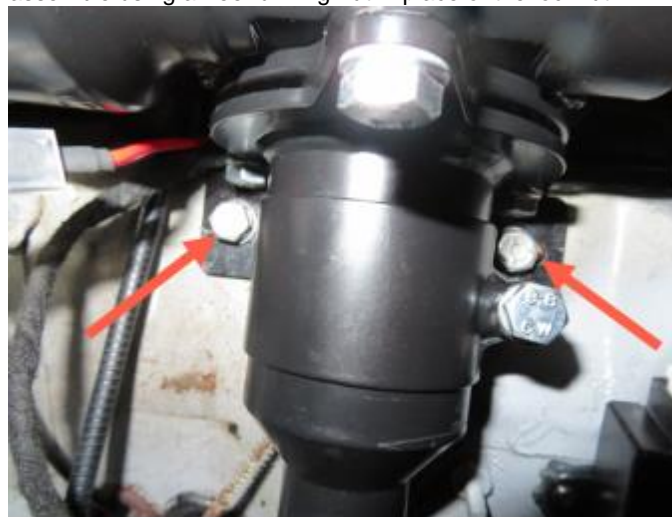
Image 8 – Lower bracket bolts

19. Fit the new lower bracket to the underside of the bulkhead using the two original screws. Do not fully tighten at this stage. See **Image 8**.

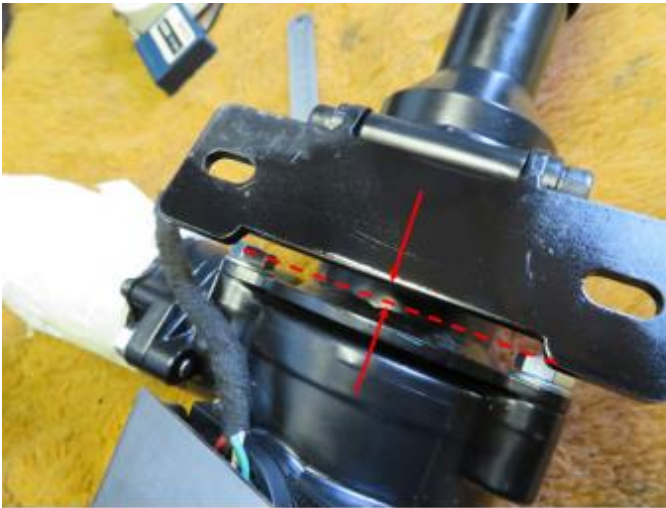
Image 9 – Lower bracket modification

Note: During the trial assembly it was discovered that the lower bracket prevented the column from assuming its correct axial position relative to the rack input shaft (i.e. within the range of the elongated slot in the shaft for the upper universal joint bolt). Rather than weakening the fixing by enlarging the mounting holes further (they are already elongated transversely) the author chose to remove redundant metal from the bracket's rear edge. See **Image 9**. Note that the lower bracket now takes the main torque reaction of the steering force and its fixing is critical.

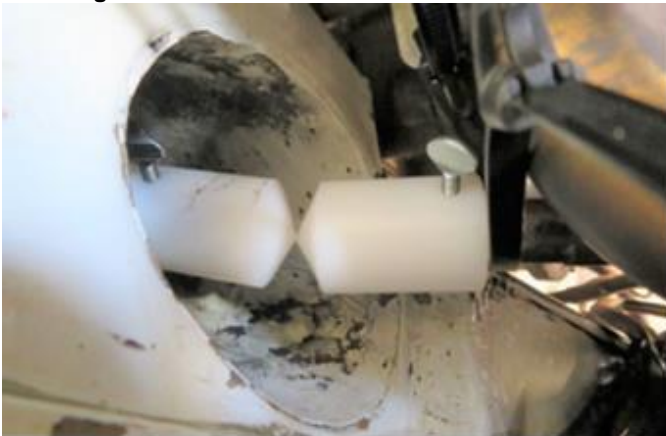
Image 10 – Aligning upper and lower shafts

21. Support the rack input shaft in reusable ties and adjust the alignment of the shafts until the points on the sleeves coincide. See Image 10.

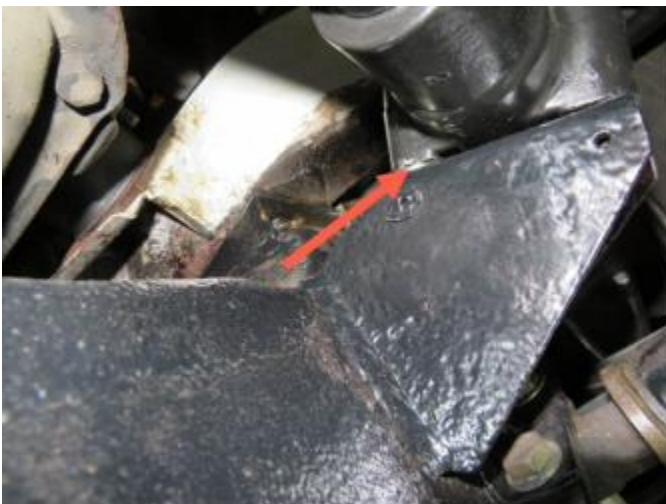
Image 11 – Steering rack shim

Note: The EZ column can be adjusted both laterally (bracket slots) and vertically (bracket hinge) while the rack input shaft

can be adjusted vertically by fitting shims under the crossmember mounting bosses. On the subject vehicle a 1mm washer under each of the rear bosses was sufficient to align the gauge points. See Image 11. This, incidentally, also resulted in the rack input shaft now passing centrally through the hole in the engine mount where it had previously contacted one edge. See Image 12.

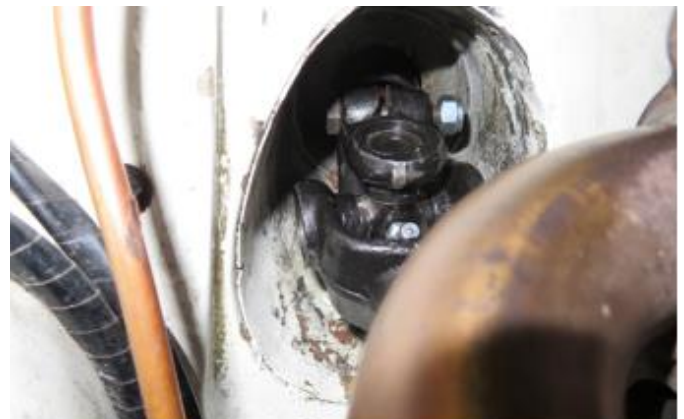
Image 13 – Upper universal joint bolt

22. Mark the position of the column supports to aid reassembly and remove the securing bolts. Remove the rack to crossmember bolts and allow the rack to slide down enough to extract the alignment sleeves. Fit the universal joint ensuring that the upper bolt passes through the elongated flat in the column shaft and the lower bolt through the groove in the rack shaft. Fit new self-locking nuts to both universal joint bolts but do not tighten at this stage. See Image 13.

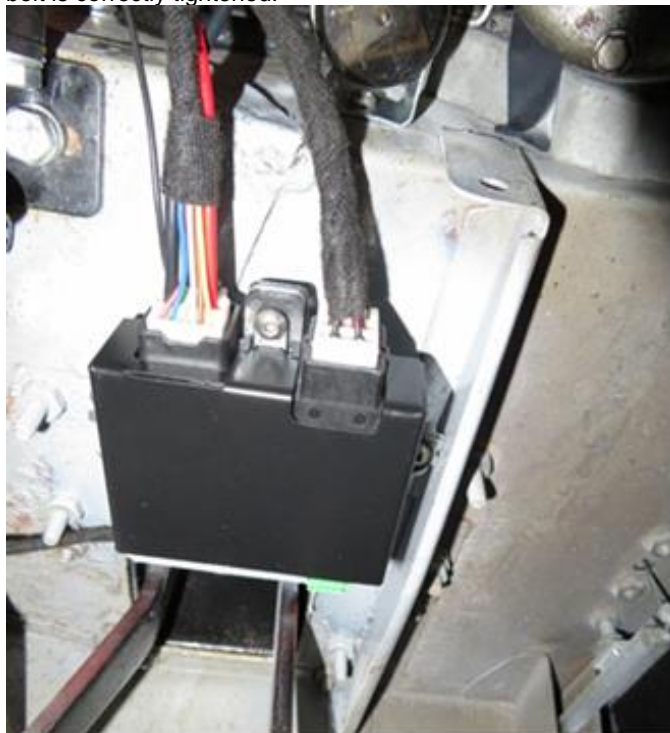
Image 14 – Control unit installation

26. Select a convenient location for the control unit and fix in position. See **Image 14**.
27. Route the 6 mm 2 power cable to the battery positive terminal and fit the 40 amp line fuse adjacent to the battery terminal. See **Images 15 & 16**.

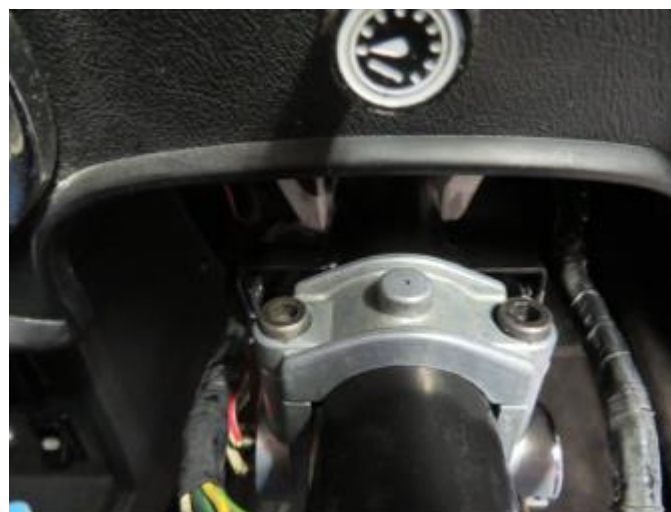
Image 19 – Steering lock cap screws

32. Refit the combined steering lock/ignition switch. The author chose to use socket cap screws instead of the shear head screws provided to obviate the need to remove the column should the lock require removal in future. See **Image 19**.
33. Refit the column cowl.

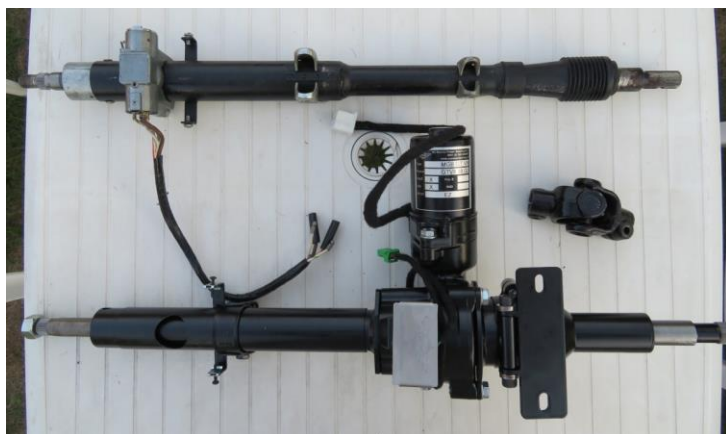
EZ EPAS kit

The kit supplied by EZ includes a replacement steering column with an integral electric motor. The image above shows both the original column on Jim Livingstone's MGBGT V8 (top) and the EZ column supplied by EZ (below). [More](#)

Research failed to unearth any commercially available electric powered rack conversion so it had to be a powered column. The **product chosen was the EZ EPAS system** which has been available for some years for a variety of classic cars. Their kit comprises a replacement steering column with an integral electric motor. EZ are a Dutch company who specialise in adapting NSK or Koyo based systems to specific European models and have an established track record in this field.
