Fitting power steering to an MGBGT V8

Jim Livingstone acquired his MGBGT V8 (Glacier White 1810) from Dr Chris Ward who had had the car [restored](#) by a specialist in Northumberland. Jim has since carried out several modifications and here he sets out a detailed note on his choice and then the installation of a power steering upgrade on the car.

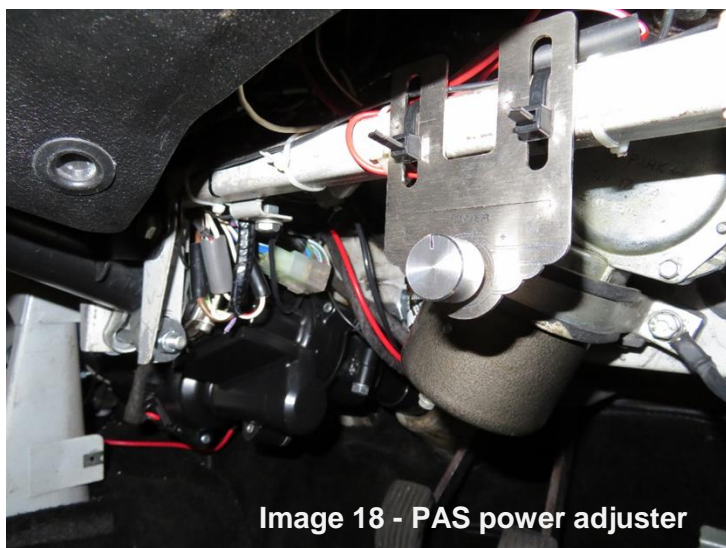
Image 18 - PAS power adjuster

29. Select a convenient position for the power adjustment unit and fix securely. The right end of the steering column support tube (the square tube joining the door hinge panels) provides a suitable location to attach the unit using plastic ties. See **Image 18** (see page 1).

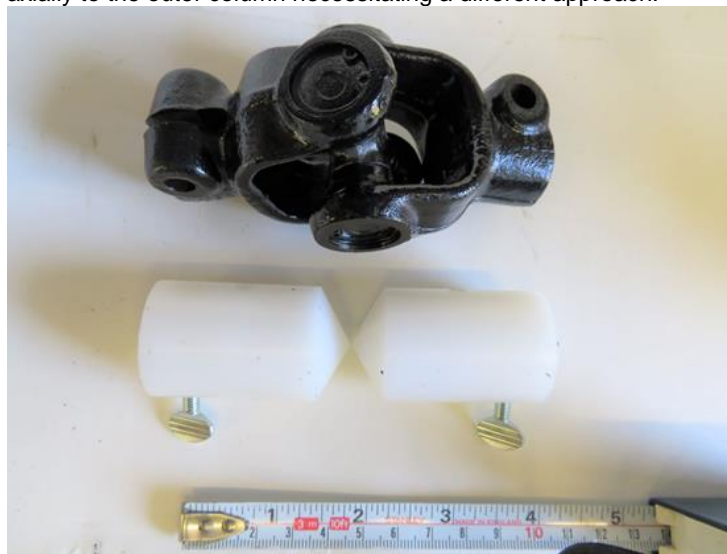
Image 2: - Column alignment tool

To facilitate accurate alignment of the upper and lower steering shafts the Moss (www.moss-europe.co.uk) **alignment kit** (part number 453-622) was purchased. The kit comprises two nylon sleeves which replicate the halves of the universal joint and two screws which simulate the clamp bolts. **See Image 2.** When the points on the sleeves are aligned the shafts will articulate about the centre of the universal joint spider resulting in lower stresses in the column and rack.

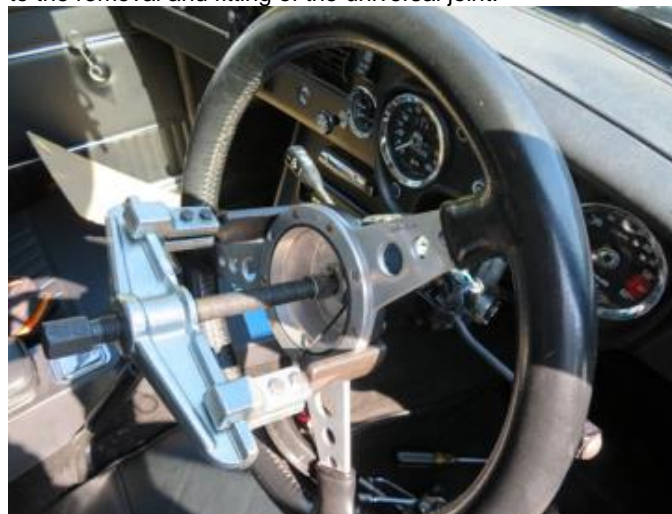
Image 3 – puller to remove the steering wheel safely

3. Prise out the horn push and remove the steering wheel by loosening the centre nut and with a suitable puller to break the taper between the wheel and shaft. **See Image 3.**

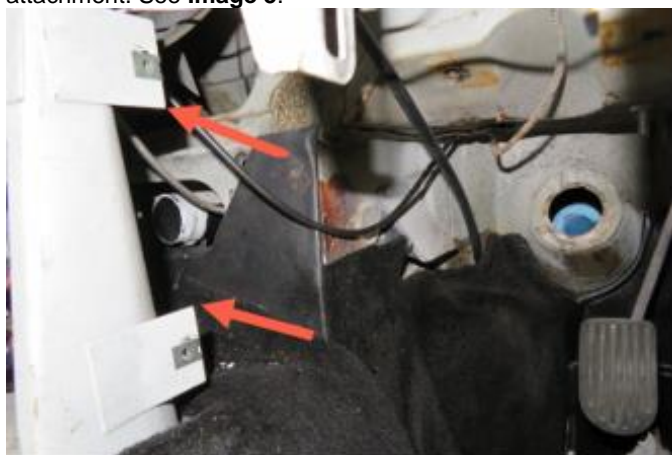
Image 6 – Radio console support brackets

Note: The brackets on the radio console support have sharp corners which should be ground to a radius to prevent personal injury and cosmetic damage to the motor unit. See **Image 6**.

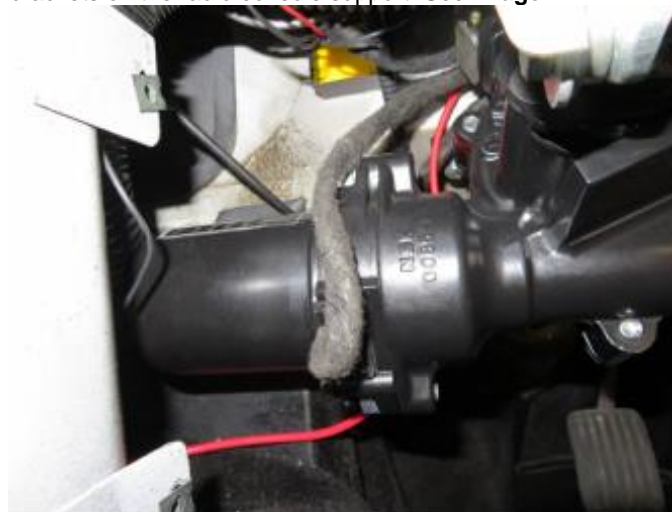
Image 7 – Motor unit in position

16. Fit the bulkhead seal to the bottom end of the new column assembly, thread the shaft through the hole on the bulkhead

and manoeuvre the motor unit into position between the brackets on the radio console support. See **Image 7**.

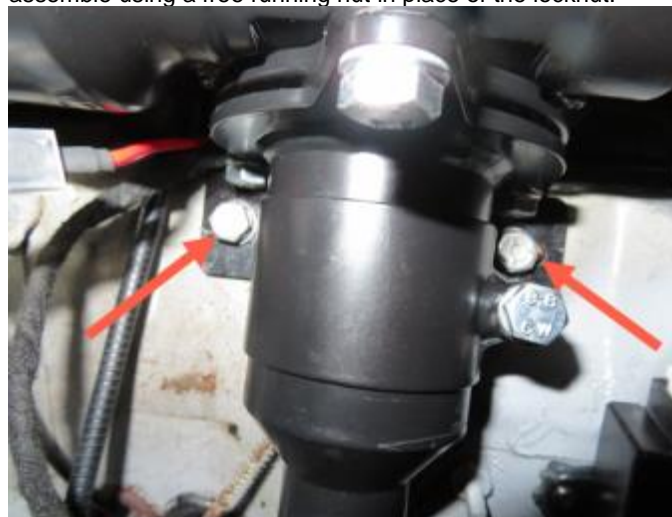
Image 8 – Lower bracket bolts

19. Fit the new lower bracket to the underside of the bulkhead using the two original screws. Do not fully tighten at this stage. See **Image 8**.

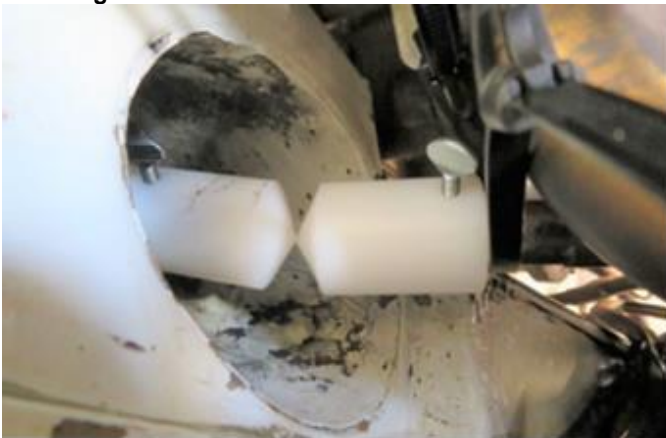
Image 10 – Aligning upper and lower shafts

21. Support the rack input shaft in reusable ties and adjust the alignment of the shafts until the points on the sleeves coincide. See Image 10.

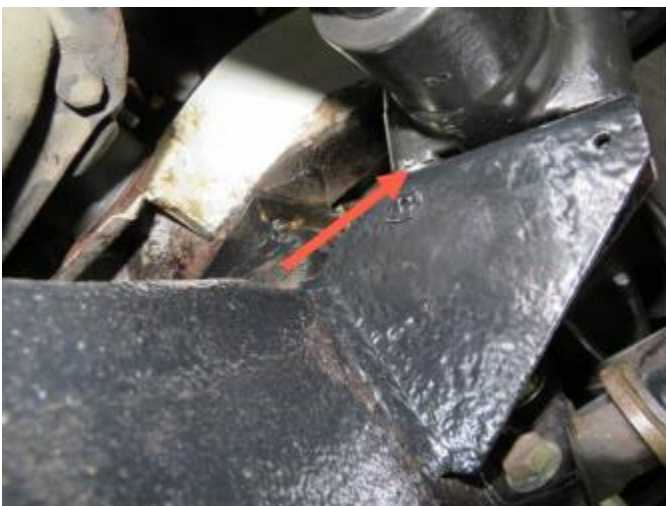
Image 11 – Steering rack shim

Note: The EZ column can be adjusted both laterally (bracket slots) and vertically (bracket hinge) while the rack input shaft

can be adjusted vertically by fitting shims under the crossmember mounting bosses. On the subject vehicle a 1mm washer under each of the rear bosses was sufficient to align the gauge points. See Image 11. This, incidentally, also resulted in the rack input shaft now passing centrally through the hole in the engine mount where it had previously contacted one edge. See Image 12.

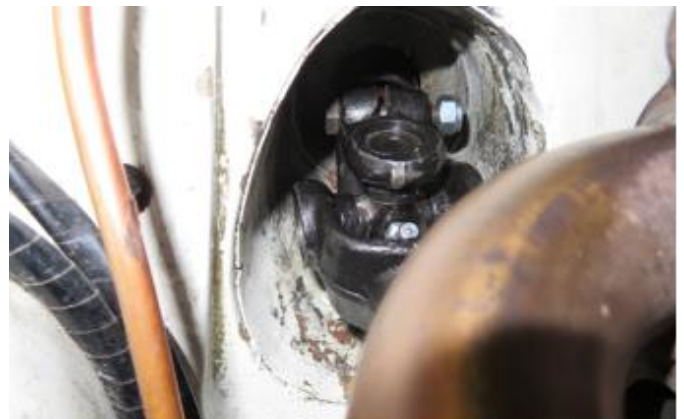
Image 13 – Upper universal joint bolt

22. Mark the position of the column supports to aid reassembly and remove the securing bolts. Remove the rack to crossmember bolts and allow the rack to slide down enough to extract the alignment sleeves. Fit the universal joint ensuring that the upper bolt passes through the elongated flat in the column shaft and the lower bolt through the groove in the rack shaft. Fit new self-locking nuts to both universal joint bolts but do not tighten at this stage. See Image 13.

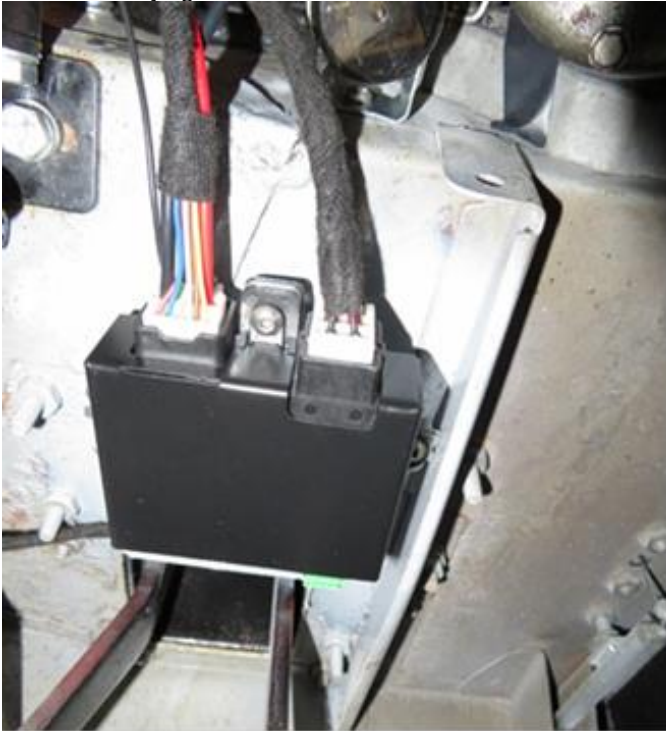
Image 14 – Control unit installation

26. Select a convenient location for the control unit and fix in position. See **Image 14**.
27. Route the 6 mm² power cable to the battery positive terminal and fit the 40 amp line fuse adjacent to the battery terminal. See **Images 15 & 16**.

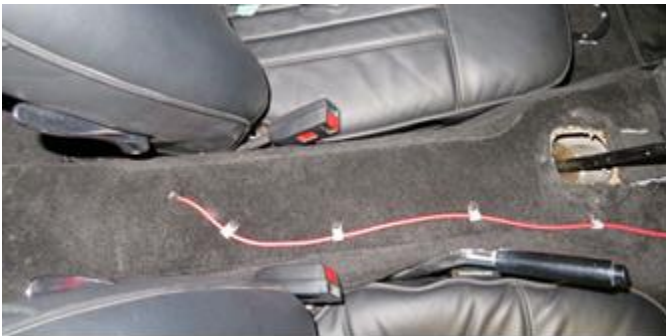
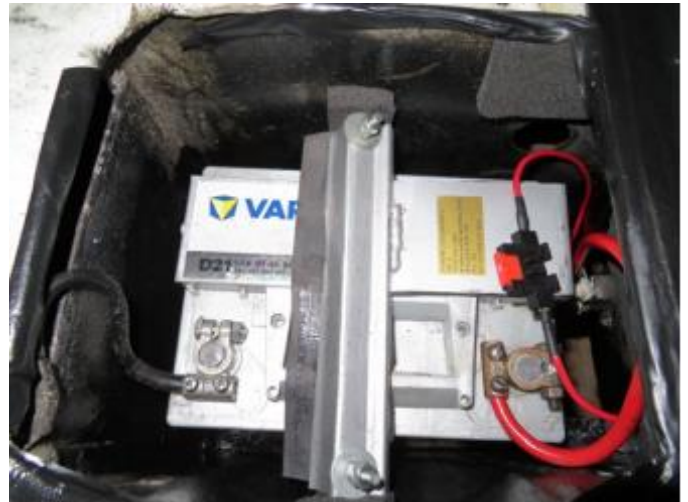
Image 15 – Power cable routing

Image 16 – power cable fuse

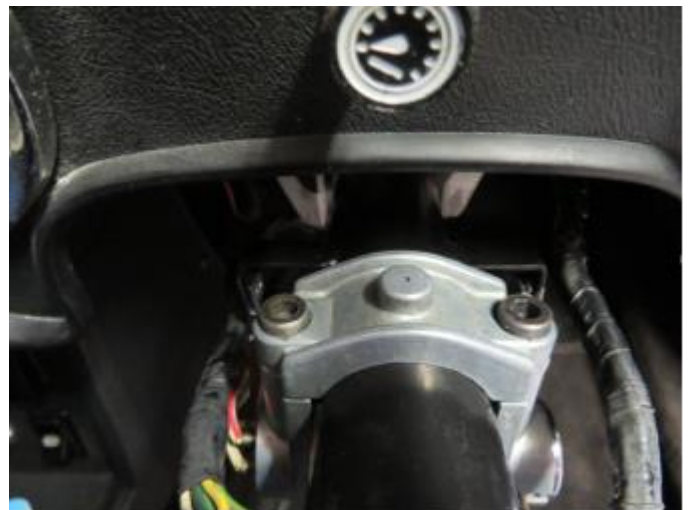
Image 19 – Steering lock cap screws

32. Refit the combined steering lock/ignition switch. The author chose to use socket cap screws instead of the shear head screws provided to obviate the need to remove the column should the lock require removal in future. See **Image 19**.
33. Refit the column cowl.

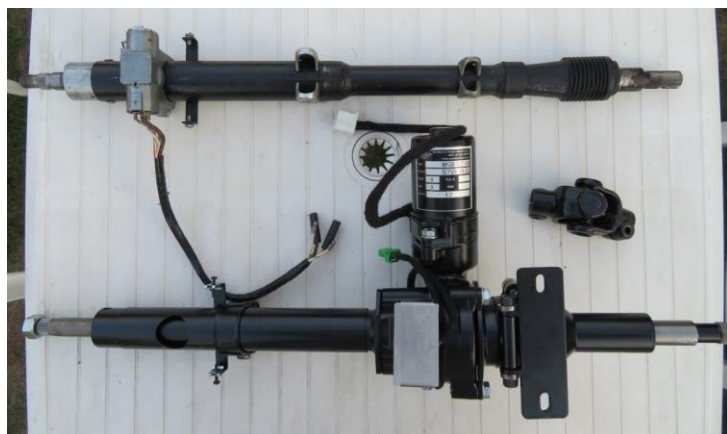
EZ EPAS kit

The kit supplied by EZ includes a replacement steering column with an integral electric motor. The image above shows both the original column on Jim Livingstone's MGBGT V8 (top) and the EZ column supplied by EZ (below). [More](#)
