Overhauling the fusebox in an MGB

Jim Livingstone had found the fusebox on his MGBGT V8 has had intermittent problems with the glass fuses since he acquired the car a few years ago. He decided to give originality and glass fuses a last chance with the purchase of a new box from a reputable supplier. On receipt he found the tension in the fuse holders to be all over the place and the procedure he sets out here describes how he corrected this. The overhauled fuse box is above. Jim says he hasn't had time to test the longevity of the 'fix'.

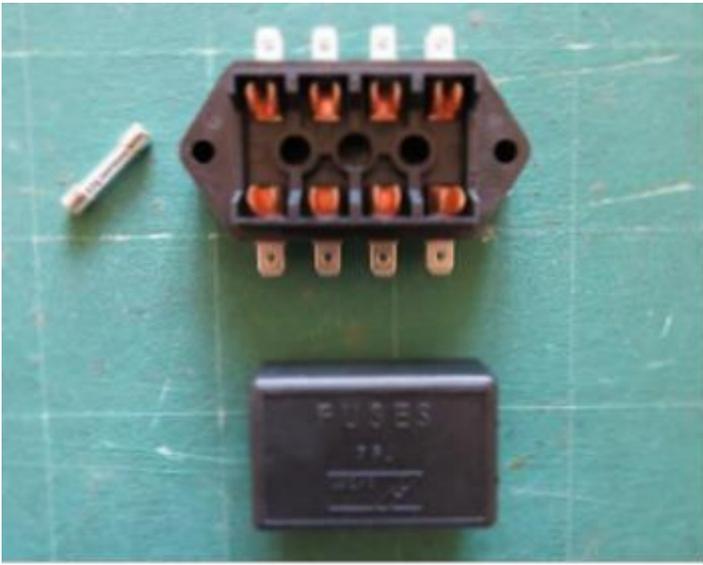
Image 1: fuse box

1. Remove the fusebox noting the connections to each terminal.
2. Examine the fusebox for loose terminals, rivets, cracks in plastic. Check the fit in the holder with a dimensionally correct fuse (1/4" x 1 15/32"). See **Image 1**.

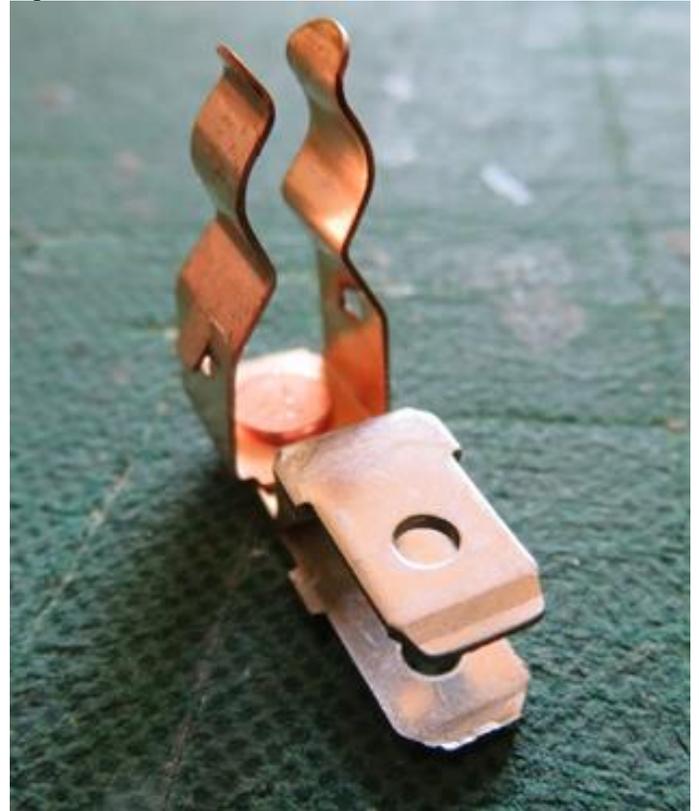
Image 2: fuse holder and terminals

3. The spade terminals are rivetted to the fuse holders and the resulting assembly can be removed from the plastic body by pressing the holder blades together and pushing downwards. The holders are secured in the body by barbs formed in the blades. See **Image 2**.

Note: terminals 1 and 3 are bridged and need to be removed together.

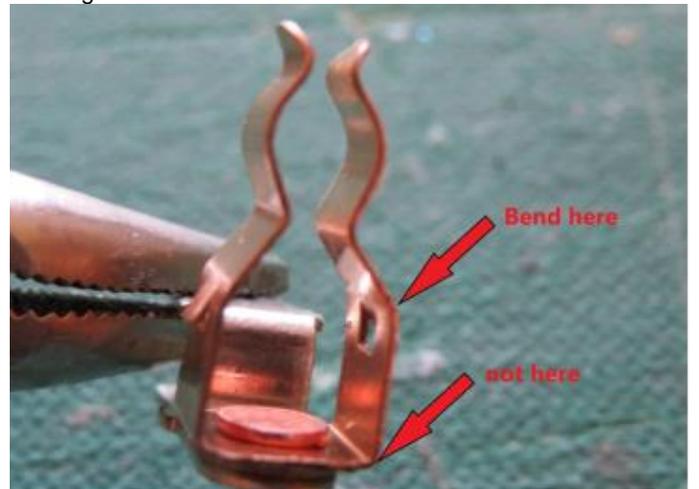
Image 3: fuse holder bending (arrowed)

4. Using long nose pliers bend each holder blade where indicated by the top arrow until the opening gap is approximately 1.5 mm. See **Image 3**. Bending at the base of the holder will result in a less stiff blade and loses the reinforcement offered by the plastic housing.

5. Check that the securing barbs are properly formed. They can be extended using a thin screwdriver.
6. Reassemble the fuse holders and check the fuse fit. The reduced gap may cause some initial fitting difficulty which can be overcome using a thin blade but avoid over deflecting the holder. **See Image 4.**
7. Refit the fusebox to the car and reconnect the harness terminals.

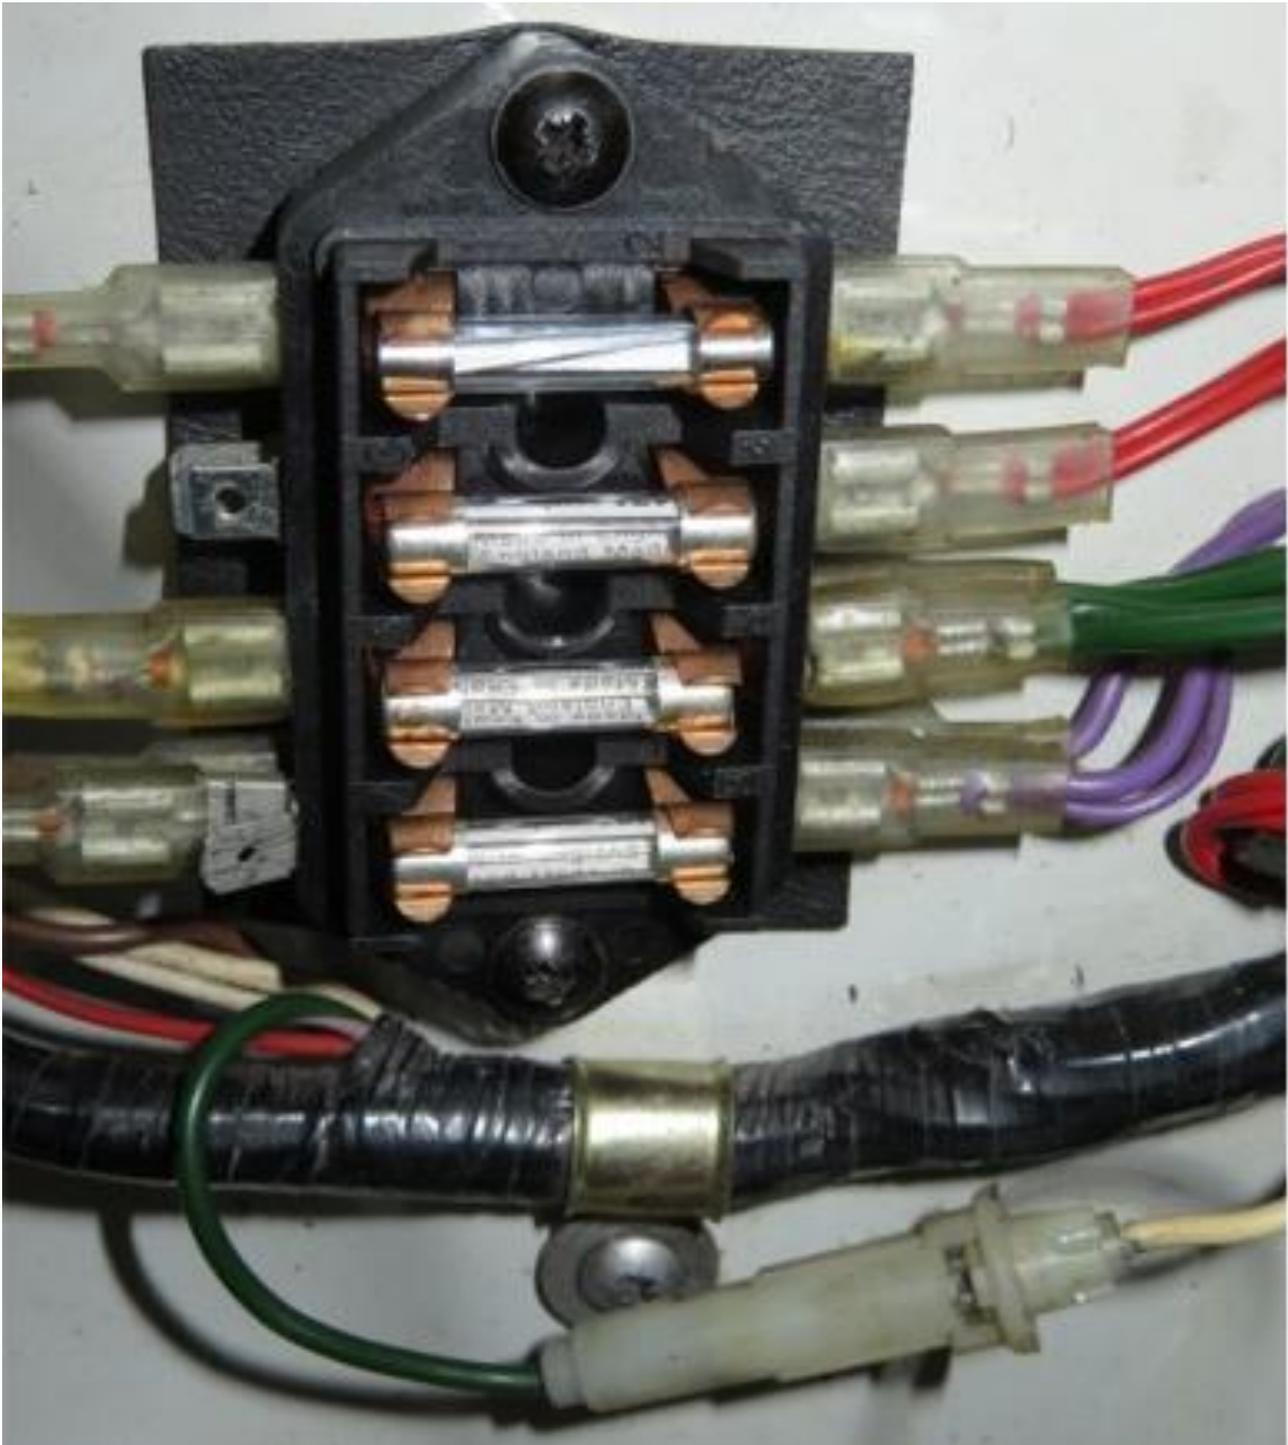
Completed fuse box installed on the offside inner wing.
