Overhauling the steering rack on an MGB

Jim Livingstone feels the steering rack is one of the most durable and reliable mechanical components fitted to the MGB and the rack on his MGBGT V8 bears testament to the design and manufacturing quality of the original Cam Gears product that it survived unserviced for over 45 years. Here he describes how he overhauled his steering rack and found no major rework was necessary so it gives added confidence that the steering system is fit for a further 45 years.

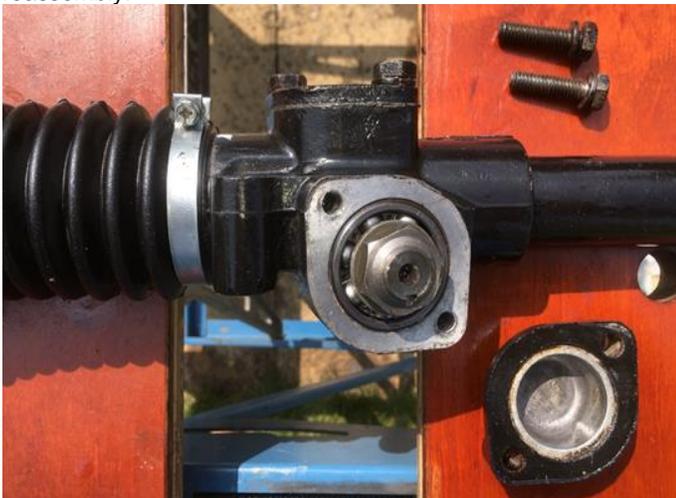
Image 4: pinion bearing housing and cover

Note: the condition of the oil is a useful indication of the state of the internal components. In the author's case the volume removed was much less than the 200cc specified and the oil was badly discoloured but free from water or solid particles.

16. Drain the oil from the assembly by removing the pinion cover. See **Image 4**.

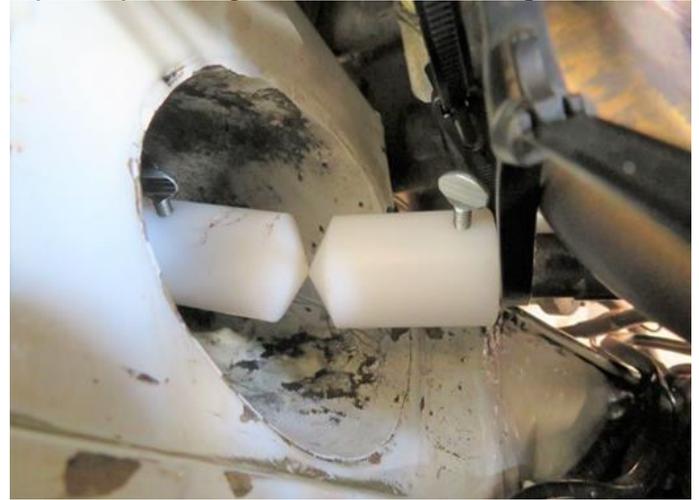
Image 9: aligning upper and lower shafts

26. Refit the lock nuts and track rod ends in their original positions and tighten.
27. Exercise the assembly several times from lock to lock to check freedom of movement and oil tightness.
Note: the author found the pinion seal leaking after reassembly to the vehicle, a condition not apparent previously due to the low oil level in the rack. The seal is easily removed by driving in a couple of self-tapping screws and levering out. As the input shaft is long and splined a sleeve of reversed adhesive tape is required to avoid damaging the sealing lip on the new seal.
28. If there is any doubt about the alignment of the rack and column shafts then it is recommended that this is checked before final assembly. Adjustment of the upper column is achieved by using the clearances in the mounting clamps while the pinion shaft is adjusted by shimming the rack mounts. See **Images 9 & 10**.
