MGBGTV8 Thermostat Replacement

MGBGTV8 owner Peter Spurr suffered thermostat problems exactly as described by Chris O'Neil in V8NOTE334 in Volume 10. There are several excellent V8NOTES covering various aspects of thermostats and their replacement. This note looks at some of the practicalities of removing parts which haven't been touched for over 46 years.

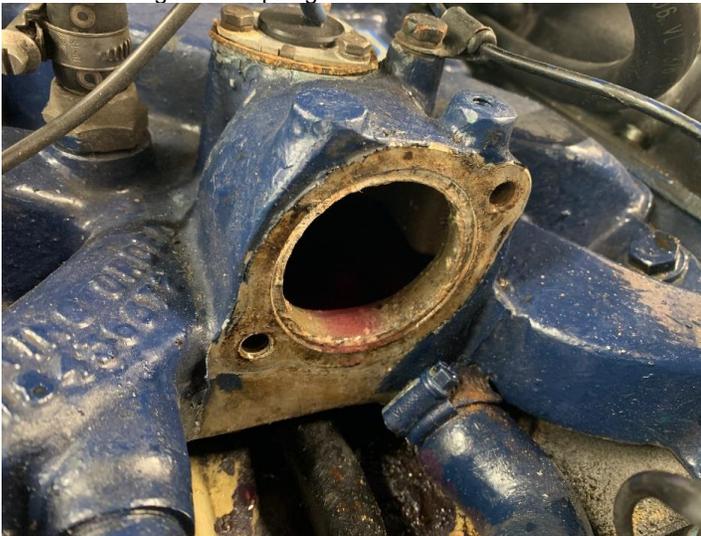
Two hoses have to be removed – the feed to the radiator and the “Steam Pipe, Thermostat to Manifold”. In this instance, the main hose had been replaced recently and came off easily. The Steam Pipe, however, could only be persuaded to part with the housing after the housing had been removed.

Two ½” bolts secure the housing. The upper bolt is easy to remove. The lower one is less accessible, but all that is needed are a ring spanner (see above) and patience.

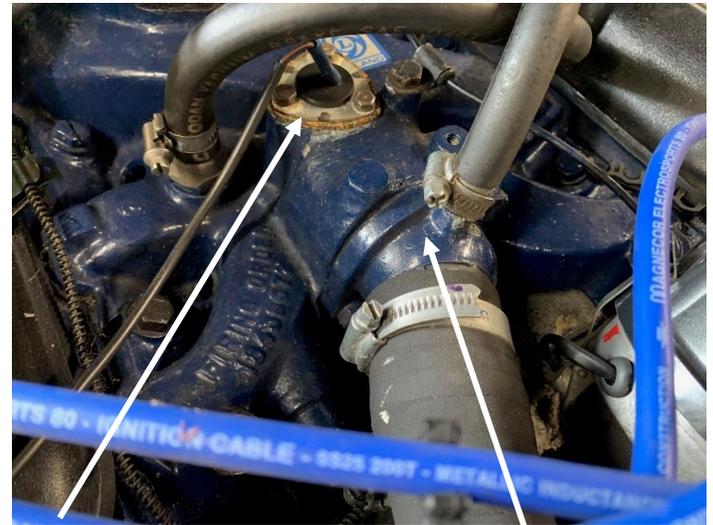
Other sensor and cooling fan switch

Thermostat housing

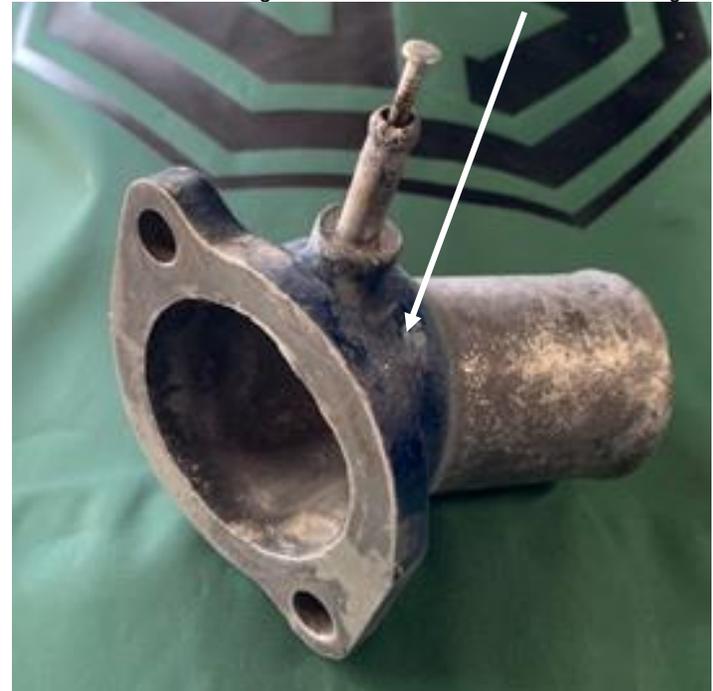
Some cleaning was necessary around the manifold. In addition to the removal of accumulated scale, a previous owner's blue brushed paint had to be paired back. Particular attention was paid to the shallow recess where the thermostat sits to ensure a good fit. It should also be noted that it is important to prevent ingress of contaminants into the cooling system.

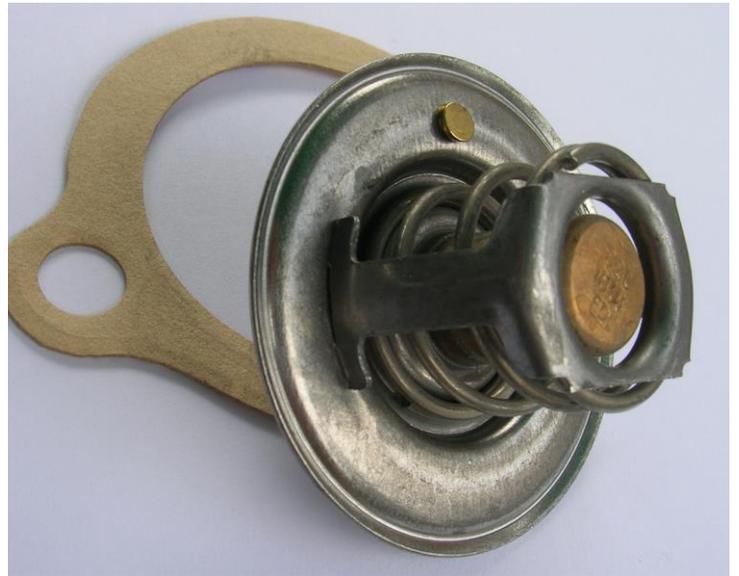
Alongside: the replacement thermostat (GTS104) and the gasket (GTG125) – note the vent pin is in the 12 o'clock position ready for refitting to the thermostat housing. [V8NOTE501](#)

Reassembly is essentially the reverse of the removal process with the addition of a new gasket. Remember to fit the thermostat to the housing with the vent pin in the 12 o'clock position. A coating of Copperslip or similar on the bolt threads will prevent corrosion. The tightness of the ½" bolts is important. I didn't tighten them enough, resulting in a leak. Access to the lower bolt is not possible with the main hose connected. It is possible to loosen the Jubilee clip and withdraw the hose a little without loss of fluid. No torque figures are provided, they would be unusable given the lack of space. Tighten by feel.
