Cooling system pressure testing and leak detection

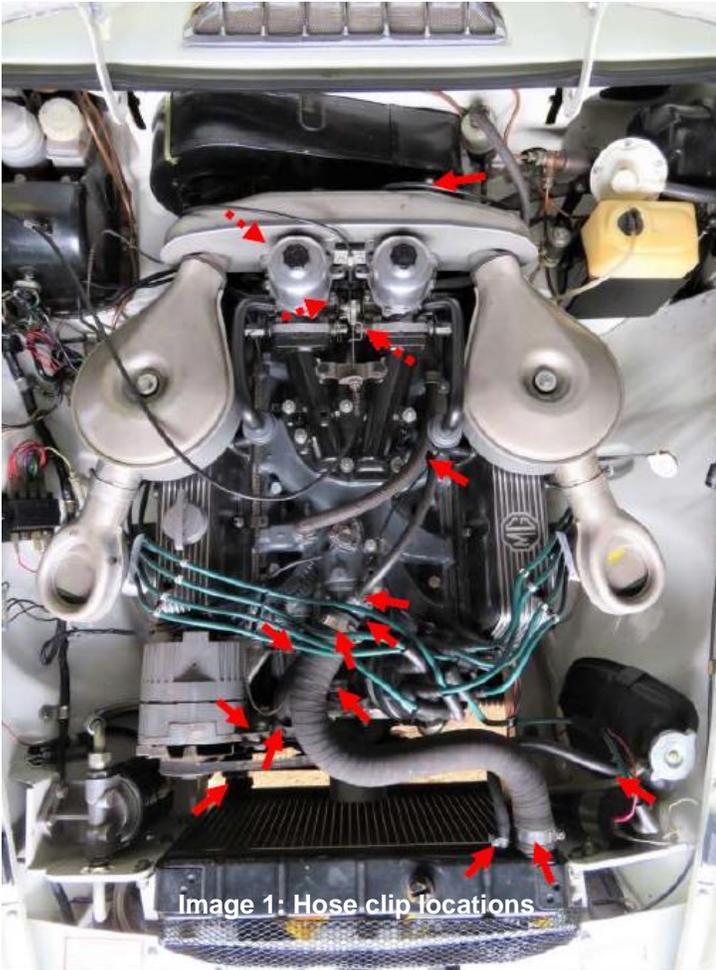
Image 1: Hose clip locations

Sealing the MGBV8 engine cooling system is particularly challenging as the system includes a large variety of joints both bolted and clipped. Of the bolted joints the inlet manifold to cylinder heads would appear to present the greatest challenge as it requires the simultaneous sealing of two junctions with four water ports at opposite corners. In practice, if assembled carefully these joints appear to be relatively trouble free. The other bolted junctions, thermostat housing and heater valve, are simple joints with gaskets and relatively easily made leak proof if the faces are flat and undamaged and new gaskets are fitted. More troublesome are the numerous hose to pipe joints. With 8 hoses and 16 joints, sealing requires careful assembly and checking. See **Image 1** for hose clip locations. As many of these will be obscured by later assembly the checking needs to be carried out while the joint is still visible and accessible. It also helps if the clips are oriented in such a way as to permit adjustment when the engine is fully assembled.

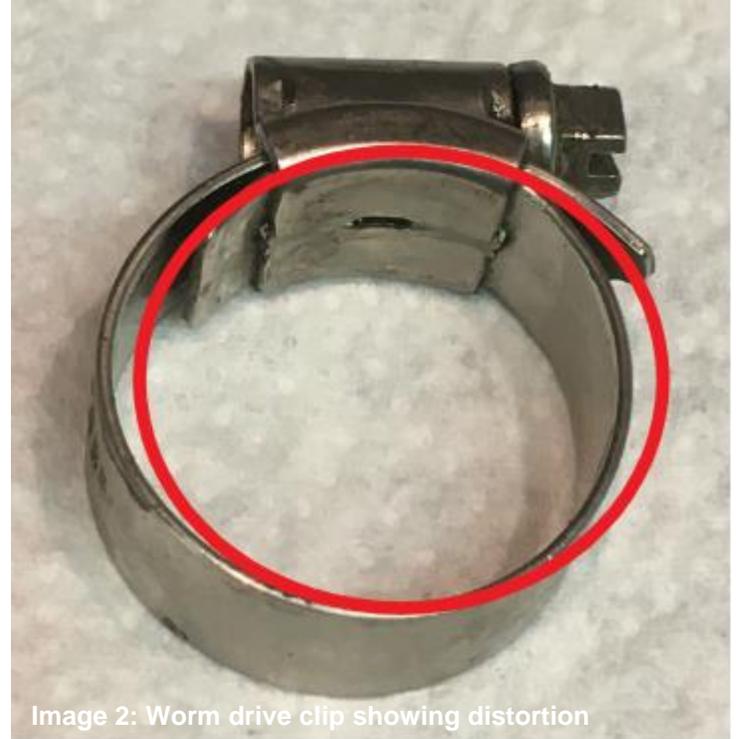
Image 2: Worm drive clip showing distortion

Worm drive clips are generally selected for classic rebuilds as they have a smart appearance, are widely available in a large variety of sizes and can be adjusted. The latter can also be a disadvantage and if the wrong size is used and adjusted to fit, distortion and uneven clamping will occur – **Image 2**.

The remedy is to select a size appropriate to the joint, check for roundness at the tightened diameter and manipulate into a round shape before assembly. The hoses on the MG V8 like most of its contemporaries were originally secured with wire clips – see **Image 3**. No doubt, the main reason was cost but the wire clip had the theoretical advantage of a higher clamping load through the use of a full nut. A third option almost universally employed in modern cars but rarely in classics is the overlapping spring band – **Image 4**. This has financial and quality advantages for the manufacturer as it has low material and labour costs and ensures a capable process, none of which is relevant to the classic engine builder.

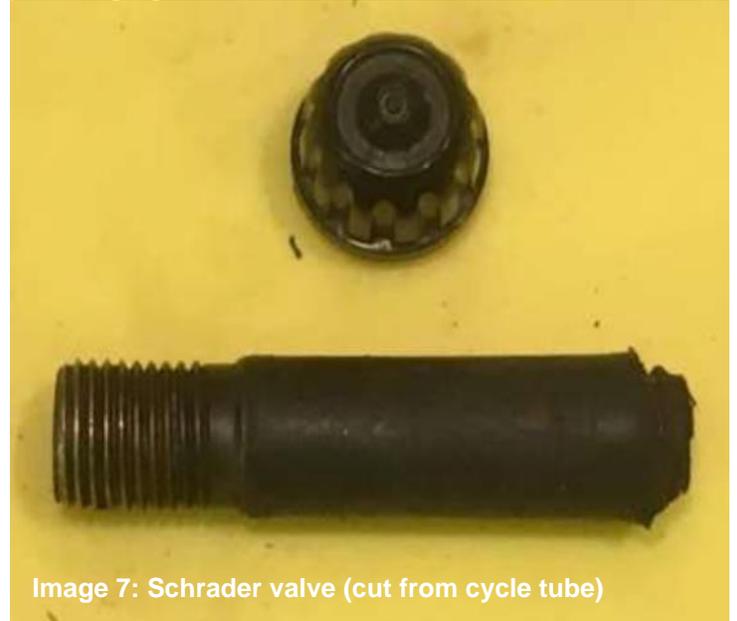
Image 7: Schrader valve (cut from cycle tube)

Professional coolant system test equipment is available but as it is an infrequent requirement and much of the kit is adaptors to suit a variety of installations the expense and complexity are difficult to justify. The essentials are a non-return valve, a pump and a pressure gauge and these are conveniently (and inexpensively) found in a bicycle Schrader valve (**Image 7**), a tyre pump and a tyre pressure gauge.

The latter is not ideal as the target pressure of 15psi (1bar) is at the low end of the gauge scale but it is adequate if, as in this instance, detecting pressure decay over a period is the objective. The Schrader valve is cut out from an old bicycle inner tube (tubeless car tyre valves have too much over-moulded rubber for this purpose) and inserted into the hose from the radiator header tank expansion vessel – **Image 8**.

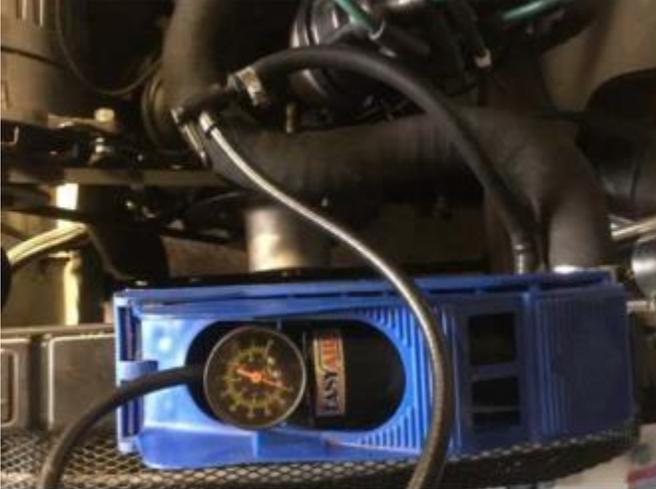
Image 9: Pressurising the system

1. Delay assembly of the carburettors and inlet manifold adaptor until the cooling system is tested. This will allow the heater hose connections (4) to be observed and adjusted.
2. Pressurise the system to 15 psi using the pump and gauge – **Image 9.**
