Door panel moisture barrier replacement

Whilst working on his door mirrors (see V8NOTE 620), Peter Spurrs needed to replace the door panel moisture barriers. Here he describes how he went about it.

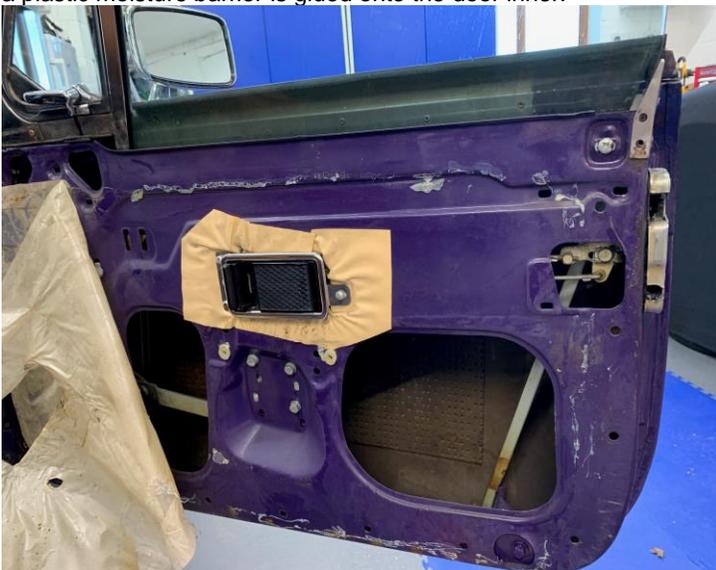
Over time, the moisture barrier can decay and become unstuck, allowing water to penetrate the hardboard in the door card. Also, when working on the interior of the door, the barrier has to be removed and can tear, especially at the glue line.

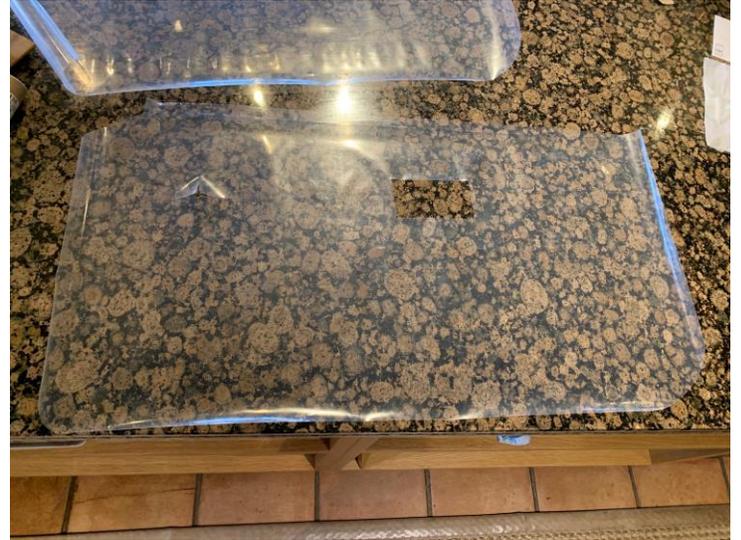
As suggested by Arnie Skirrow, I used Moss part 643-135. Peter Beadle listed several other sources (see V8BB topic 'Door Mirror Mount').

A certain amount of cutting and trimming will be needed, whatever the option chosen. A decent pair of scissors is good enough. Unless a self-adhesive membrane is chosen, an adhesive will be needed. Primarily because I had nothing else to hand, I used blue gasketing compound. I'm not putting that forward as the best answer, just Hobson's choice.
