MGBGTV8 – Tunnel Console. Modification of Armrest Catch

V8 owner Jim Livingstone (Glacier White 1810) was unhappy with the excessive play in his armrest when it was latched and investigated how this might be cured.

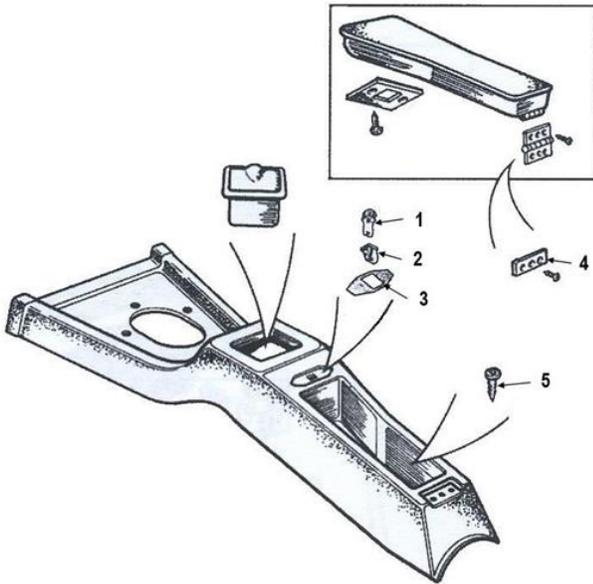
The key features involved in the investigation and subsequent rework are identified in the illustration above and described below:

1. **striker peg**, assembled into a plate which, in turn, is screwed to the underside of the armrest,
2. **catch**, assembled into the console,
3. **catch plate**, not listed in the official parts catalogue but available as a repair part from Moss (moss-europe.co.uk),
4. **nut plate**, fitted to the underside of the console to secure the hinge screws, and
5. **screw**, securing console to tunnel.

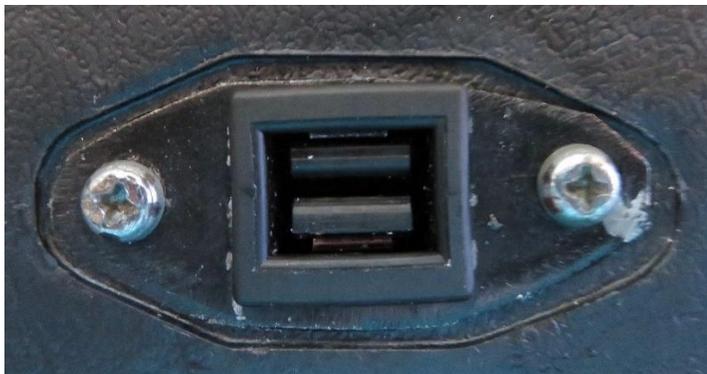
It was immediately apparent that the play was the result of the catch being fitted with its slot oriented transversely. The catch is rectangular and its assembled orientation is determined by the shape of the cutout in the catch plate which, in the writer's car, had its major axis disposed transversely. Removing the plate revealed a cutout in the

console which would accommodate the catch in either a longitudinal or transverse orientation. The striker peg has a square base and a simple trial with both components rotated 90 degrees demonstrated that with careful assembly of the hinge there was sufficient lead-in on the striker to assure engagement. This resulted in a more satisfying feel to the latched assembly. The writer contacted Victor Smith, editor of the V8 Register, who confirmed that on his car the catch was oriented fore and aft indicating that the writer's car had been assembled incorrectly in the past. Correction only required minor disassembly and the fabrication of a simple plate.

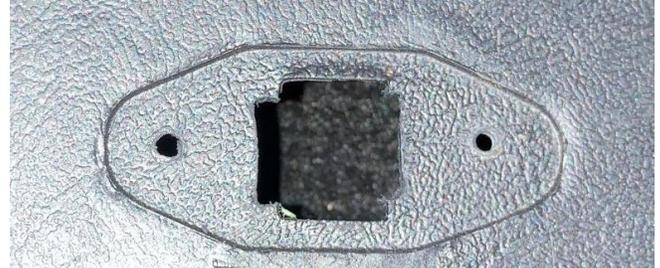
1. Remove the four screws securing the gaiter retainer followed by the retainer itself. Note the location of all parts for reassembly and that the front screw is shorter than the other three.
2. Remove the screw from the rear of the tunnel console – item 5.
3. Remove the console to a convenient workplace.
4. Trace out the outline for the catch plate using the moulded impression in the console as a template.

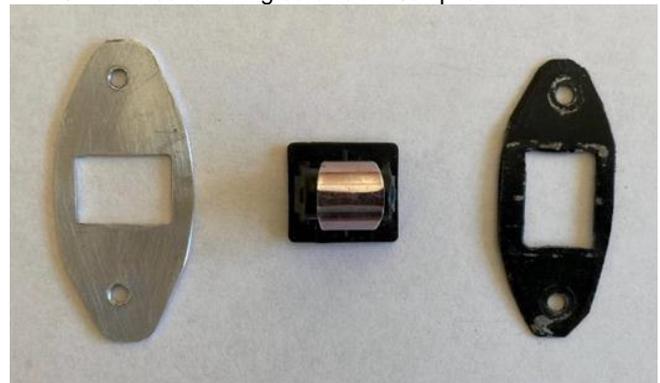
5. Transfer the tracing to sheet metal and cut out a blank catch plate.
6. Mark the centre of the blank and drill a 12mm hole.
7. Carefully enlarge this hole to 12mm x 17mm using a square file. Note that the major axis of the rectangular hole is now fore and aft. Drill two 3mm holes for fixing screws at 1½" pitch.

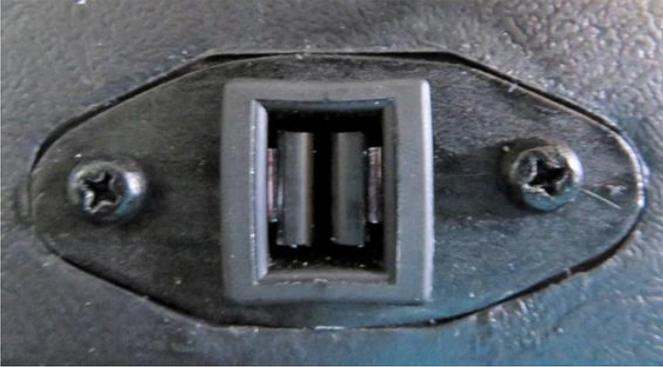
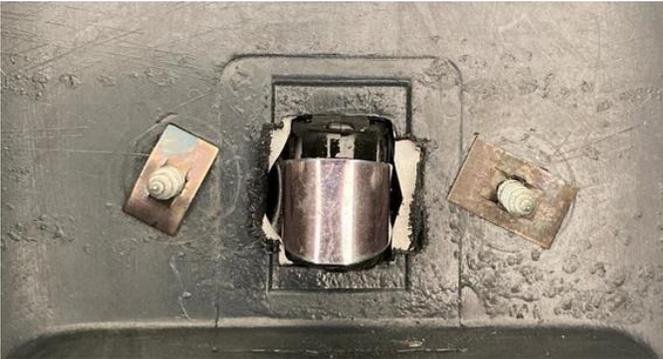
8. Finish with matte black paint and insert the catch.

9. Secure the plate and catch to the console using sheet metal screws and spire nuts.

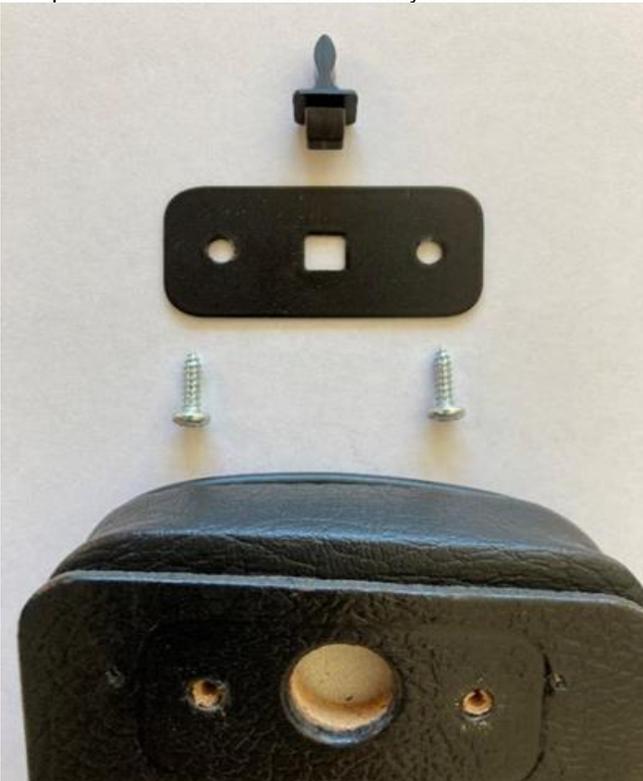
10. Remove the two screws holding the peg plate to the front underside of the armrest, remove the peg from the plate, refit at 90 degrees to its original position and reattach the assembly to the armrest.

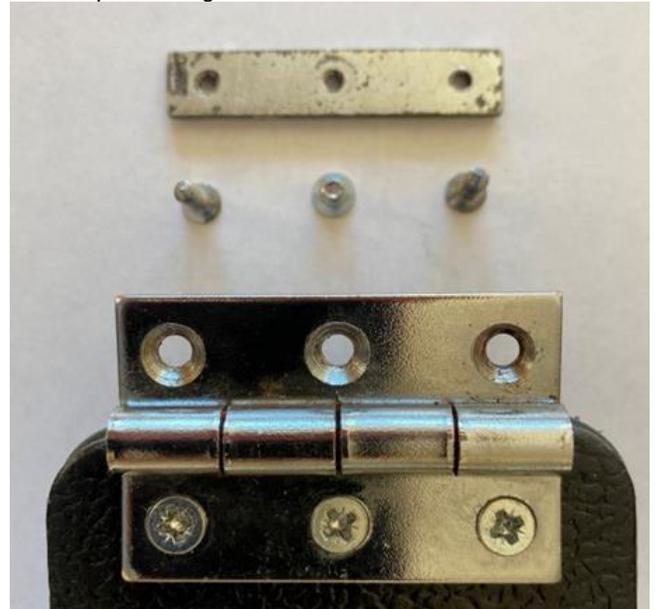
11. Loosen but do not remove the three machine screws securing the hinge to the console. Note that these are screwed into a floating nut-plate – item 4.
12. Close the armrest and check that the peg engages cleanly in the catch.
13. Without disturbing this position of the hinge, reopen and tighten the three screws.

14. Recheck the closure. The optimum position is achieved when the peg is in the centre of the catch when the armrest is in the middle of its lateral play.
15. Refit the console in the reverse order of removal
