Tailgate Seals

MGBGV8 – Tailgate removal and fit new outer seal

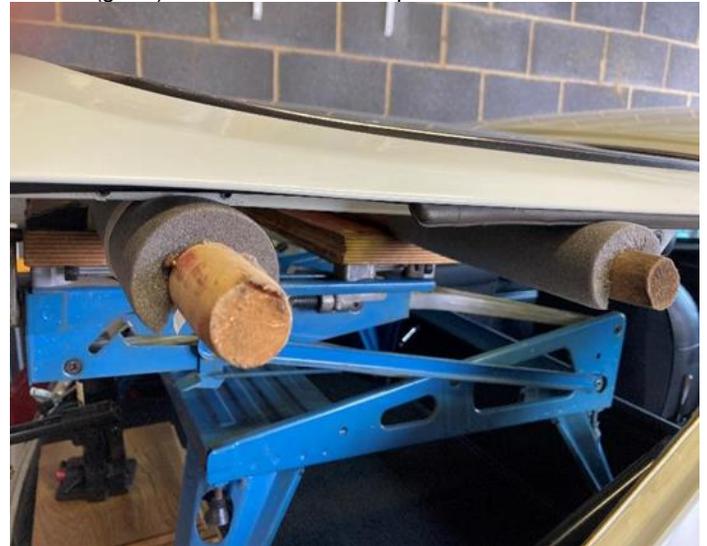
Several schemes were considered to support the tailgate while the hinge screws were removed. The basic requirement is height adjustment combined with a stable non damaging means of support for the tailgate. The problem was resolved by employing the folding properties of a Workmate together with a hydraulic bottle jack to provide the height adjustment. In the event this proved satisfactory provided the jack was positioned under the heavier (glass) end of the Workmate platform.

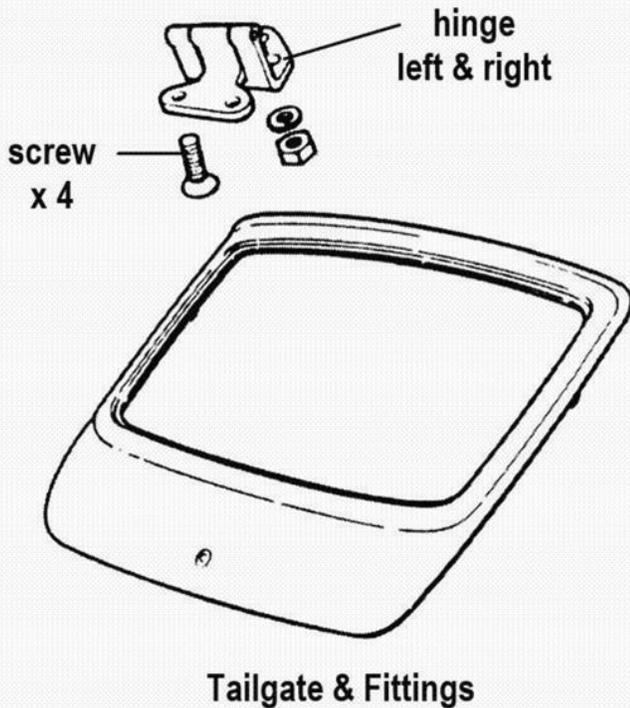
1. Position the Workmate on the rear luggage platform.
2. Fit padded extensions to support the tailgate. The writer used broom handles with foam pipe lagging.
3. Lower the tailgate until it is horizontal.
4. Using the jack raise the Workmate from its storage position until the padded supports contact the horizontal tailgate.
5. Remove both tailgate stays.

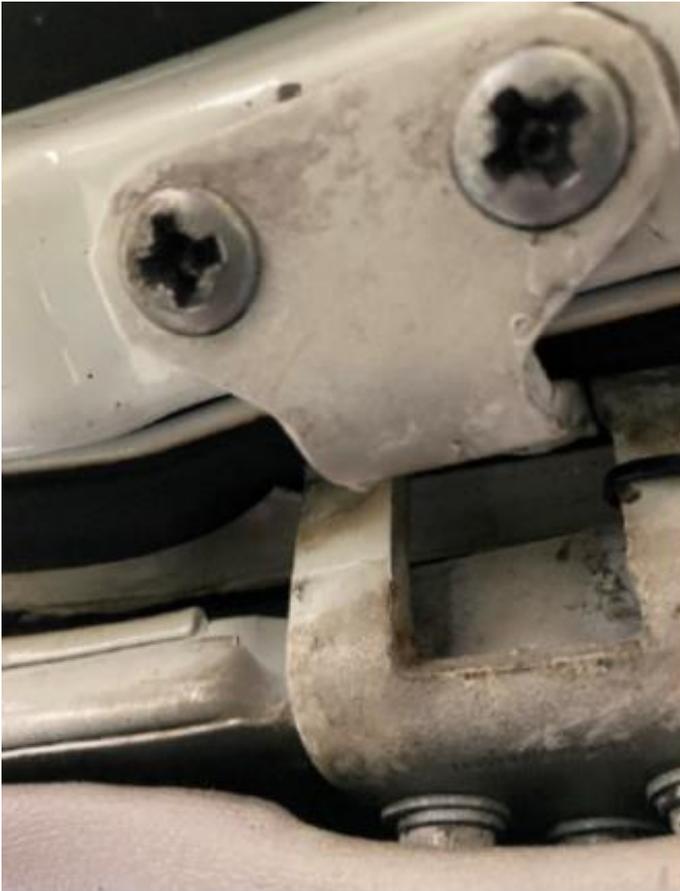
6. Disconnect the bullet terminals to the heated rear window.

7. Using a PZ4 bit gradually loosen the four countersunk hinge screws.
8. Check that the tailgate is securely supported and fully remove the screws.
9. Either roll the tailgate backwards on the Workmate until the ten retainer screws are accessible or remove it with the aid of an assistant and support it vertically with its forward edge uppermost.

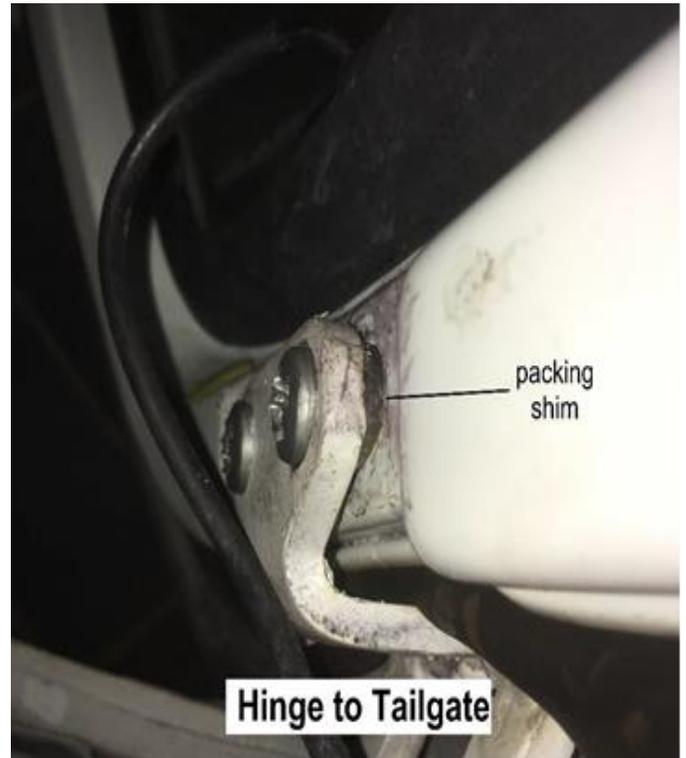
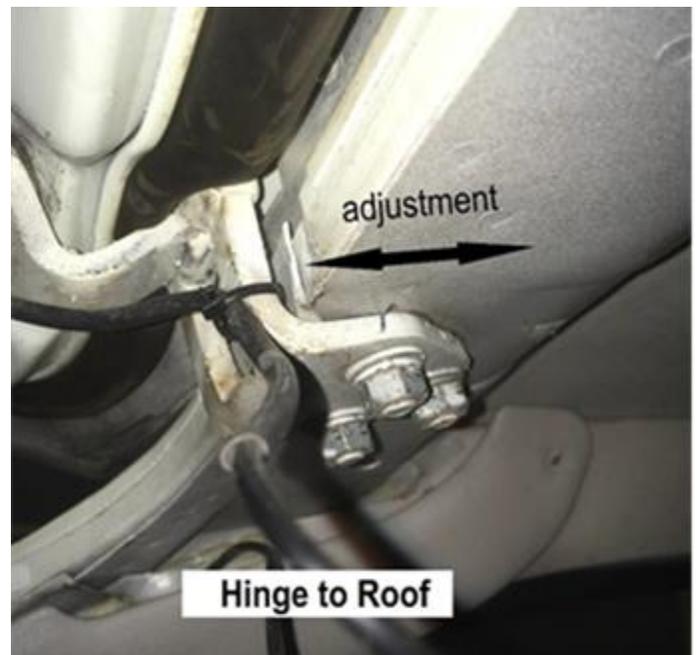
10. Remove the screws followed by the retainer and outer seal. Note: the position of the outer seal in the retainer and that it is attached to the tailgate with adhesive at its corners and sides.

11. Remove the remnants of old adhesive.
12. Inspect the inner seal and clean as required. Ease it out of its retaining channel at the top corners and sides.

13. Fit the new outer seal to the retainer in the position noted in step 10. Some adhesive applied at intervals along its length will help to retain it.

14. Apply fresh adhesive to the tailgate side of its top corners and sides and secure in position with the ten screws.
15. Refit the inner seal into its channel.

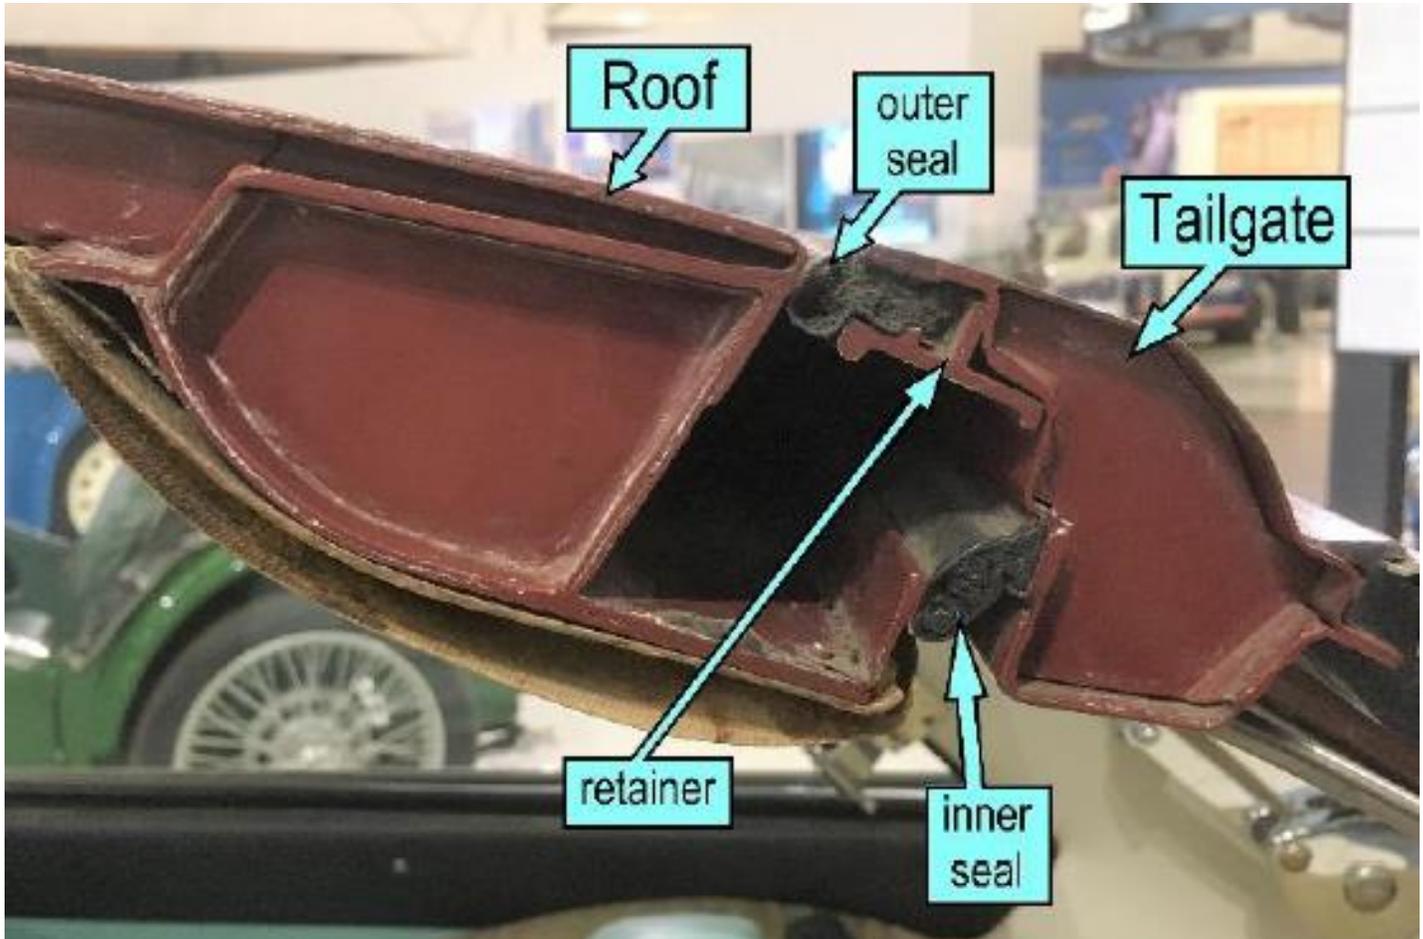
The sectioned MGB GT at the British Motor Museum, Gaydon reveals details of the tailgate sealing arrangement which are helpful in understanding how it works. Note that the original inner seal was of foam construction like the outer seal. Commercially available replacements are hollow extrusions which explain the differences in performance characteristics.
