Rebuilding an MGBGTV8 – Damask 0450 (Part 22 of a series of reports)

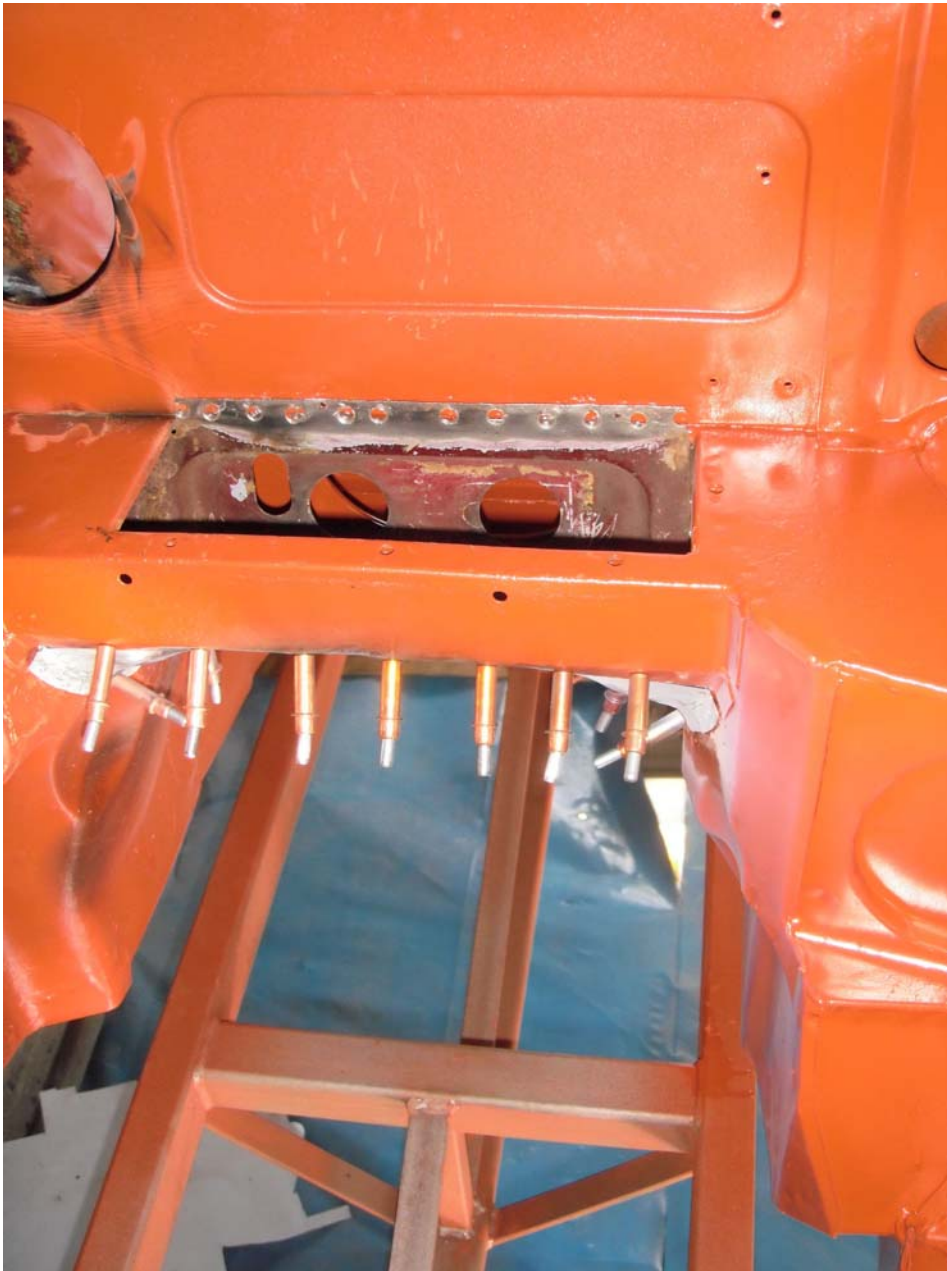
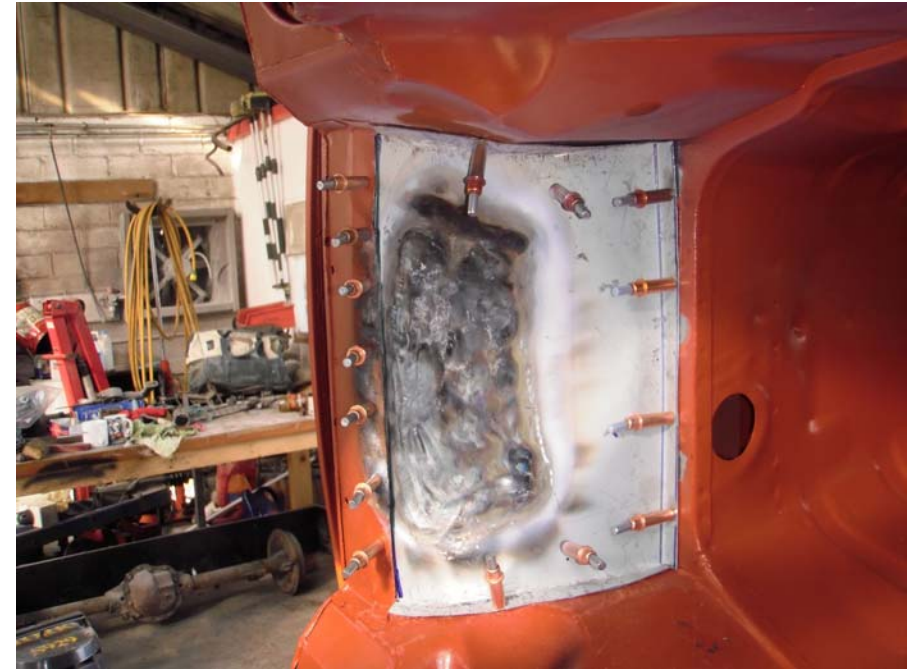
Damask 450 is back from the sand blasters and is now coated in 2-pack orange primer for protection of the bare metal. The sand blasting has revealed a few extra holes that had not been spotted earlier, but nothing serious apart from the heater box area. Below the heater there is a closed box, and in order to repair it, the base of the box has had to be removed. Here you can see a new base being trial-fitted. The strange looking pins are temporary fasteners, as widely used in the aircraft industry. They are effectively 3mm rivets, but they are spring-loaded so they can be removed and re-used.

The blister effect on the replacement panel above is because we have used heat to soften the new panel, so that it curves easily. It needs the curve to clear the top of the bellhousing. The temporary pins are strong enough to withstand the panel beating.
