Rebuilding an MGBGTV8 – Damask 0450 (Part 28 of a series of reports)

These notes were made when I rebuilt the rear brakes on Damask 450.

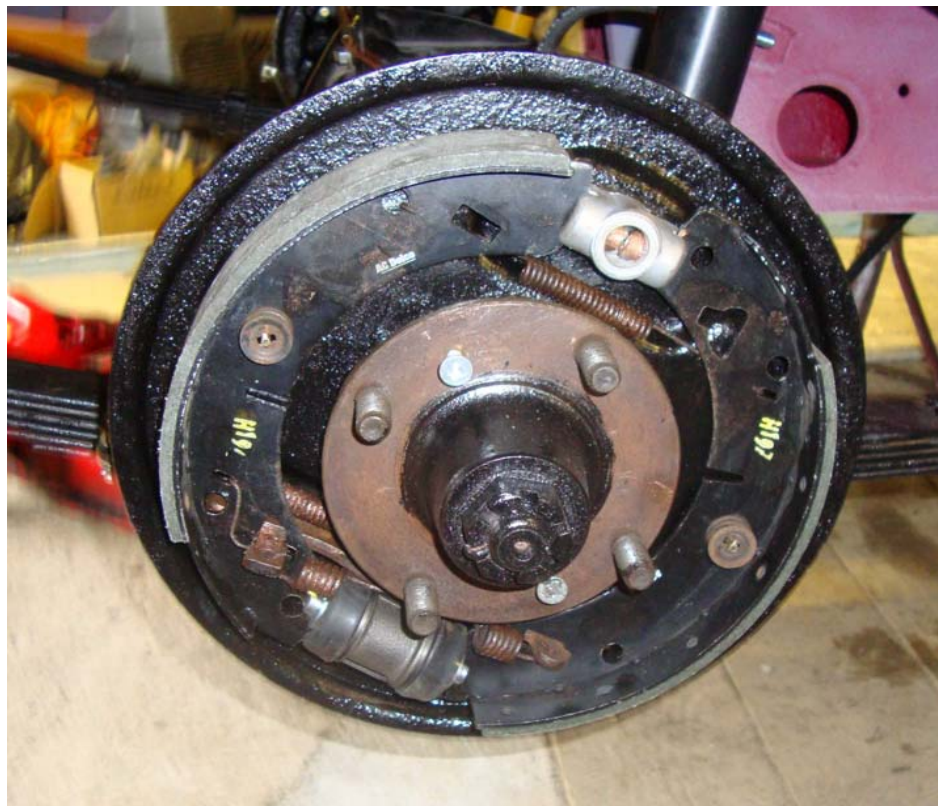
In the MGB Workshop Manual there is an excellent diagram of the rear brakes. Unfortunately, it doesn't state which side of the car it refers to, so here is a photo of the offside rear brakes, correctly assembled. The brown stains on the return springs are copper grease, which I use liberally.

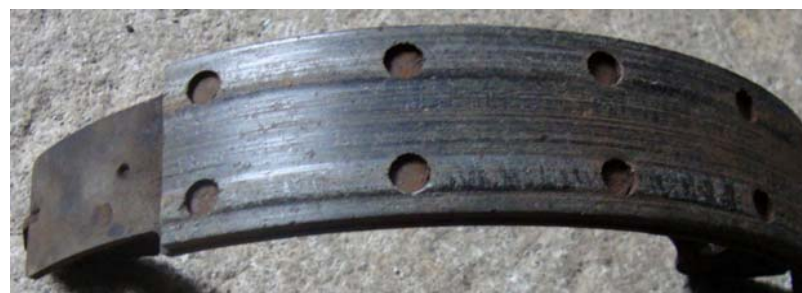
When I removed one of the rear drums I found it to be badly scored. It would appear that the car had been driven for some time with the rear brake shoes completely worn out, so the copper rivets had scored two deep grooves into the drum. Worse than that, the brakes had then been fitted with new shoes, and the badly scored drum then proceeded to ruin the new shoes. When components reach this stage, it is best to throw them away. I have fitted new drums, new shoes, new cylinders and new adjusters.

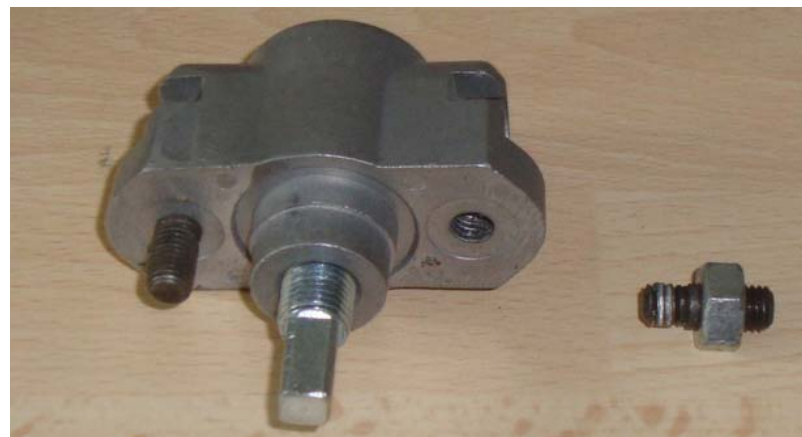
When I fitted the new adjusters, I could feel that something was wrong - one of the nuts just kept on turning. Here is the reason - one brand new adjuster with a stripped thread! I do worry about the quality of some newly re-manufactured parts.
