Rebuilding an MGBGTV8 - Damask 0450 (Part 13 of a series of reports)

Progress has now resumed on Damask 450. Here Barrie Jones provides another of his rebuild updates.

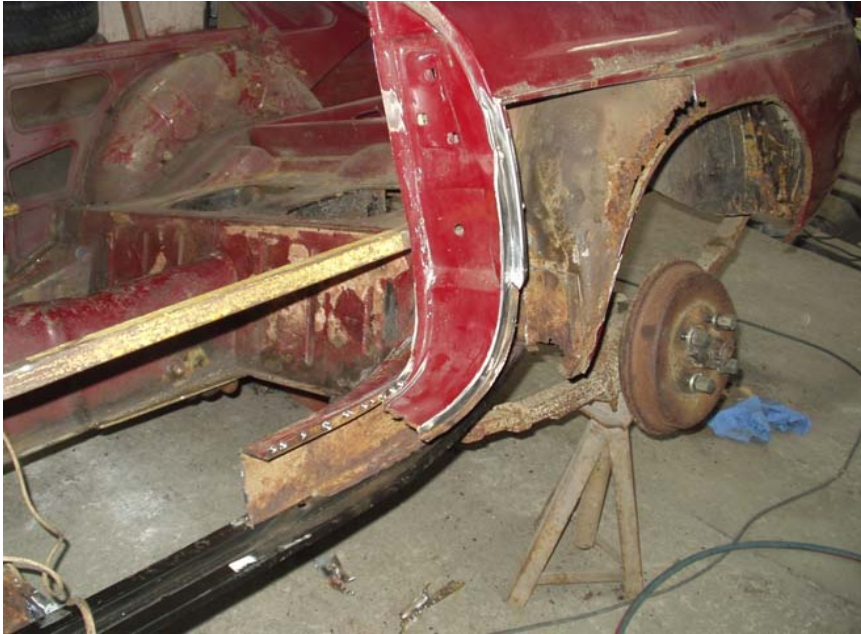
In the **first photo** you can see that the outer sill and the centre membrane have been totally removed, and the inner sill has been cut so that a 3 foot long repair section can be inserted. Underneath, a new castle section has been fitted, plus a temporary bar across the door opening. These should prevent the shell from losing its shape.

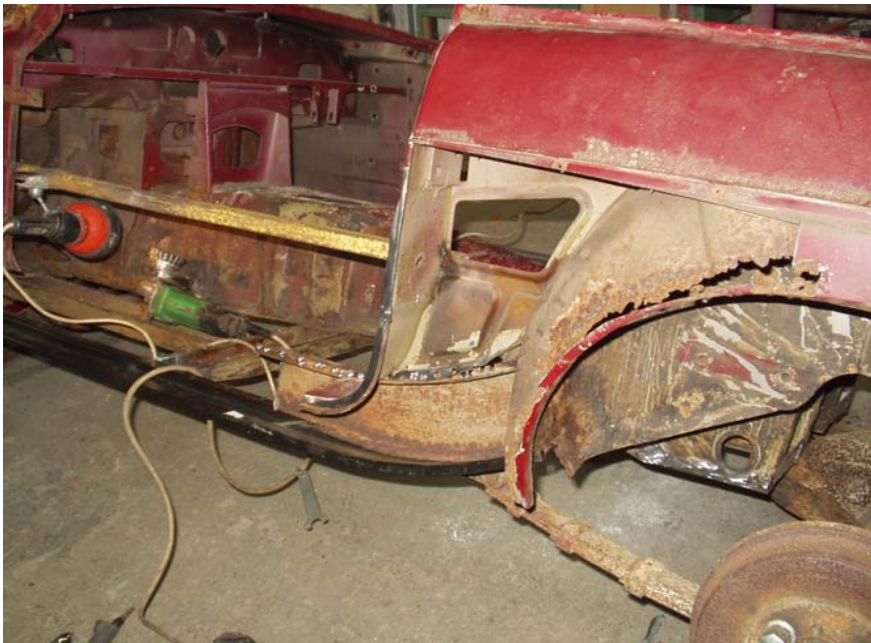
In the **second photo** you get a better view of the inner wheel arch, which will be replaced shortly. Underneath, you can just make out the new bottom fitted to one of the battery carriers. These always rust badly. I like to re-position the forward stop further forward, so that a pair of 12 volt batteries can be fitted. I use standard 063 batteries, which are very common and readily available.
