Rebuilding an MGBGTV8 – Damask 0450 (Part 14 of a series of reports)

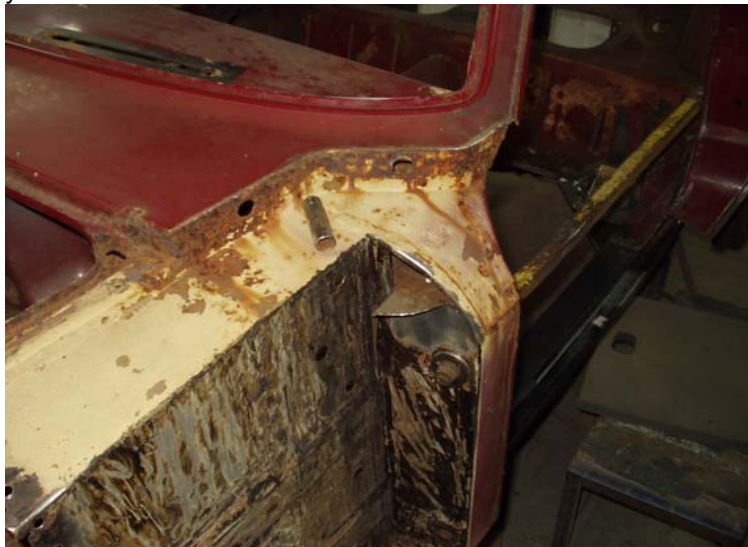
'Tis Christmas, and something was shining inside the nearside A post. A quick zing with the cutting disc, and look what I found - a chromium plated socket. Imagine what that would have sounded like, every time you went round a corner!

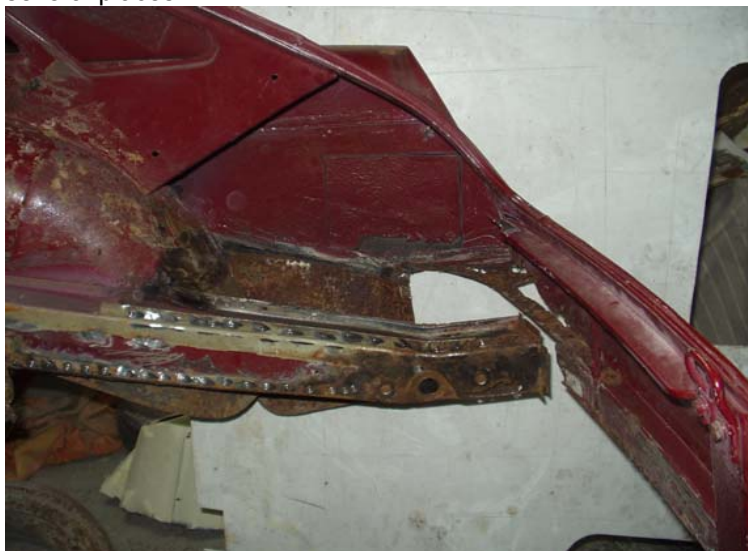
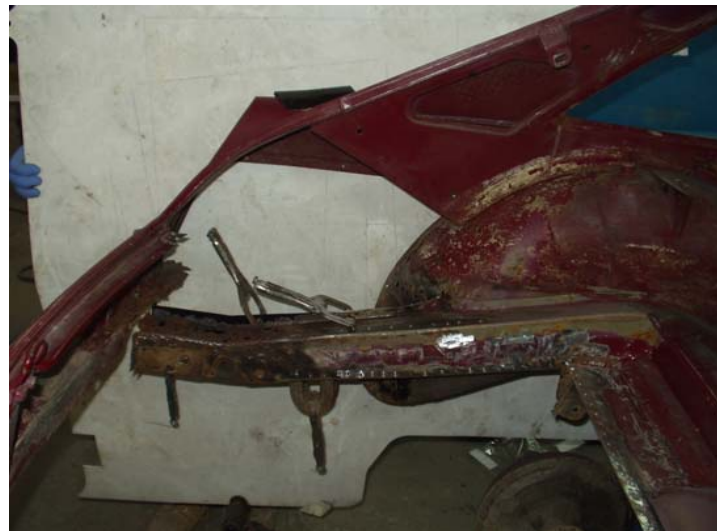
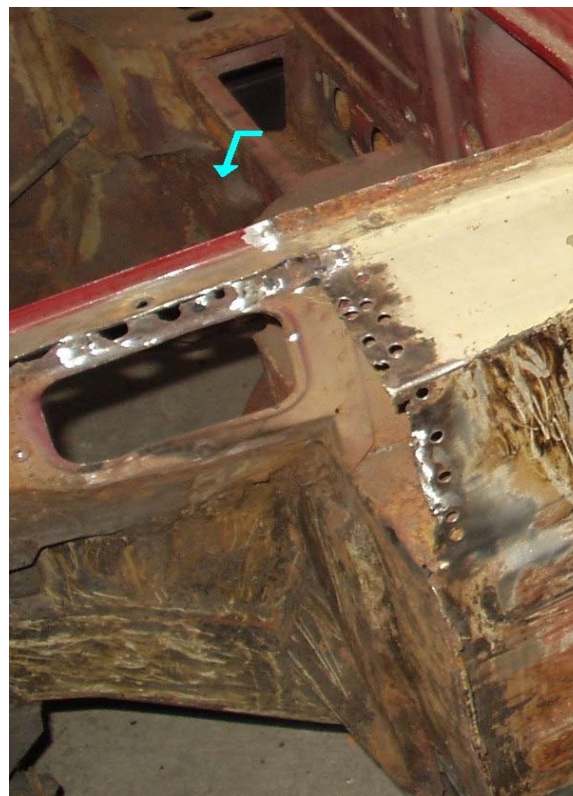
This week, the boot floor came out. Not only was it totally rusted out, but also it gave access to the rear chassis rails, which were holed in several places.
