MGBGTV8 restoration project

Instrument Renovation March 2016

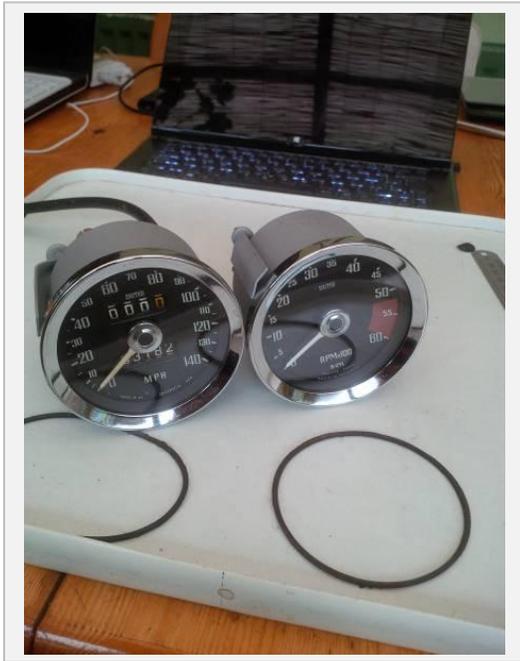
Tachometer and speedo renovation complete except new O rings required for installation.

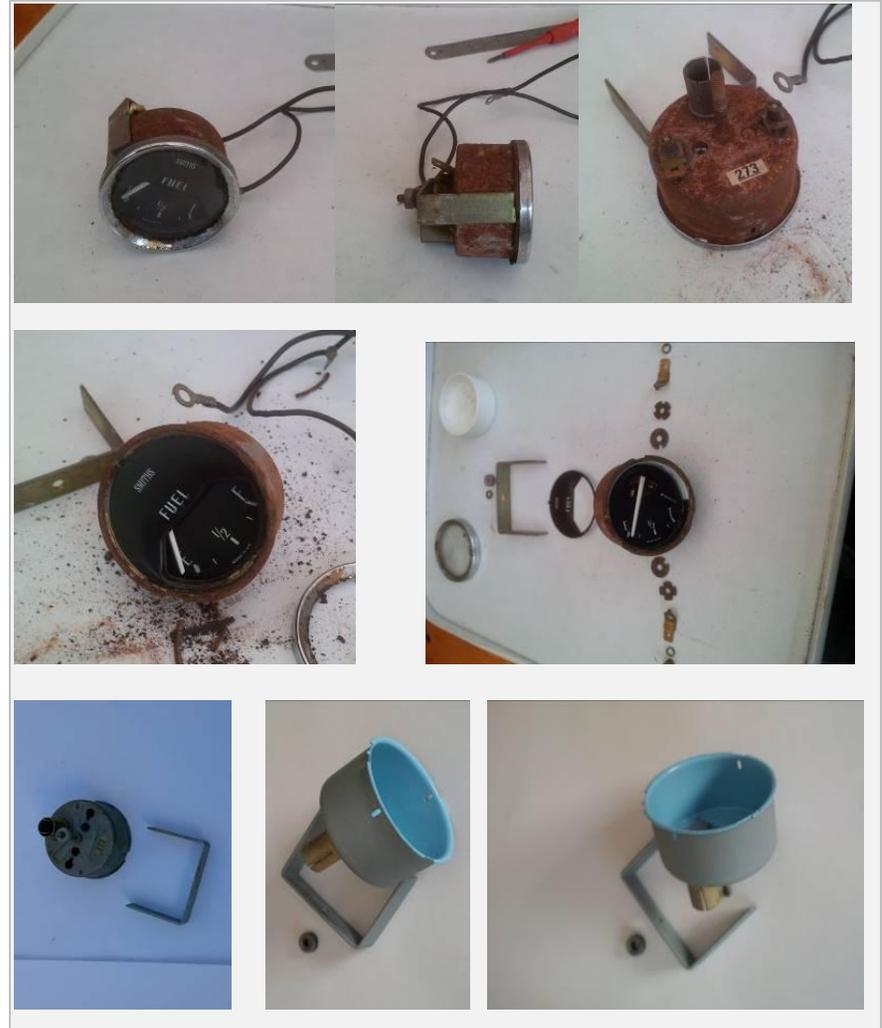
It is a Smiths Instruments 2" type 273. The chrome bezel was very difficult to remove as there was a lot of corrosion on the instrument housing. Generous use of WD40 won the day. The outer scale requires re-spraying with mat black in areas, I will use my air brush it has a very fine setting which allow repair without affecting the lettering. At each stage I take pictures to aid the reconstruction.

The connections through the housing are insulated from the case by several insulating spacers, these were very dirty and when cleaned I used a 100 V

insulation tester to check that they were reusable. Unfortunately the coil was open circuit and a new one will be required. I found a tatty instrument on e-bay for £4.99 and when I receive I will remove the movement and installed in the renovated housing.

The housing was sandblasted inside and out along with fixing bracket and knurled fixing nut. The outer surfaces were sprayed with galvanizing paint, the interior surfaces sprayed with duck egg blue. The top quadrant of the inner dial was painted white to reflect the back light on to the scale, this needed to be resprayed. After masking the scale I used the airbrush to touch this area. The lettering was touched up with a fine white paint marker. The bezel although very dirty was in good condition under the dirt and this was polished ready for re construction.

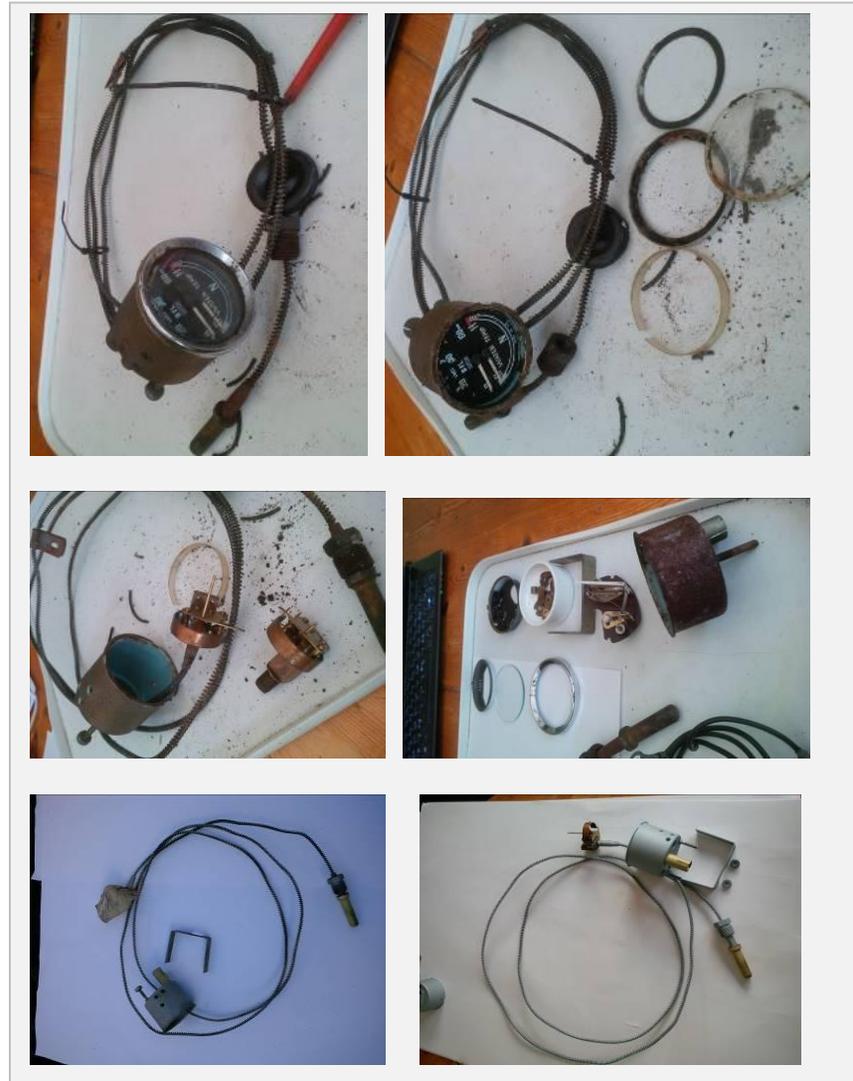
This is a 2" Smiths Instrument type 123 Black scale. Again the chrome bezel was very difficult to remove as there was a lot of corrosion on the instrument housing. Generous use of WD40 won the day again. The inner scale was equally difficult to

remove, it is an interference fit in to the housing with cut-outs in the vertical surfaces to allow for back lighting. There is also a thin clear plastic "lens" that wraps round the scale. The scale lettering is slightly damaged but not sufficient to warrant a replacement as it will be touched up using a very fine paint pen and new rub down letters.

The pressure movement was removed from the case and cleaned. I used compressed air through a regulator to check the operation, all was well. Next I removed the temperature movement from the case however the bulb on the end of the capillary prevents case being separated from the instrument.

I sandblasted the case and the capillary / bulb with care and once done degreased and sprayed the case with galvanizing paint. The interior was spayed duck egg blue as it was originally. The pressure and temperature movements were installed in the case followed by the plastic lens and dual scale. The needles were re painted white with a black centre and installed in the needle movements. Before installing the glass I put the bulb in water and brought it to the boil, all worked fine.

The inner rim of the bezel was filled with black sealer. The glass was installed followed by the chrome bezel. The bezel is a bayonet fit and to ensure the glass is tight the tags on the rim need to be bent slightly inward at an angle to allow bezel to be pulled down on to the housing.
