MGBGTV8 restoration project

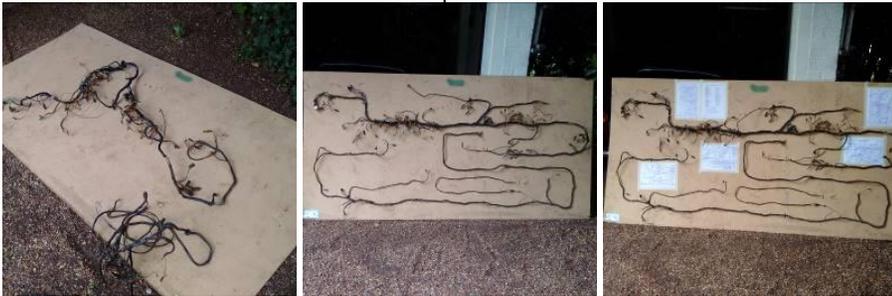
The first job was to check and re tape the loom changing all of the insulated connectors having cleaned the bullets on the loom. Continuity was checked and new sections of colour coded cable were inserted where required.

To do this I mounted the loom on a board as shown above and worked from one end to the other initially cleaning the cables then stripping the tape a section at a time.

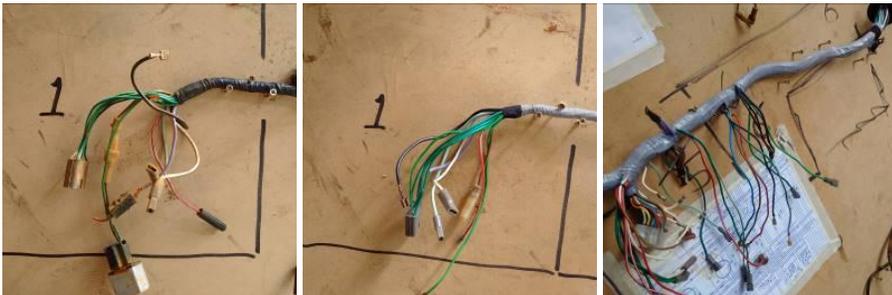
All the bullet connectors were cleaned and checked, new push connectors will be used for the final assembly. Several cables had been spliced with incorrect colour add on and these were replaced by the correct colour coded cables.

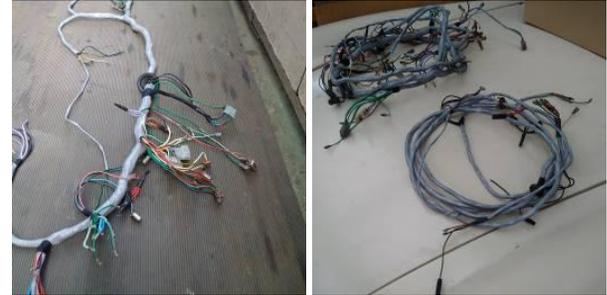
Once the work on the loom was complete a continuity check was carried out and all tested out correctly.

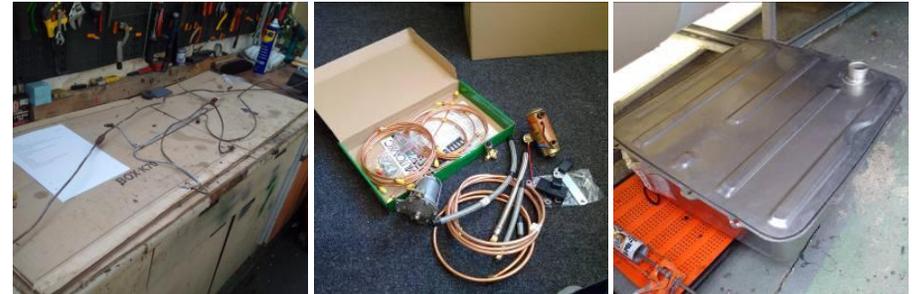
I checked the fuel and brake pipes and they were found to be badly corroded so new were ordered as was a fuel tank.

I had a red top fuel pump from a previous rebuild of my MGB GT and a fuel filter which I intend to use on the V8. The fuel tank was cleaned and primed with a suitable primer for the galvanized tank then sprayed with stone chip before finishing with semi gloss black paint to match the rest of the running gear.

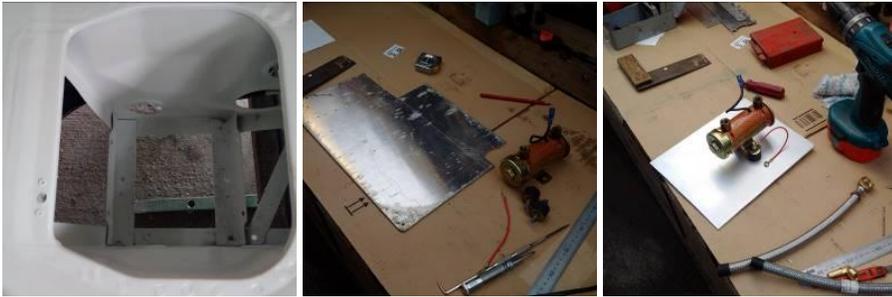
I made a mounting plate and floor plates to seal the well with 1 1/2" (38mm) and 2" (50 mm) diameter blind grommets to seal the holes in the side however the 3" (75mm) holes will be fitted with filters to allow for ventilation in the event of a fuel leak.

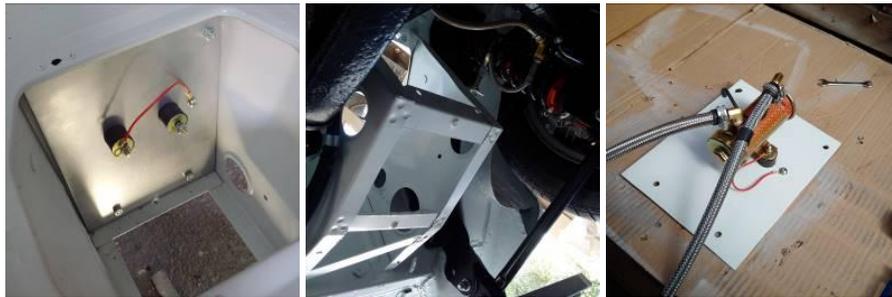
The pump backplate was made from 1/8" aluminum for rigidity where as the bottom plates were made from 1/16" mild steel. The pump backplate was fitted using studs for easy removal and rubber sealer to prevent the ingress of water. The bottom plates were pop riveted in position with Tiger seal between the chassis frame and the plates.

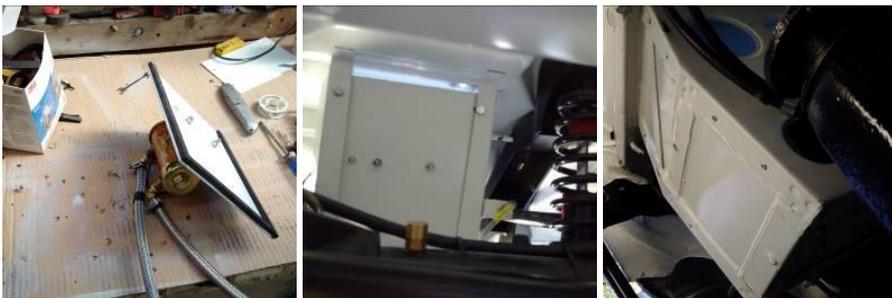
Before installing the plates were sprayed with glassier white to match the body colour.

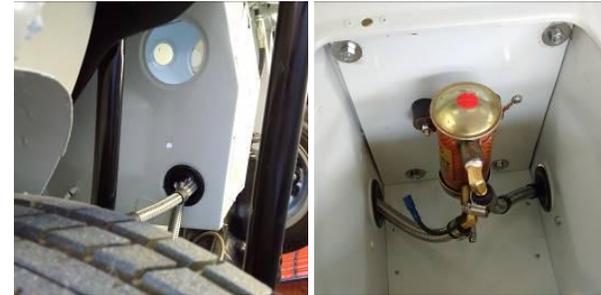
As the red top pump tends to be noisy I will put soundproofing on the underside of the removeable lid of the battery compartment.

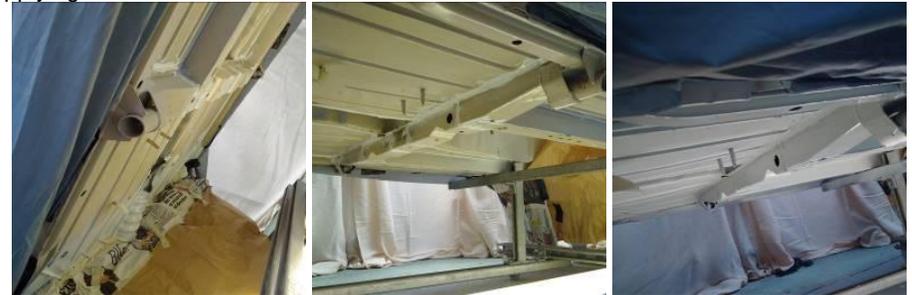
Everything was now ready for the installation of the under floor components with the exception of the floor itself. This needed to be prepared primed and sprayed but to do this I need to move the support points on the dolly. Having done this the under floor area was cleaned, all joints sealed, primed and then four coats of top coat applied. The area under the drivers and passenger floors were costed with stone chip prior to applying the undercoat.

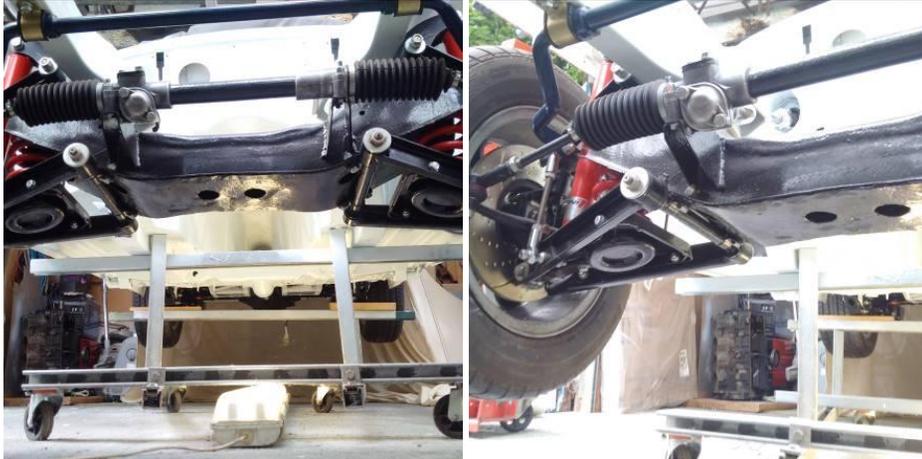
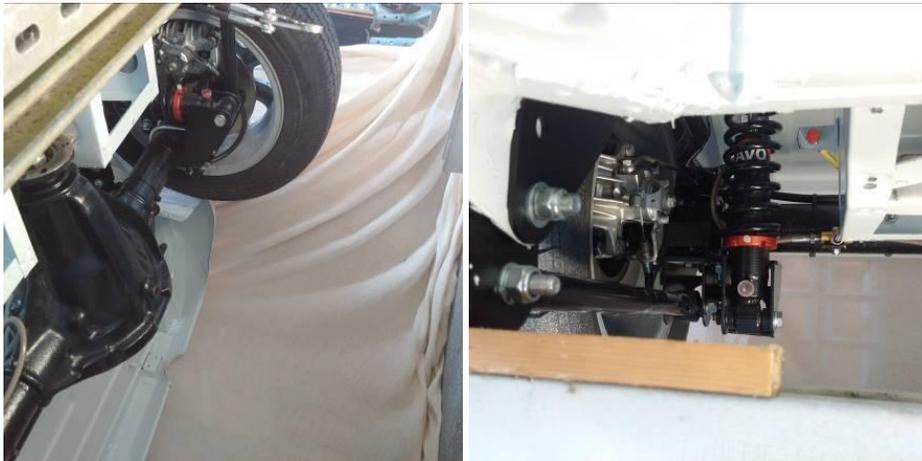
Before installing the pipes and cables I took a few shots of the underside before it becomes cluttered, these also showing the moveable cradle that the body shell has been resting on since the beginning of the restoration, Hopefully next month it will be off the cradle and sitting on its own wheels. These wheels are temporary, once the rebuild is complete it will be back on its V8 rims.

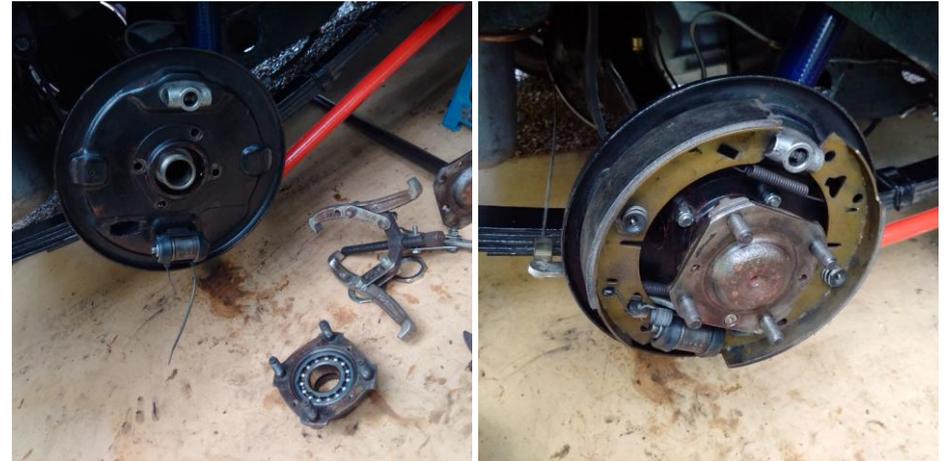
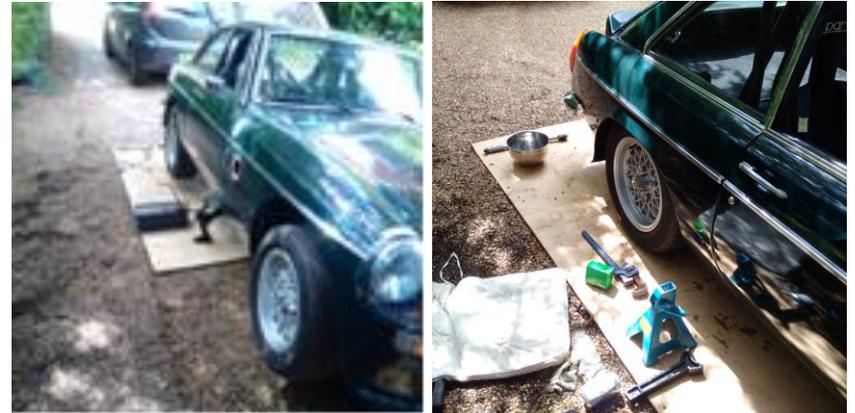
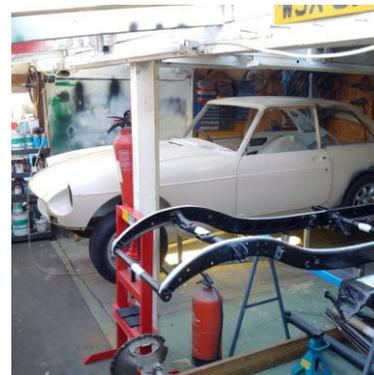
Ideally I would have liked to get the loom installed this month however my MGB GT decided three days after its successful MOT this month to blow a seal on the rear offside half shaft which needed attention as I will be using it on a track test day very soon after my return.

Note my MG 3 hiding in the background! Alongside I am also carrying out the restoration of my MG TC the chassis of which can be seen beside the V8 – Oh the delights of owning classic cars.
