MGBGTV8 restoration project – Report 11

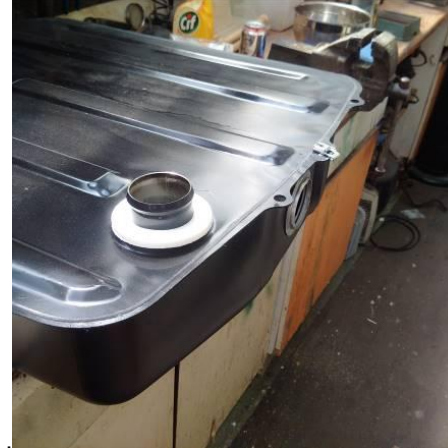
This is a push on plastic connection and I do not feel happy as it is vulnerable to damage. I decided to add a brass take off with an extension to the tank low point.

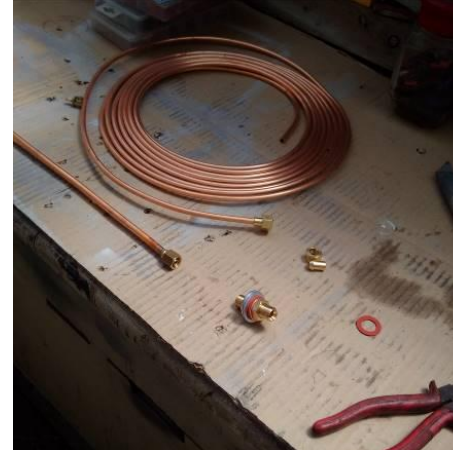
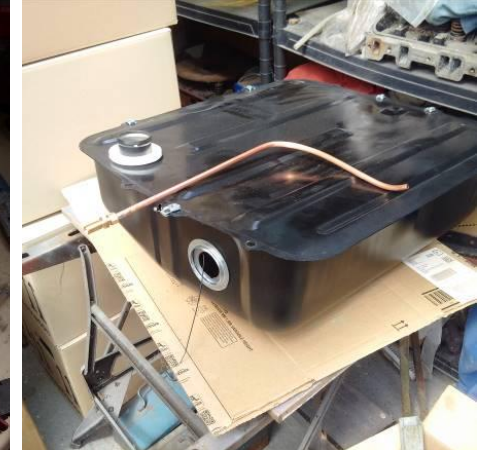
I added a mesh over the intake to prevent large particles entering the fuel line. There is a filter on the intake to the red top filter to take out small particles before the pump.

Having drilled the tank I washed all swarf from the internals of the tank using petrol tank cleaner. I pressure tested all soldered joints before installing the pipe to ensure that the pump can self prime. I threaded the take off in to the tank after fitting a fiber washer and a penny washer to the bulkhead fitting internally.

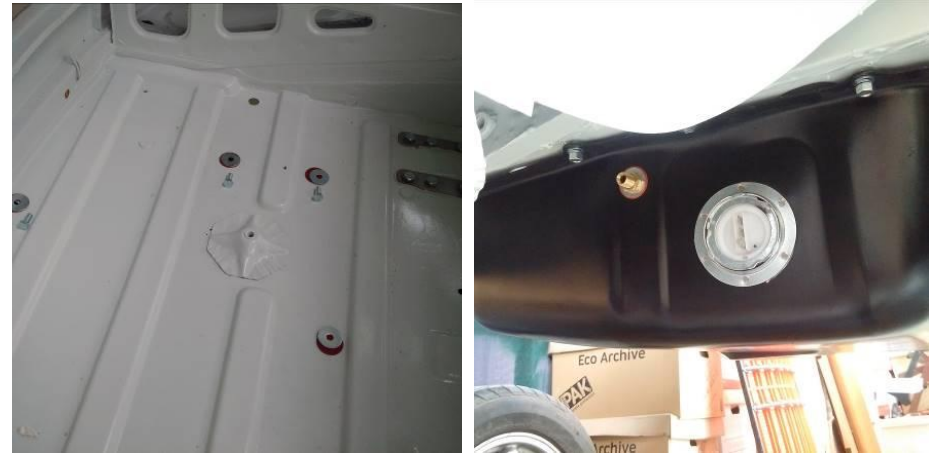
I then fitted strips of self adhesive felt packing to the top of the tank and the tank seal to the fill point to ensure that fumes cannot enter the car. I used the standard fixing kit with fiber washers and fitted blind grommets to all through floor penetrations. When I fit the loom these will be changed to accommodate the loom where required.

All bolts were smeared with copper ease to protect from corrosion and I will add protective caps once everything is installed under.

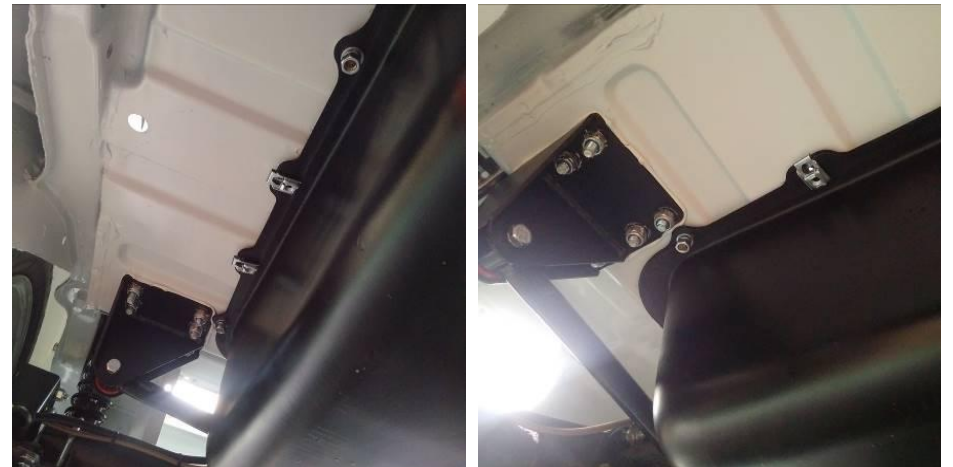
I was a little concerned that the Panhard rod bracket may interfere with the tank however although tight it cleared the tank.

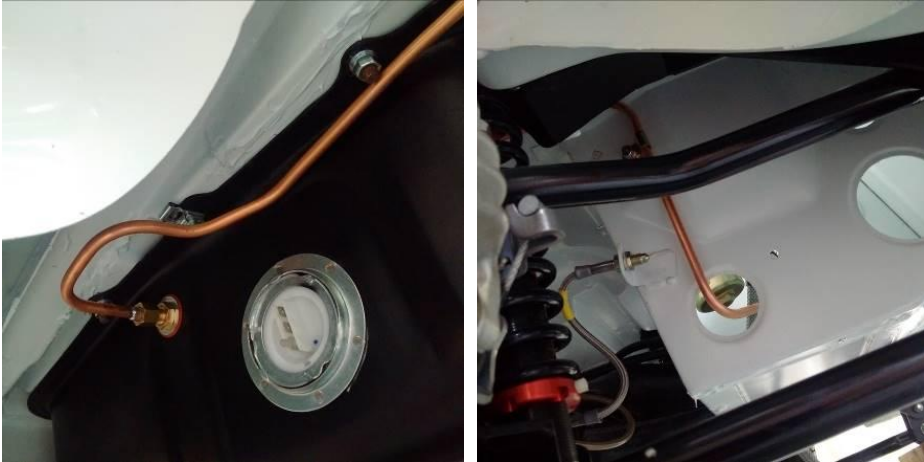
Next came the fuel pipe from the tank to the fuel pump located in the offside battery well, I ran it along the lines of the original route using the studs welded to the shell, these studs will also be used to locate the loom that feeds the rear lights and fuel sender.

Additional clips will be installed to hold the fuel line once the loom and brake pipes are installed as copper can crack from work hardening normally at fittings due to vibration. The fuel line follows the profile of the body to ensure it clears all moving parts of the rear axle and is clear of the brake lines.

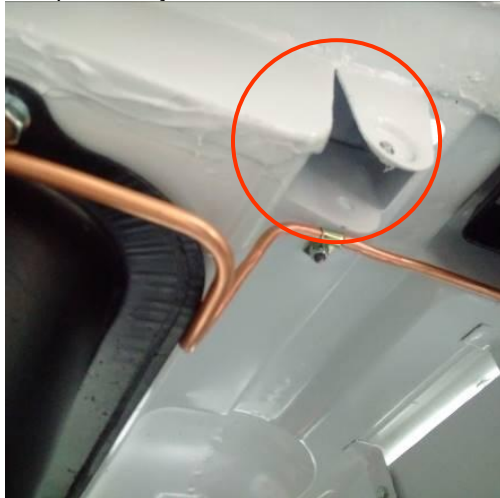
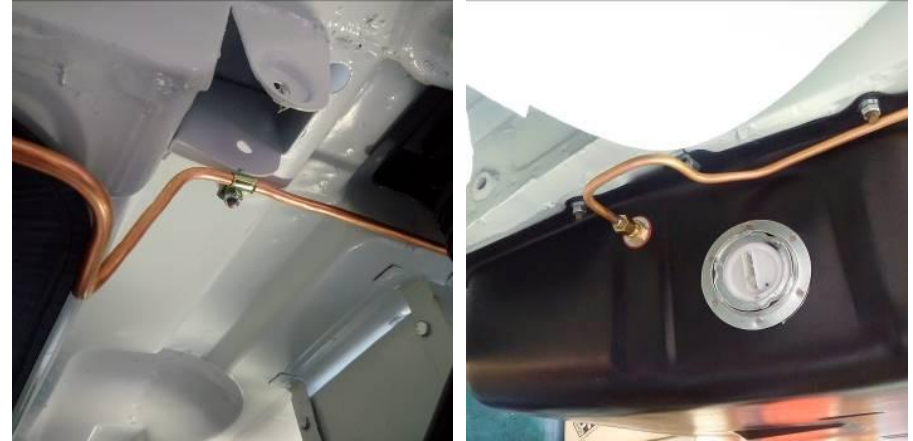
You will see that items such as the drop straps appear to be missing however this is not the case as the 5 link suspension system does not need these.

The pictures below show the routing from the tank through to the batter box.
