MGBGTV8 restoration project

On with the V8. Today the starter motor. It was seized solid so before testing the solenoid time to strip and clean the rotor and pre-select assembly. After liberal coating with WD40 the casing screws started to move however the cable connection screws would not budge, used heat and eventually they came undone. Once undone I was able to remove the solenoid fixing bolts and remove it from the starter casing.

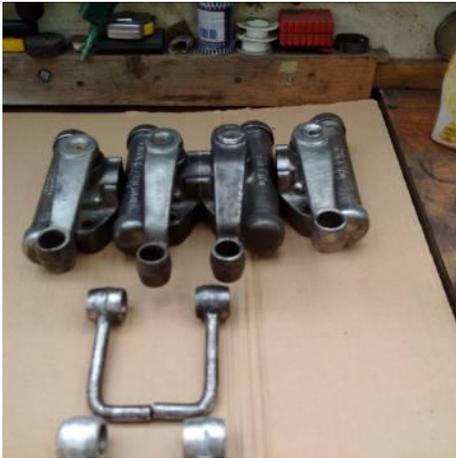
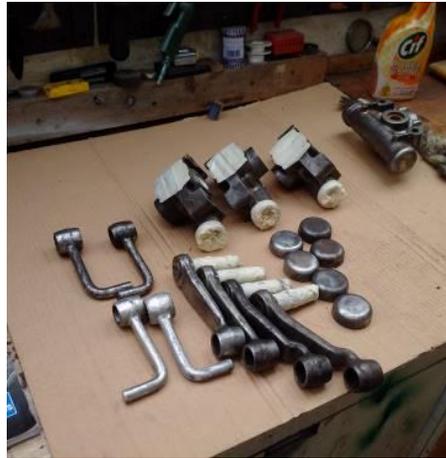
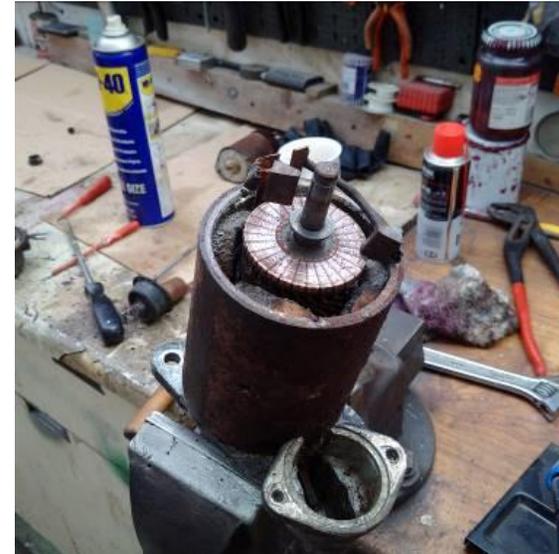
As I am trying to get my TC to a rolling chassis state, I took a day out to get the damper cases and associated parts ready for spraying.

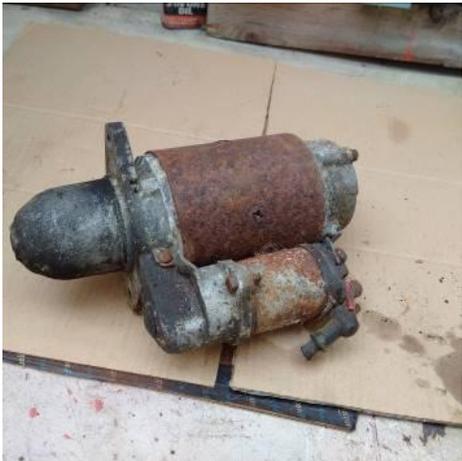
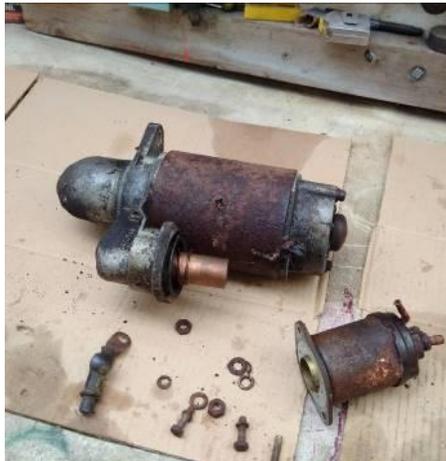
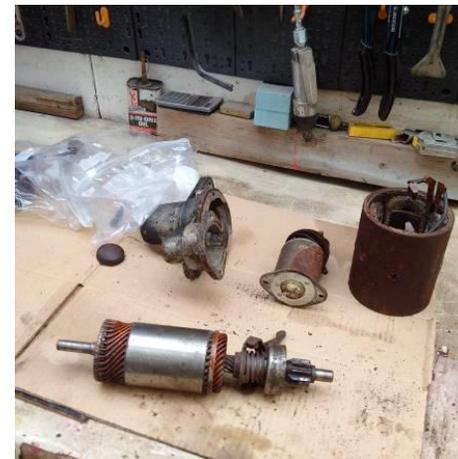
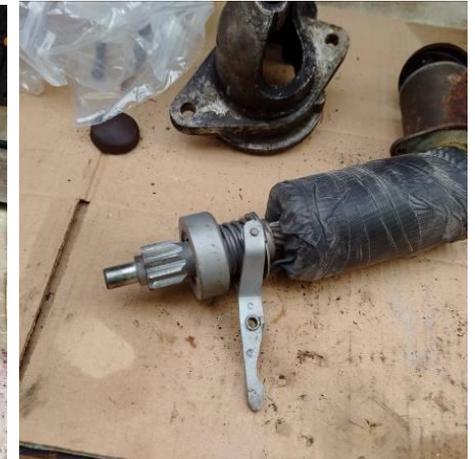
The pre-select was seized as was the starter cog. I covered the windings with duct tape to protect them and blasted with glass bead to remove corrosion from the shaft and operating mechanism.

The end cover came off with a little gentle persuasion, the brushes and rotor looked in good condition and the windings checked out showing good continuity and resistance.

After washing out the system with cleaner and blowing it dry with compressed air I immersed the mechanism in penetrating oil and gradually worked the pre engage mechanism which became free, I then did the same with the gear which also freed up but released in the correct direction to allow it to disengage from the flywheel when deenergized.

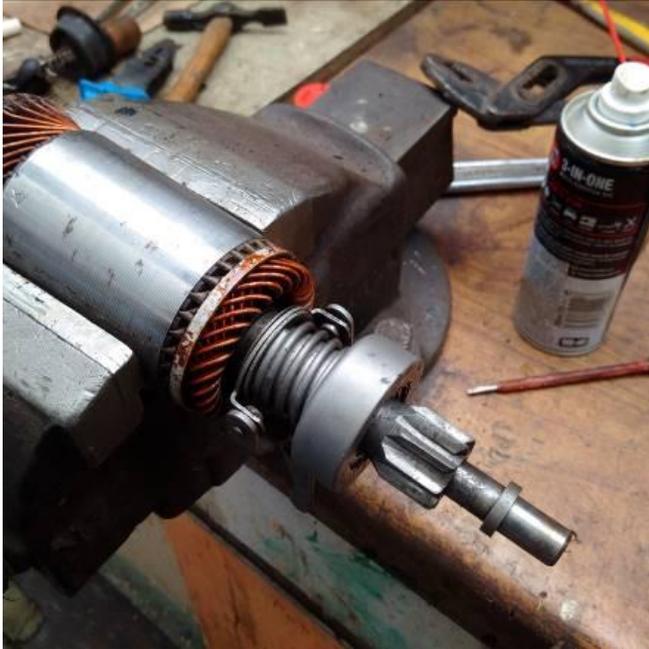
I washed the mechanism out again, blew it dry and re applied oil. The pre-select now moves under gravity freely and the gear runs smoothly.

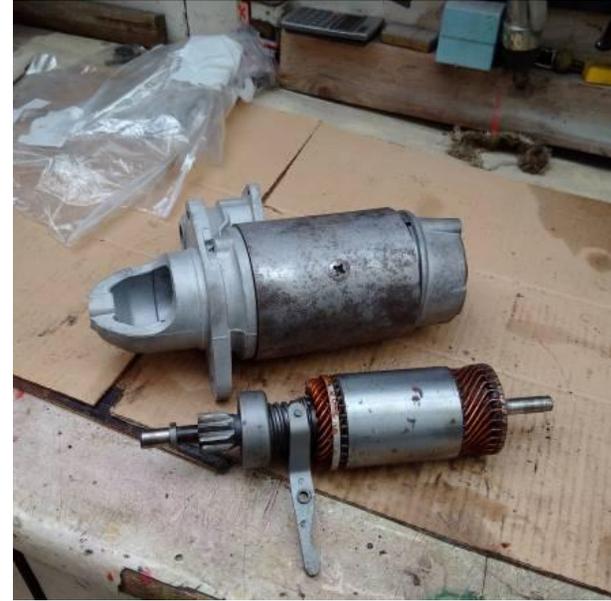
Next, I bead blasted the end covers in preparation for re assembly. I will not be polishing them clean is good enough although they will be pressure washed every time the car is cleaned. The cast iron casing will be painted maroon to match the rest of the engine steel components and brackets.

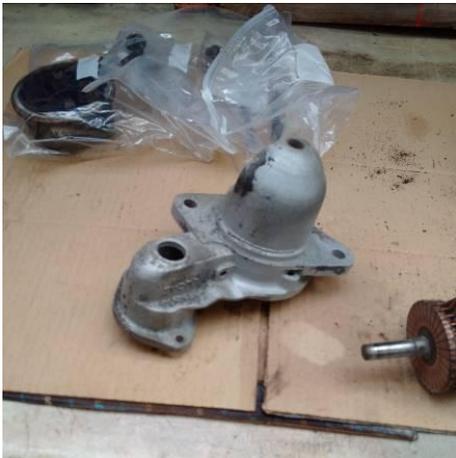
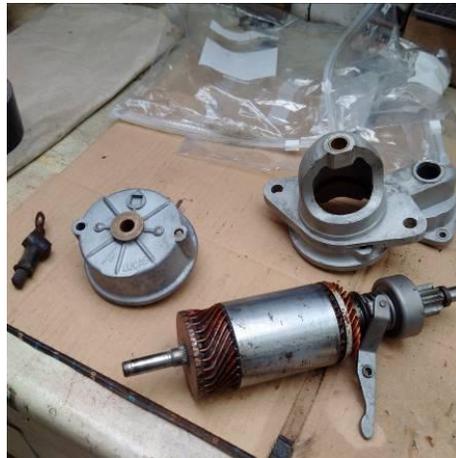
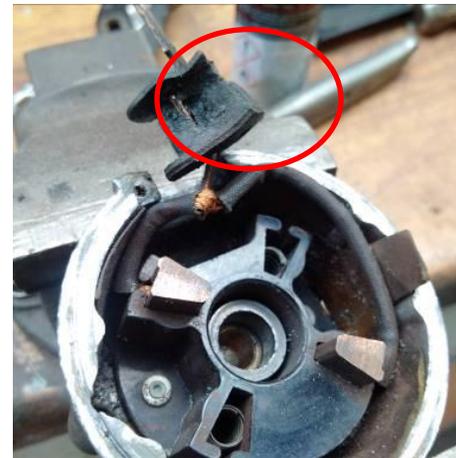
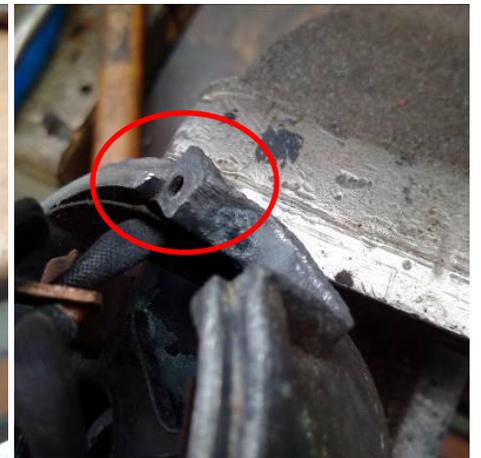
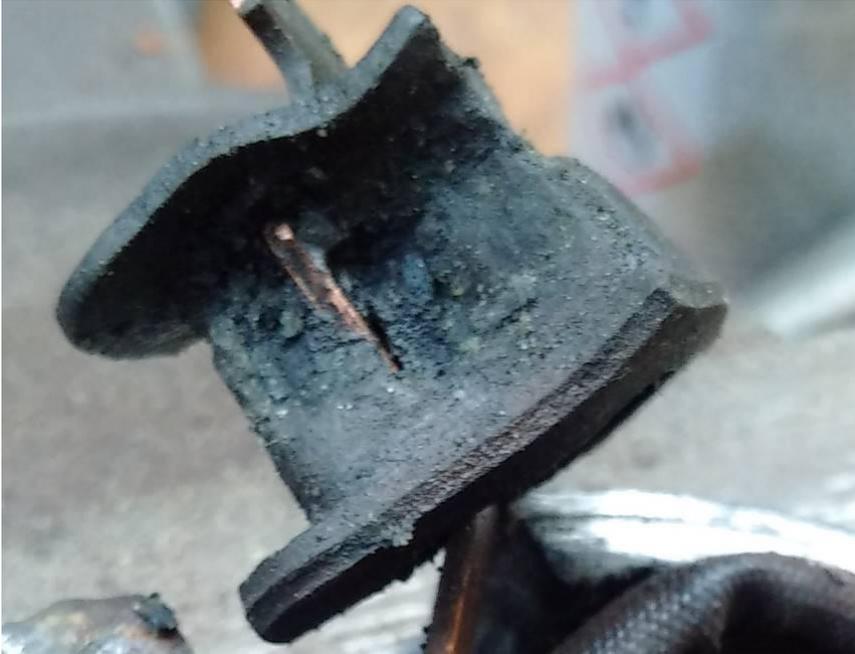
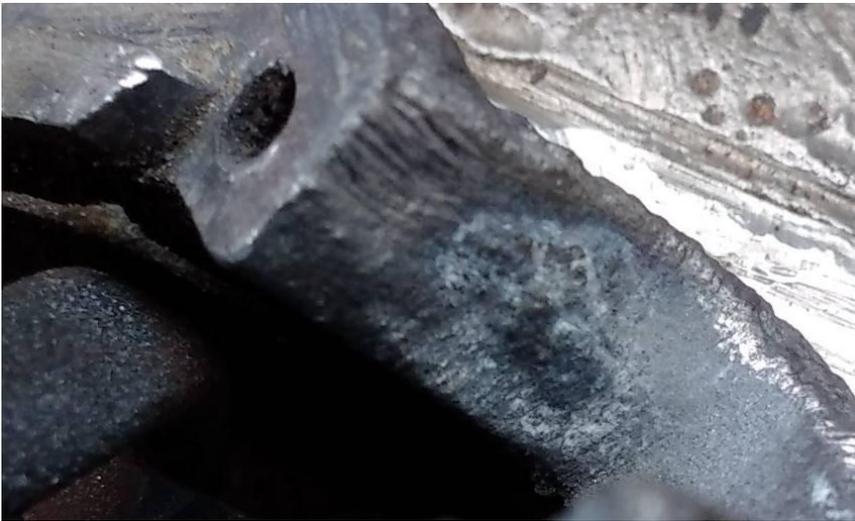
While cleaning the end cover I noticed that there were marks on the aluminum casing that indicated shorting had occurred between the main feed cable and the case where it connects on to the solenoid. Inspecting the rubber insulator showed that this had been worn through over time and the copper connector was protruding through the gaiter sufficient to short against the case whenever the starter was operated, this was a high resistance short so the starter would still have operated however eventually it would have become more serious and could have damaged the feed cable and welded the main contacts together in the solenoid causing a fire.

I will build up the rubber insert using Liquid Tape which is an air-dry synthetic rubber coating that can be brushed on. It exhibits excellent moisture, acid, alkaline, abrasion, and dielectric resistance and I have used it before on industrial installations as well as car repairs. Much better than tape.

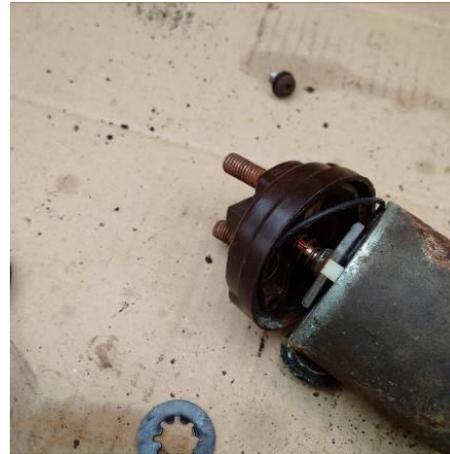
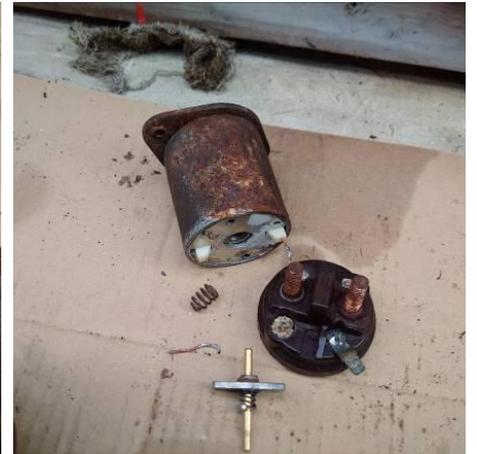
Now on with the solenoid. The coil showed an open circuit so I unsoldered the connections and removed the cover, one of the coil connections fell off showing that the lead to the coil is broken. This cannot be repaired as it is imbedded in the solenoid casing and although many non consumer repair items can be repaired this is not one of them.

Replacement ordered £39.99 including postage so a relatively cheap repair in place of an exchange starter motor up in the £200 bracket. The solenoid arrived however it was the wrong one, the supplier accepted that it was their error and sent the correct one that night and a prepaid return shipment label.

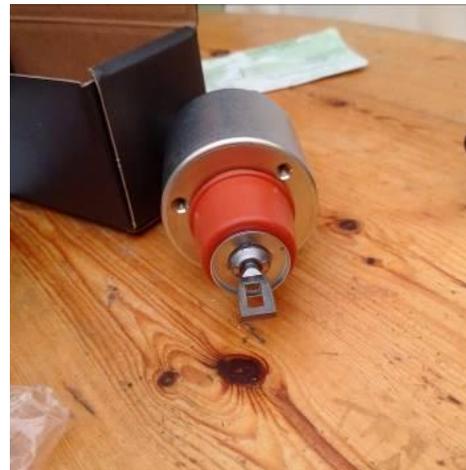
The wrong one

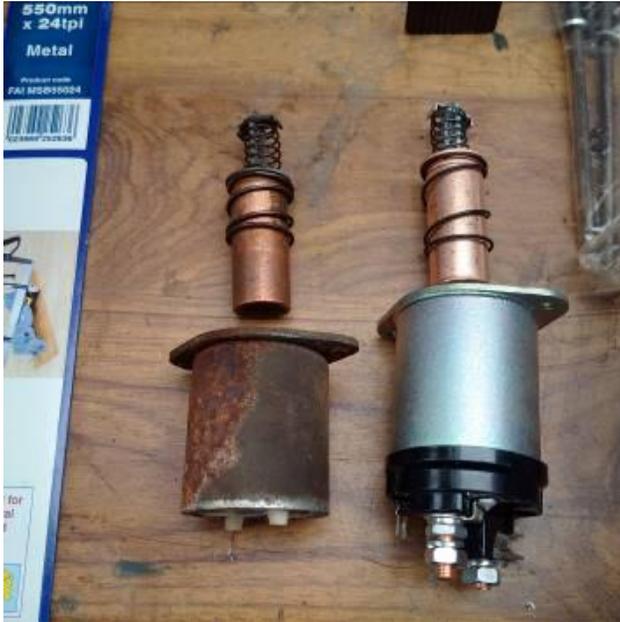
The old one and the right one

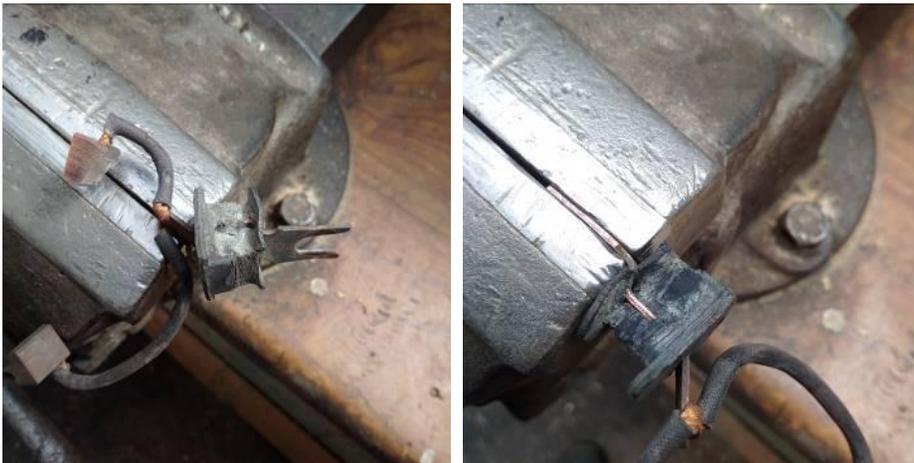
The insulator where the power feed passes through the starter motor casing requires repair by building up the rubber with Liquid Electrical Tape. First the grommet was cleaned and roughened so the new rubber would adhere

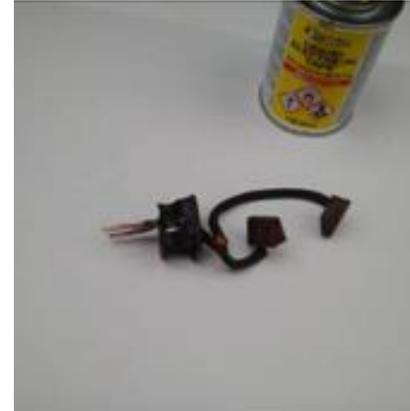
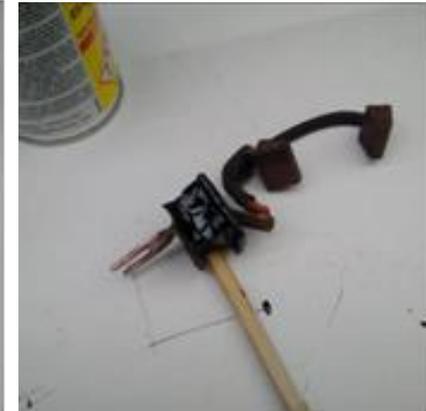
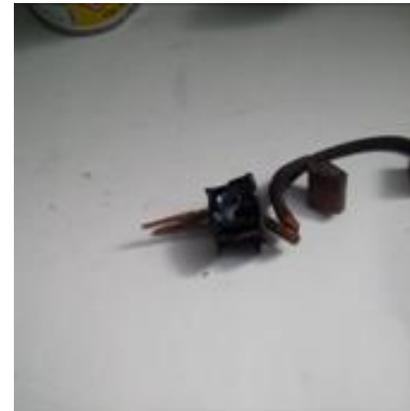
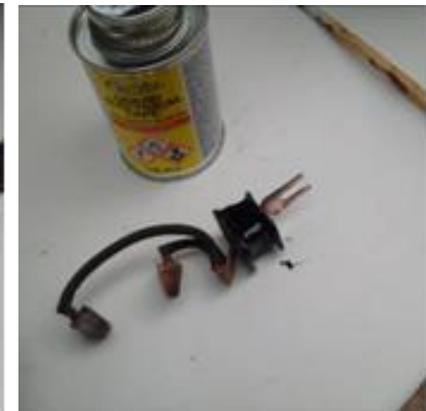
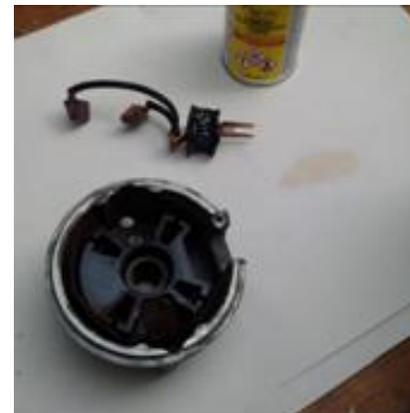
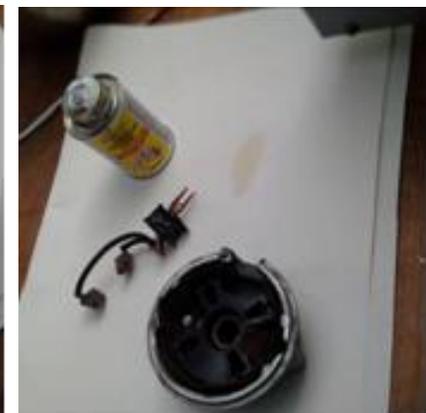
Layer after layer was added over a period of a few days to build it back up to the original size so it seals the casing completely when installed.

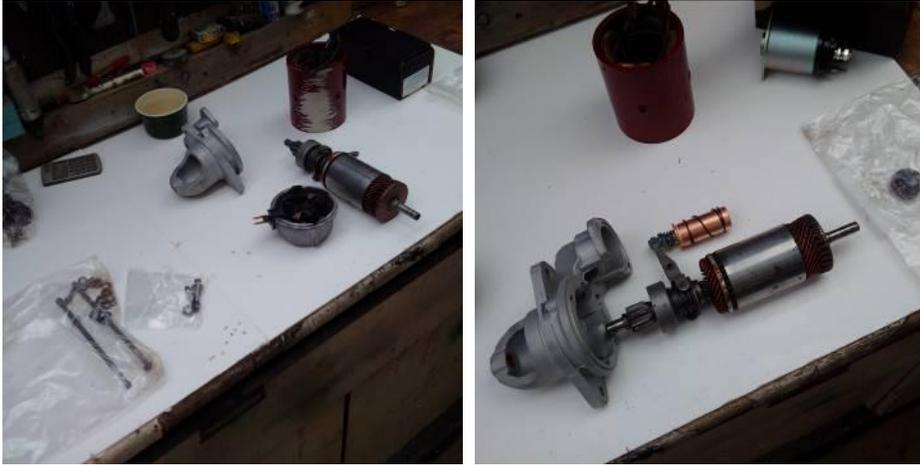
First the armature was put in the casing and the preselect pivot pin installed. New Starlock washers were used where required.

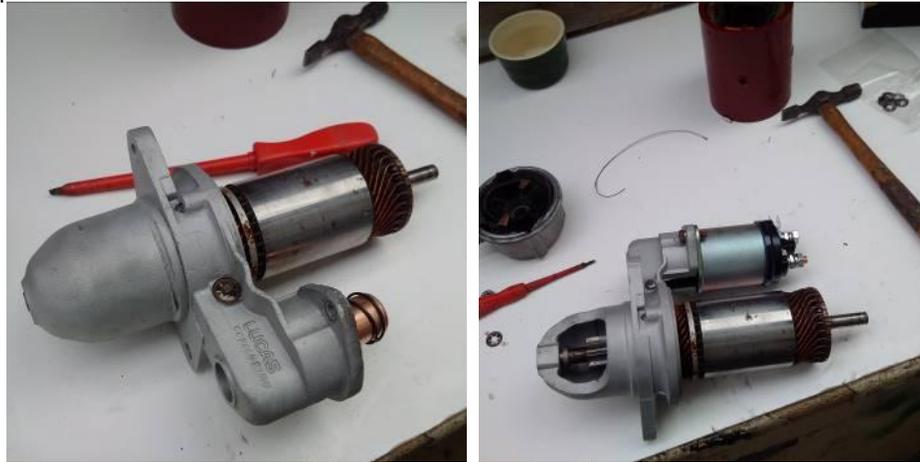
Next the solenoid armature was located on the pre select shaft and the coil was bolted on to the casing. At this stage I tested the solenoid, it operated correctly moving the drive cog to the meshed position and the return spring pushed it back to the disengage position

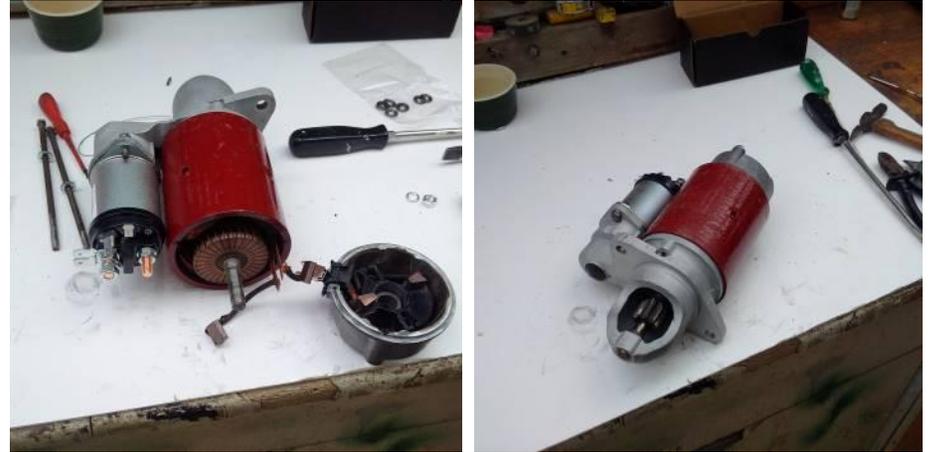
The outer iron case and field windings was then positioned over the armature and located on the peg that is fitted to the casing to ensure that the assembly is correctly orientated.

Next the brush casting was installed making sure that the cables that connect the windings via the brushes are correctly positioned and insulated from the casing. The two long screws that clamp the two aluminum casings to the iron casting to which the field coils are fixed were installed and tightened. The starter motor electrical connection was then connected to the solenoid and tightened.

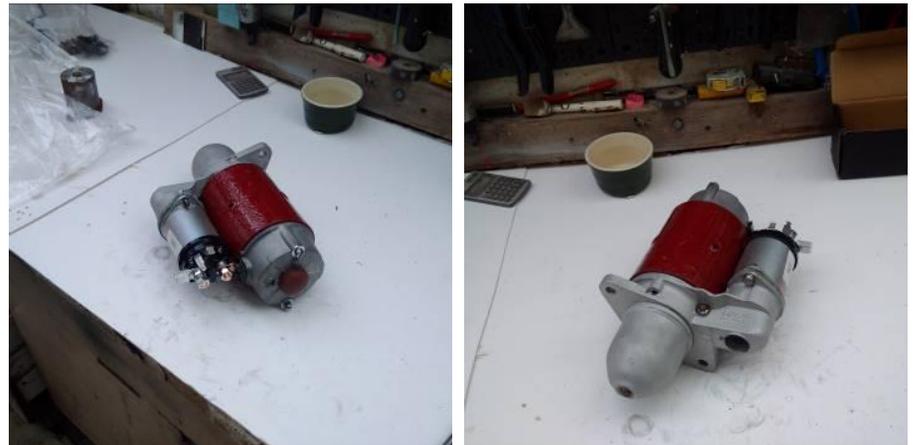
Once the assembly was complete and all screws and bolts tight I tested that it operated correctly. As the starter motor is very powerful with a very high torque capability it was bolted on to the old V8 engine and power applied to the solenoid. The pre select engaged and engine turned over smoothly, when power was removed the cog disengaged and power was removed from the starter windings.
