Coolant flow in an MGBGT V8 engine

Why did the temperature gauge go near the red and lead to a breakdown recovery?

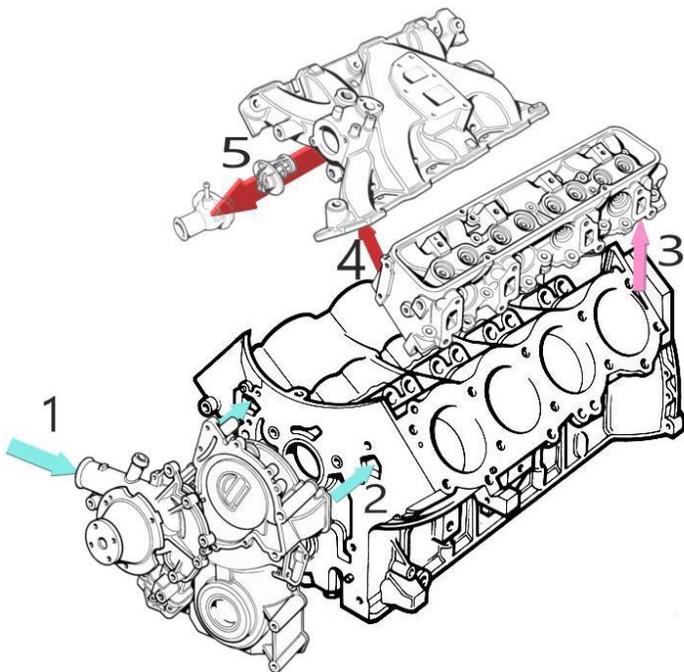
1. Coolant from Radiator to Water Pump Inlet (cooled water)
2. Flow from Pump Outlet (in Front Cover) to Cylinder Block (both banks)
3. Flow from rear of Cylinder Block to Cylinder Head (both banks)
4. Flow from front of Cylinder Head to Inlet Manifold (both banks)
5. Flow from Inlet Manifold to Radiator via Thermostat and Outlet Elbow

Note that the coolant flow is from front to rear in the Cylinder Block and from rear to front in the Cylinder Head.

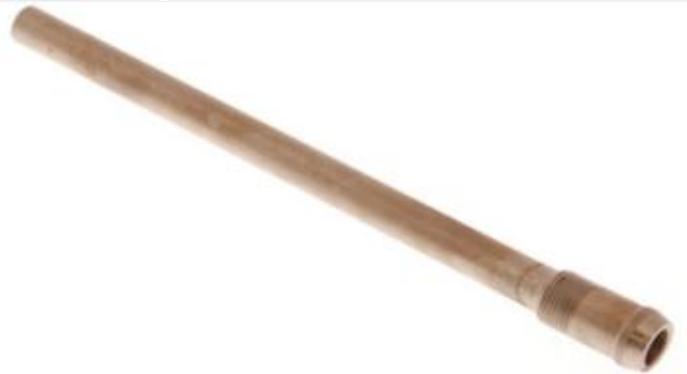
A week later I went up to Baldock to collect the car and heard that they had found coolant had been leaking into the "Vee" under the inlet manifold. Searching for the cause of the leak they found the **Heater Feed Pipe 90611532** between the water pump and heater, which is an internal pipe that is screwed into the intake manifold, was in good condition and was not leaking and causing the problem. The original pipe can corrode quite badly but mine was a replacement composite stainless steel pipe with a "copper like" look to it and was in good condition.

Heater Feed Pipe – water pump to heater 90611532 with a swaging near the end for the hose to grip to.

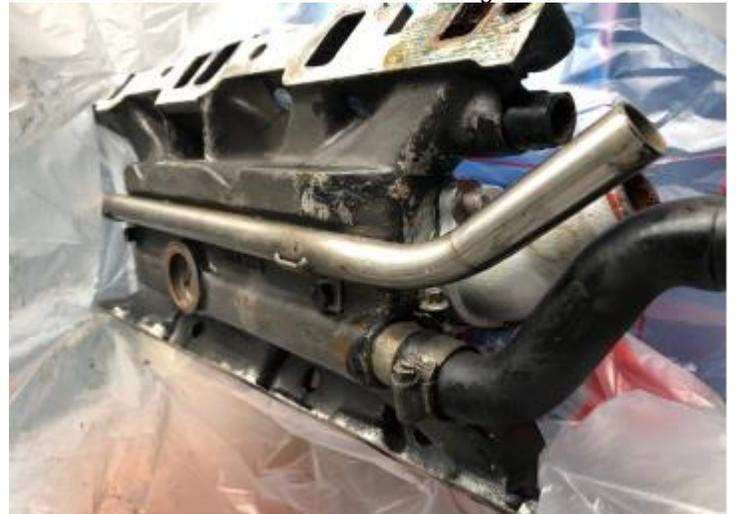
The **Bypass Pipe Heater Outlet 603049** attached to the underside of the intake manifold was also in good condition.

Stainless steel replacement Bypass Pipe Heater Outlet 603049 attached to the underside of the intake manifold (Ralph Hardwick)

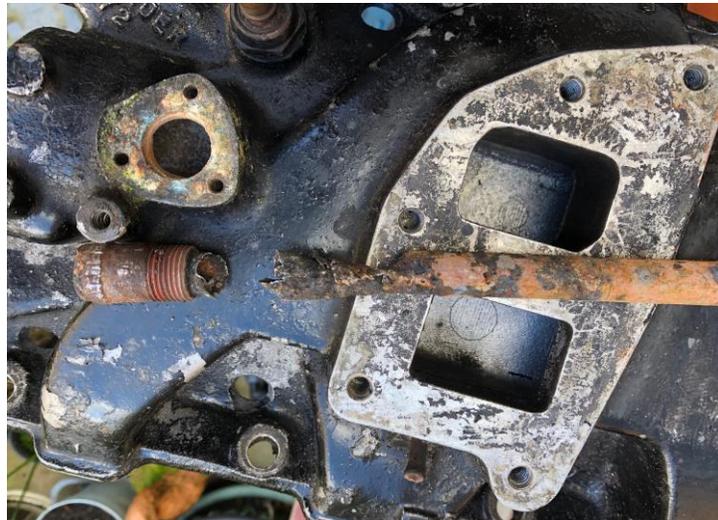
Severely corroded internal **Heater Feed Pipe 90611532**. (Ralph Hardwick)

We then entered Covid lockdown so I decided to venture further. I removed the intake manifold and removed the internal **Heater Feed Pipe 90611532** (see above) which was severely corroded. A replacement was sourced from Rimmers. In the process I had the pair of trousers and intake manifold powder coated in black and grey as it had left the factory. I cleaned up the 'Otter' switch and cleared the steam pipe. The Heater Feed Pipe 90611532, is screwed into the inlet manifold, should not be confused with the bypass pipe that runs under the manifold and is attached to it by two screws.

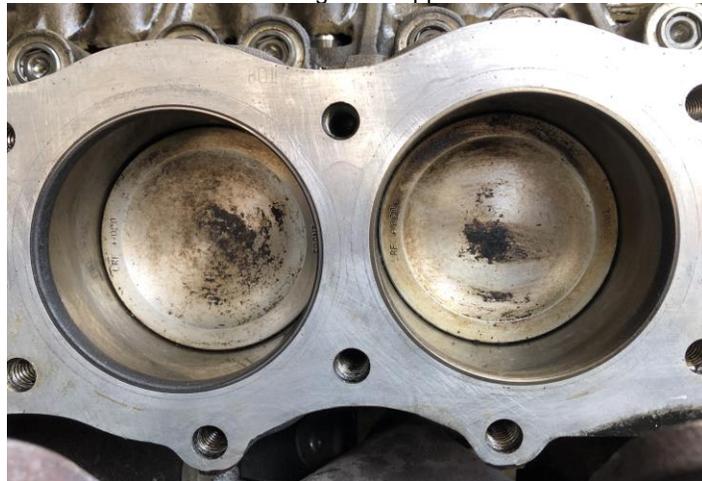
Still in lockdown I decided that I would remove the cylinder heads to ensure that the passageways were clear. A decision was made to fit some later cylinder heads that I had bought secondhand and I had them refurbished at Powers Performance. When I had removed the heads I discovered that one of the liners was slightly lower than the block deck height. A slipped liner.

Removing the heads discovered that one of the liners was slightly lower than the block deck height - a slipped liner (Ralph Hardwick)

The clean piston crowns also indicate that they had been steam cleaned! I removed the engine and gearbox and had Powers Performance fit new 'top hat' liners and rebuild the engine with new HC pistons sourced from Turner Engineering.
