Welcome to the V8 Newsletter

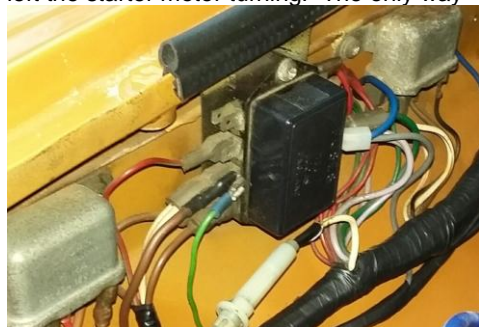
On examining the faulty 6RA relay Steve found the contacts in the switch came together under the magnetic force of the coil in the relay but did so at an angle and not parallel to each other as they should, so there was a reduced area of surface contact between the contacts. With the large current drawn by the starter motor, the result was a fusing in one spot with the limited area of surface contact between the fixed and flexing contacts. This could only be broken by tapping the 6RA case to free the contacts. Steve also detected a lack of sufficient spring tension on the sprung blade (the lower of the two contacts in the photo above).

Recently Steve Newton replaced the 6RA relay for the starter motor as part of the refurbishment of an MGBGT V8 owned by a longstanding V8 Register member, John Gay. Within a day or so a fault developed where having turned on the ignition key to engage the starter motor to fire up the engine, the starter would not stop turning once the engine was running. Usually once the engine fires up the starter motor automatically stops and disengages, but with John's V8 even turning the ignition off left the starter motor turning! The only way

to stop this was to tap the alloy case of the 6RA to free the contacts or to break the power supply to the starter motor from the batteries. With John's car he has a battery isolator switch so that was a readily available option.

Steve replaced the 6RA but the problem was repeated a few days later. So he opened up both 6RA relays to investigate what was going on and causing this problem. What he found was sadly not unusual with many replacement parts in the classic car spares market today – poor quality parts, often imported from Far Eastern suppliers and manufacturers.

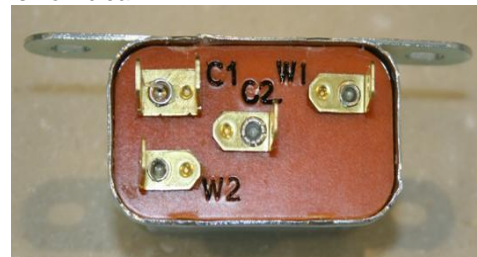
The 6RA designation is a generic one and more properly it should include information on the number of contacts so that you get the right part. To start with, let's use the one we often see on the MGBGT V8, the **6RA with 4 terminals**. The 6RA relay below is a new one so I scraped away the silicon sealant that was applied to keep the canister watertight and bent the crimps slightly to allow the internal workings to be exposed. Highlighting the markings stamped into the Bakelite base with a small marker pen ensures that the legend **C1, C2, W1** and **W2** is now clear.

Older 6RA relays may not have the silicon sealant, certainly original equipment would not have had sealant. With replacement 6RAs the sealant also obscures the terminal markings, so you may need good light and even a magnifying glass to see them.

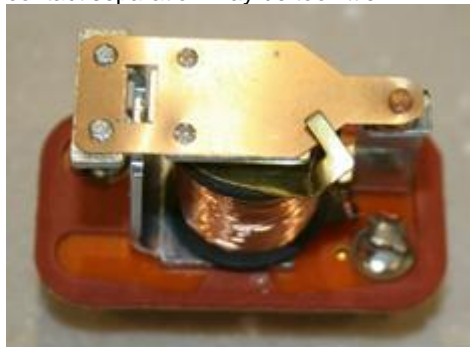
The **top view of the 6RA relay** workings reveals a curious piece of bent brass that protrudes over the top of the Armature. Despite its crude construction, this is a very critical part of the relay and should not be bent or moved at all. Its function is to limit the size of the air gap between the Armature and Pole piece so that when the Coil is energized the Armature is instantly attracted. If the gap is too large the Armature may not pull in, too small and the contact separation may be too little.
