# WELCOME TO THE V8 NEWSLETTER

#### Door mirror instability

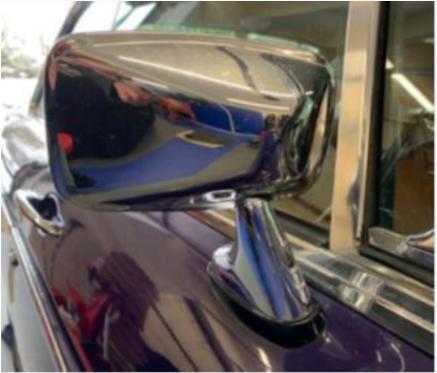
Peter Spurrs found the two door mirror fixings on his MGBGTV8 were unstable. Here is how he solved the problem.

The method the Factory used for fixing the mirrors to the door was a quick and easy solution for the production line, but did not give a stable mounting. Firstly,on the production line, the two plugs on the plastic base plate were fitted into the two holes in the door. Next, the mounting plate was held in place with two self-tapping screws. Finally, a single screw held the mirror in place on the mounting plate. The single screw is on the rear facing side of the mirror to allow the mirror to break off on impact.

The logical steps are to make the mirror to mounting plate connection more robust, then to improve the mounting plate to door connection. To

make the mount more robust, I glued in place a small aluminium plate to the plastic screw contact face. I then filed the base of the mirror to lower the point at which the grub screw contacts the plate. Sufficient material was removed to ensure the point on the grub screw contacted the middle of the aluminium plate and did not ride over the top.

Once I had access to the inside of the door, I cut down the plugs on the base plate leaving enough plastic to hold the plate in the door and protect the metalwork. I then fitted the base plate into the two holes and placed the mounting plate over it. Two 25mm M5 countersunk machine screws were then threaded through the mounting plate to hold the parts in place.

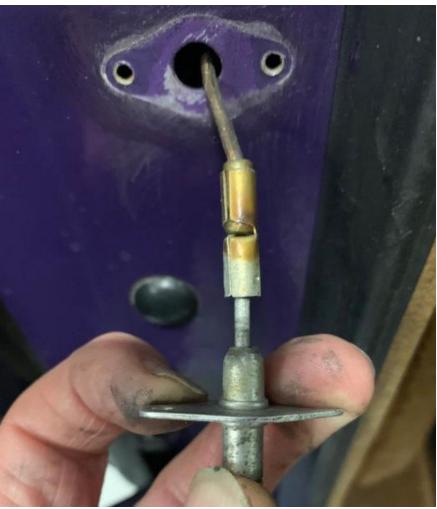
Whilst I had access, I took the opportunity to grease the window winding mechanism. It looked as if it hadn't been touched since 1973. To copy the phrase from workshop manuals, replacement of the door card is the reverse of removal. Result, two stable and useable door mirrors.

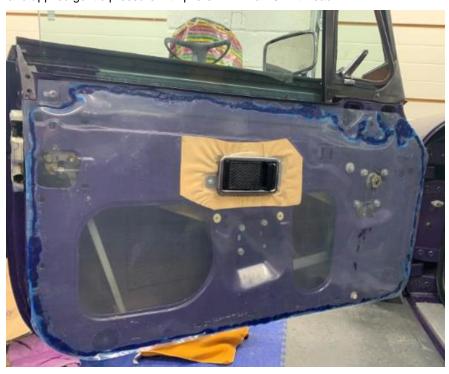
The moisture barrier can decay and become unstuck, allowing water to penetrate the hardboard in the door card. Also, when working on the interior of the door, the barrier has to be removed and can tear, especially at the glue line. The replacement access to the membrane entails removing the door card. That removal procedure is described as a step by step guide in the article covering door mirror stability.

solution was to use polythene from a mattress wrapper. Mike Howlett uses self-adhesive carpet protector, available from most DIY outlets. A certain amount of cutting and trimming will be needed, whatever the option chosen. A decent pair of scissors is good enough. Unless a self-adhesive membrane is chosen, an adhesive will be needed. Primarily because I had nothing else to hand, I used a blue gasketing compound. I'm not putting that forward as the best answer, just Hobson's choice.
