WELCOME TO THE V8 NEWSLETTER

RV8 replacement aluminium radiator

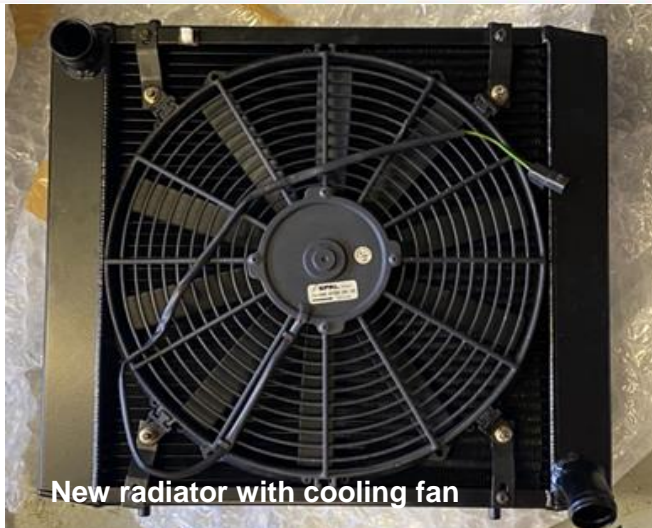
New radiator with cooling fan

Julian Drew explains that he purchased an aluminium Radtec radiator for his RV8 last September because he was a little concerned that the relevant standard replacements available were probably units that had already been refurbished a number of times. Having experienced a couple of poor examples he felt a new fabricated unit was the way to go.

In terms of fitting the Radtec radiator, this was fine. The "out and in" through the bottom as normal, and finding the mountings were all in their correct locations. Sizing was pretty much spot on, although the shape of the side tanks are more square on the uprights, but this does not present any real problem. One point to watch for is the small retaining clip that supports the expansion tank metal pipe coming from the far side of the radiator. As the clip needs to be adjusted to fit the thicker material with the aluminium, but this really is a straightforward operation.

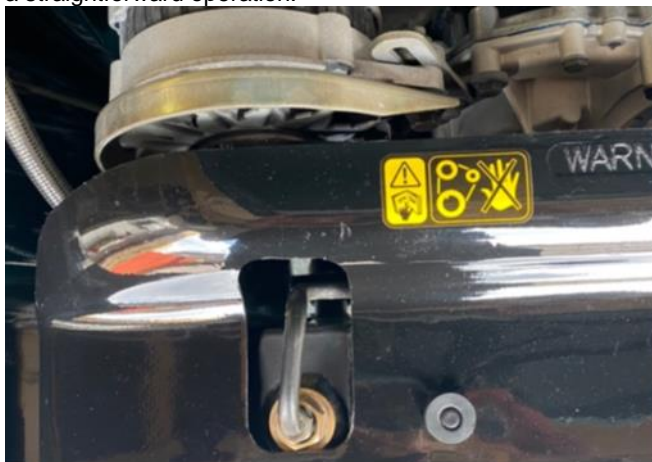
The cover does mask most of the radiator, however, the expansion take off union is visible and would look different with the aluminium radiator not being black powder coated to match the original.

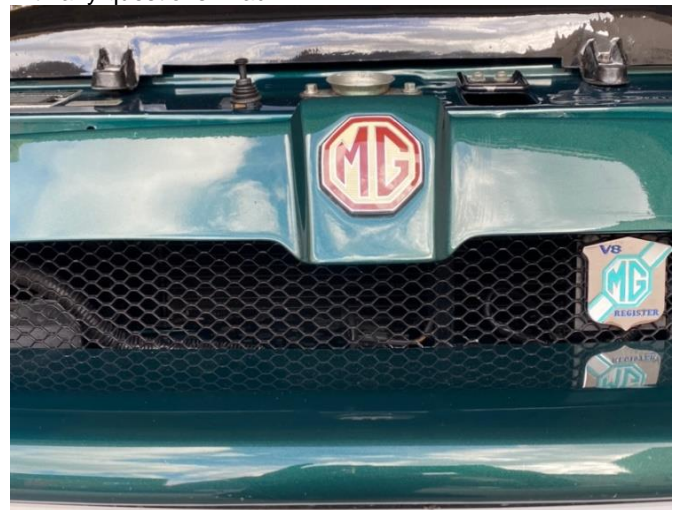
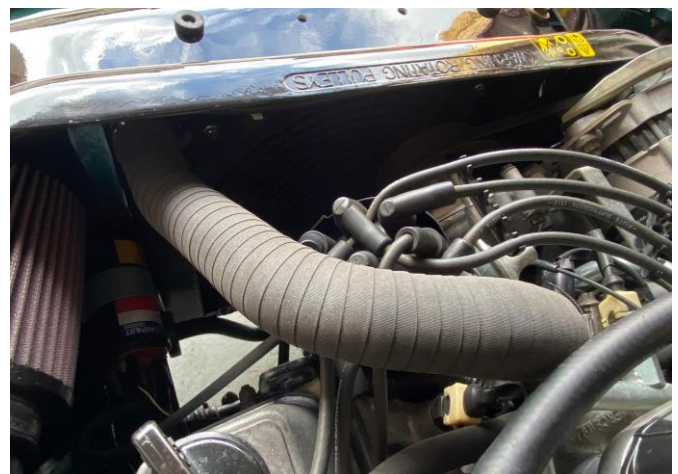
Through the grill, an aluminium radiator that is not powder coated would stand out somewhat as the grill is also black. Similarly from the inside of the engine bay, without powder coating the aluminium radiator would be quite noticeable.

I would suggest you pay the little extra to have the radiator powder coated in black, similar to the original, as I feel the aluminium coloured radiator may look out of place through the grille, especially with the black radiator grilles we have on an RV8. That's unless of course you prefer a rather different look.

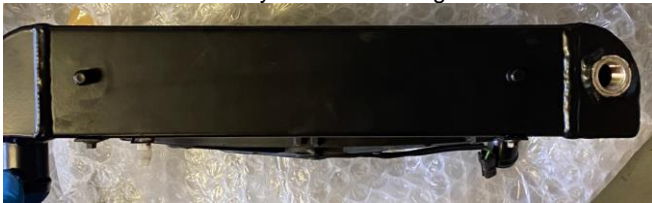
A matt black powder coated aluminium radiator.

Radtec advertise the RV8 option, which is what drew me to their radiator in the first place. **Part Code: RMGRV8**, an all alloy radiator designed from an original pattern. Powder coating and fitment is as the original RV8 radiator so no modification is necessary. **£432** including VAT

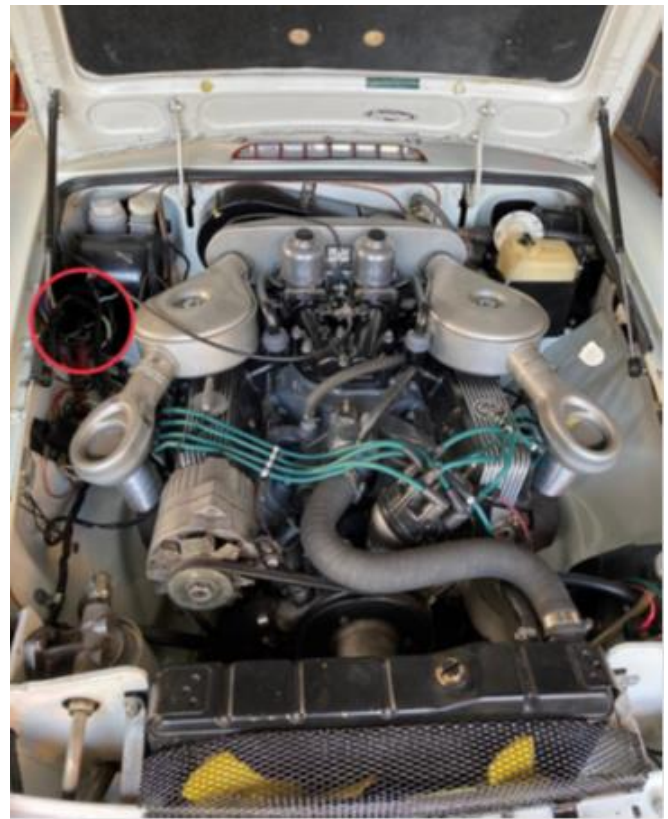
Jim Livingstone feels this note may seem trivial but the circumstances at the time the problem occurred (on the eve of his departure for a visit to Australia) made the failure of this simple bullet connection quite dramatic. The observed symptom was a failure to restart after a short stop. The cause was not immediately obvious and as the light was fading the breakdown service was summoned. It took all the detective skills of the RAC technician to eventually trace the source to an open circuit in the connection between the main harness and the rear harness just forward of the brake and clutch master cylinders (red ringed above). Jim reveals more.

There was evidence of burning on the connection and adjacent harness which indicated the the cause was overheating due to high electrical resistance in the bullet connector. As modern breakdown services do not carry obsolete connectors, the wires were reconnected by soldering and the journey resumed, albeit five hours behind schedule.

Maintenance of connectors should include regular inspection of the connector for corrosion and to ensure prompt replacement if any is evident. Separation of corroded components can overstrain the cables, and this makes a strong case for incorporating strain relief in the terminals. A light coating of grease or wax to exclude moisture is recommended on reassembly of the connection. An insertion tool for the bullet and connector can be used but is not essential. Our "More" webpage has a link to the full article.
