RV8 coolant bleed insert

Check your antiroll bar drop links

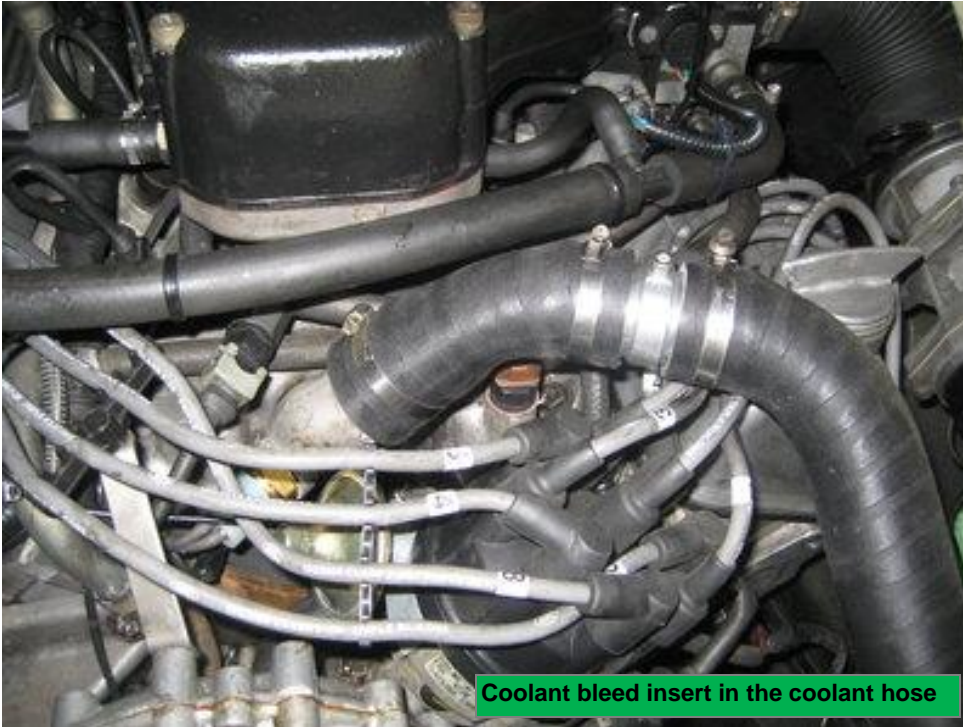
Coolant bleed insert in the coolant hose

I have devised a solution in the form of a **coolant bleed insert** fitted in the top radiator hose. A prototype fitted to my car is shown alongside. My company has now made a small batch of the bleed inserts and these should be available shortly through Clive Wheatley at MG V8 Parts.

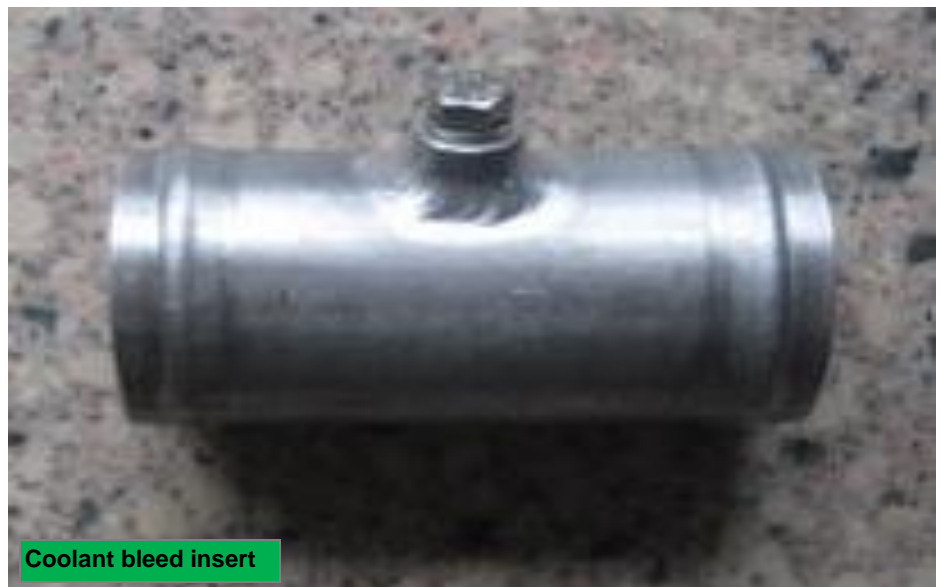
Coolant bleed insert

1. **Partially drain down the system** so that the top hose is emptied. Cut the top hose in the centre of the arched portion. Fit the bleed insert, secure with two 45mm hose clips (preferably stainless steel) and remove the bleed screw.

6. **Refit the expansion tank cap** when the level is correct and then continue to fill until coolant starts to issue from the bleed screw hole in the bleed insert. A rag placed under the insert will catch any small spillage.

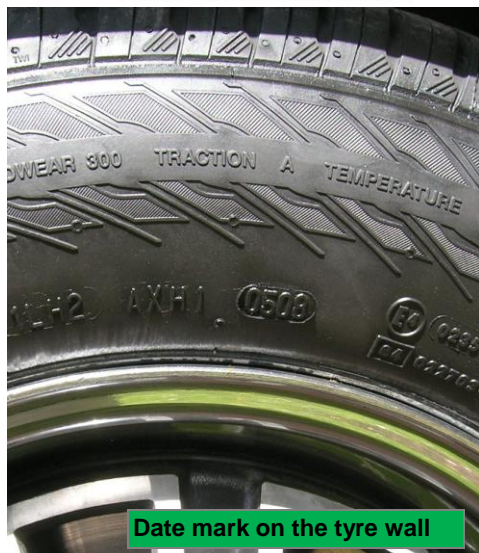
Date mark on the tyre wall

You can check the age of your tyres very easily by reading the **date mark on the wall of the tyre**. You will see an elongated circle containing two numbers, for example **0508** which dates the tyres as **week 5 in 2008**. So those tyres will be coming up to 8 years old in February 2016. – see our guide note on tyre wall marking via our “more” link below.

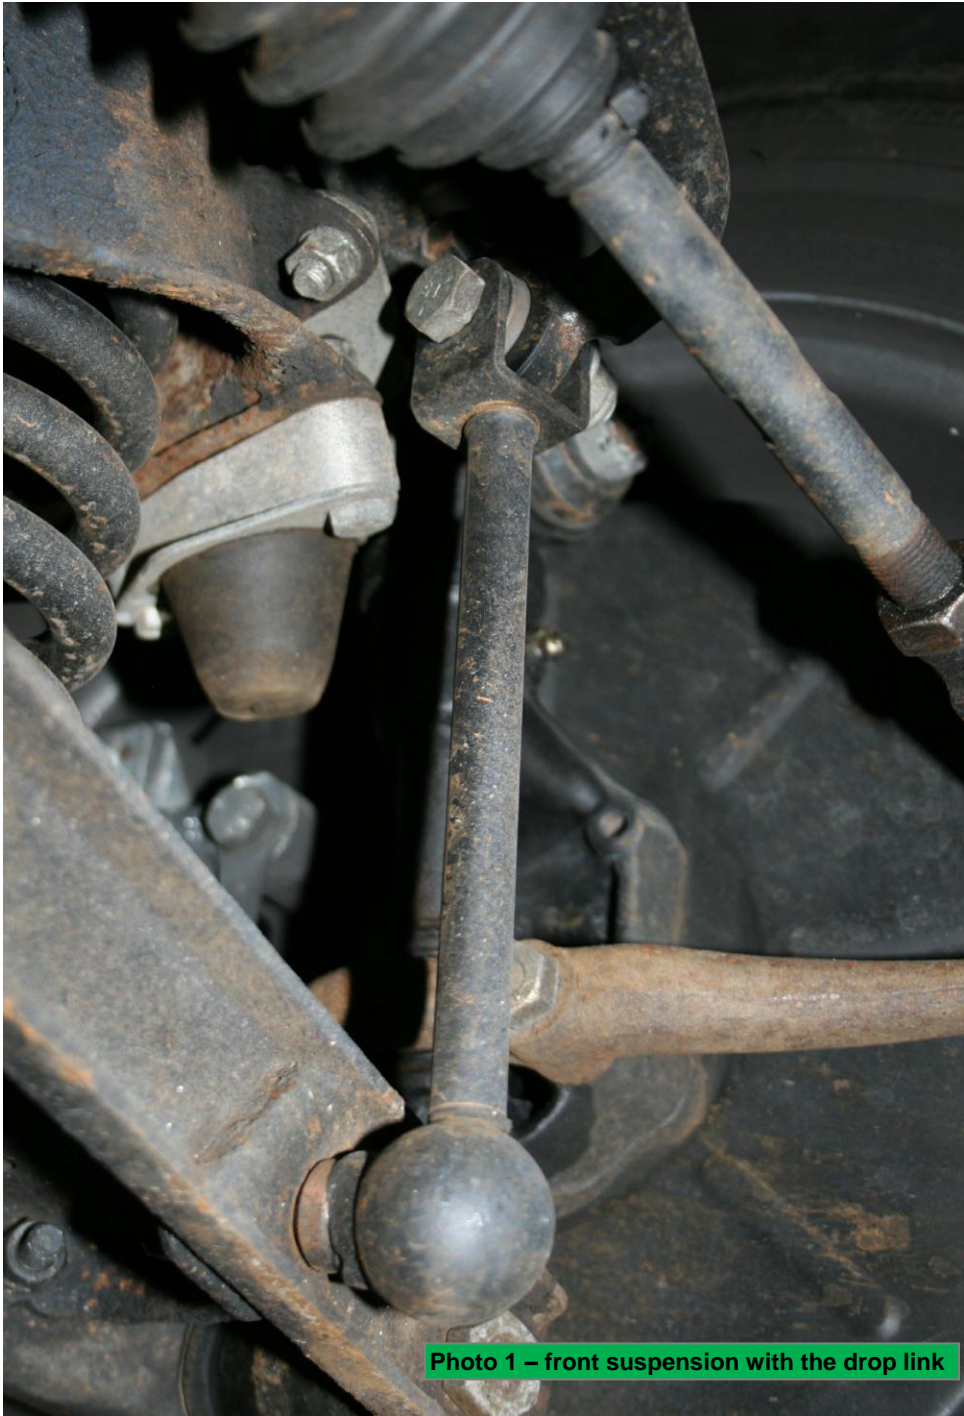
Photo 1 – front suspension with the drop link

The general arrangement of the suspension is shown in Photo 1 taken of my MGBGT, but the V8 is similar, as is the RV8.

The MGC has a different arrangement of links and is not covered here. The ball ended part of the drop link is a bonded rubber to metal bush that allows some compliance as the movement of the lower suspension arm and the antiroll bar are not in the same plane and also minimizes the transmission of noise into the structure of the car. The top end, a forked metal pressing is attached to the end of the antiroll bar with a bolt that passes through another bonded rubber to metal bush inserted into an eye in the end of the roll bar.

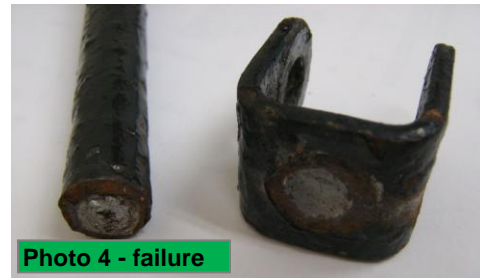
Photo 4 - failure

The drop link failures seen recently (Photo 4) have occurred where the steel tube is welded to the forked end. Photo 3. Rust or corrosion in this area should be scraped or wire brushed away, if there is any sign of a crack or gap, the link is suspect and is best replaced, as they are not expensive. It is important to source good quality replacements. Buying replacements from a reputable source is a good idea, although there are some which seem to have a rather spotty weld quality where the steel tube is welded to the forked end. In Photo 5 you can see the forked end of two new drop links, obtained from B&G, the one on the left is for an RV8, Part Number ZKC5754, DROP LINK LH, (RH is ZKC 5755) while the one on the right is for an MGB, Part Number AHH6544A, DROP LINK LH ANTI-ROLL BAR (RH is AAH6543A).

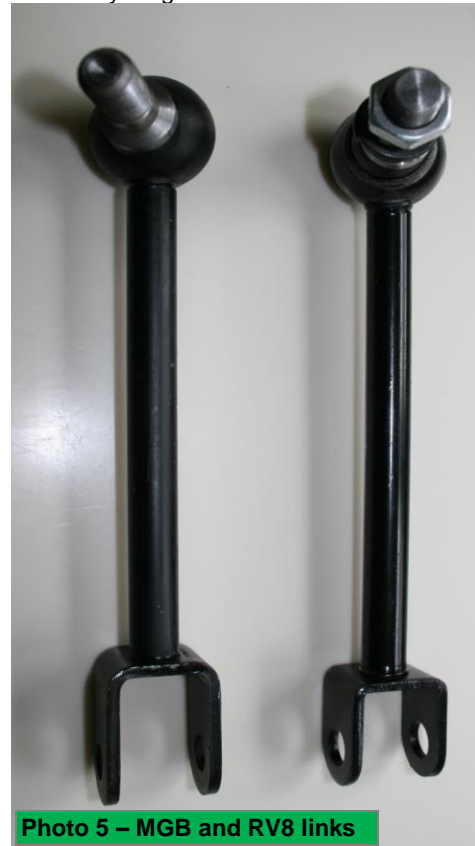
Photo 5 – MGB and RV8 links

Close inspection of these parts reveals some differences, not the least of which is the thickness of the material used for the fork and the depth of same, Photo 5. In other respects the parts are the same dimensionally except the diameter of the holes in the RV8 fork, which are 11mm dia. More on this later.

RV8 part, but not vice versa, so to prove this I fitted an RV8 part to the left side of my MGB. The diameter of the hole in the fork needs slight modification to allow the bolt pass through, on the B the hole is 7/16" (0.4375") while the RV8 Part is drilled 11mm (0.43307").

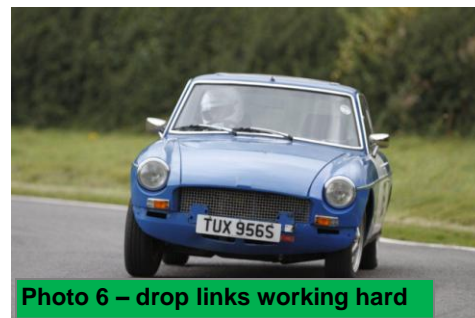
Photo 6 – drop links working hard

To prove this modification works I have run the car for an extended period under hard cornering, in Photo 6 you can see me placing the LH link under extreme compression load and the RH link under tension; the opposite occurs when taking left hand corners. Note: this MGB is fitted with a thicker than normal antiroll bar so the test will be arduous.
