WELCOME TO THE V8 NEWSLETTER

Routine engine oil change on a V8

Fitting a grille badge to an RV8

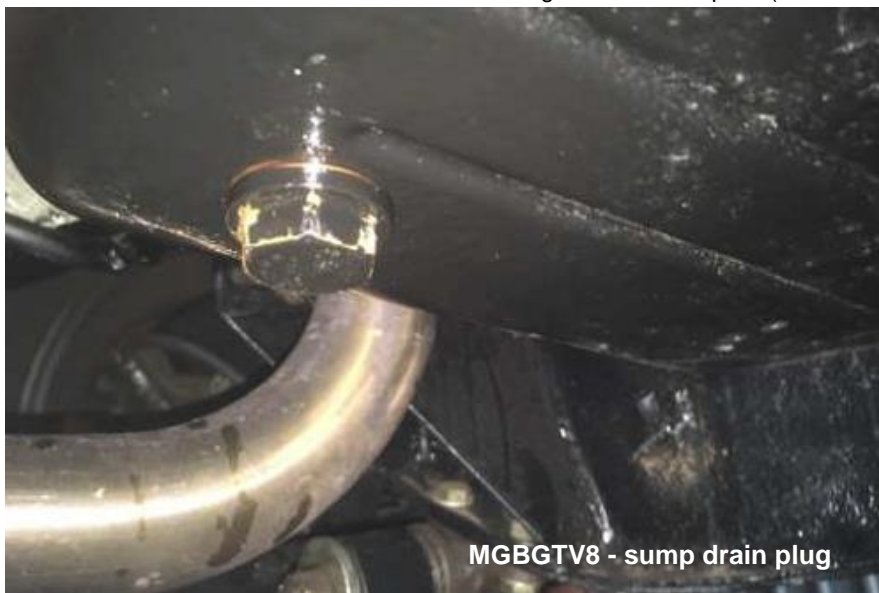
MGBGTV8 - sump drain plug

1. Warm up the engine to get the particulates into suspension and reduce the oil viscosity. A brisk drive of up to 5 miles should be adequate.
2. Check that you can reach the sump drain plug. It is located at the left rear corner of the sump (see image 4) and is most easily accessed from behind the left front wheel. If additional height would be an advantage low rise ramps or axle stands may be useful.
3. Place the drainage container under the sump, wipe clean the surrounding area and carefully remove the plug. But note a caution: a gallon of hot oil will exit rapidly, so ensure that you are protected from contact as it will burn bare skin and also contains harmful

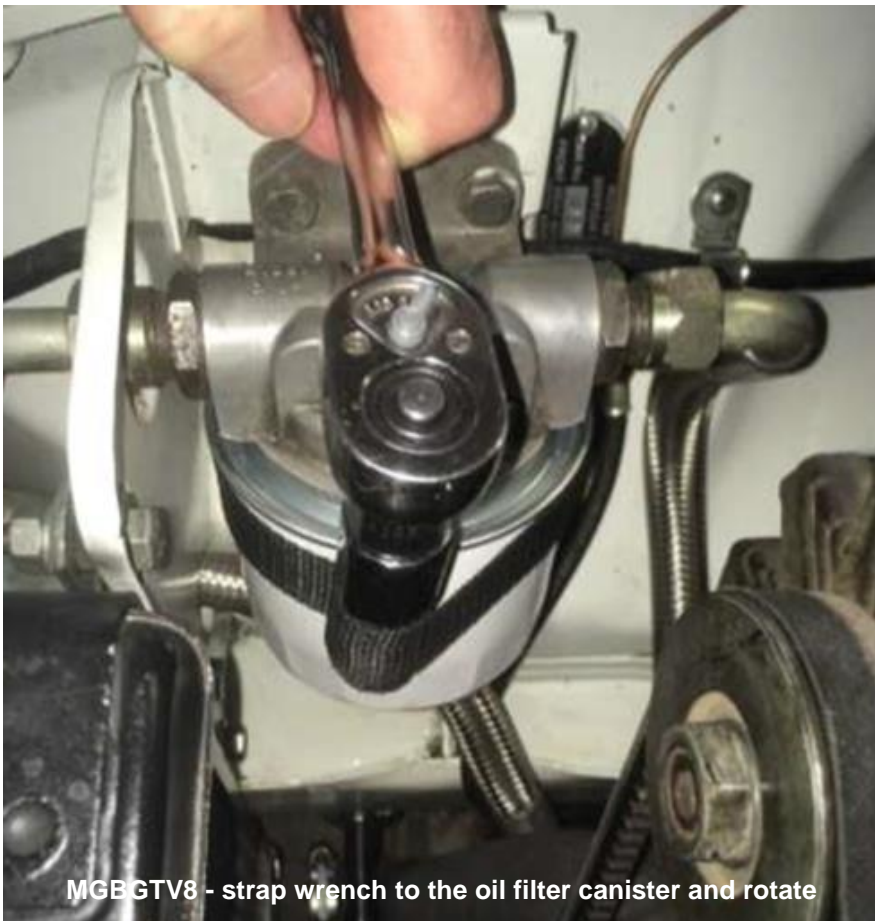
MGB GTV8 - strap wrench to the oil filter canister and rotate

4. Leaving the sump oil to drain, attach the strap wrench to the oil filter canister and rotate clockwise when viewed from above (see image 5). A spray of light oil like WD40 on to the top seal may help.

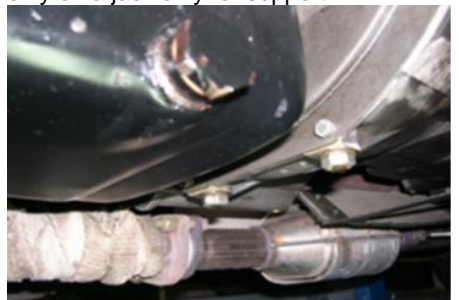
RV8 - sump drain plug on nearside

Next the sump drain plug is located at the left side rear of the sump and is most easily accessed from behind the left front wheel. The small ground clearance of the RV8 makes this difficult and it is therefore advisable to raise the front of the car, either on ramps or by jack and stands under the front suspension cross-member. Never rely only on a jack only for support.

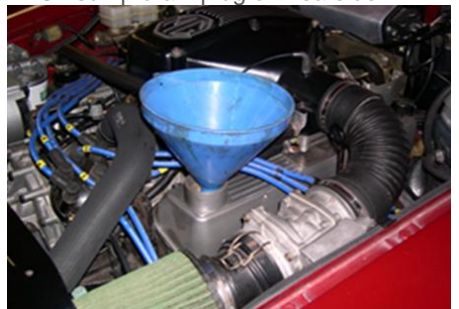
RV8 - oil fill point and funnel.

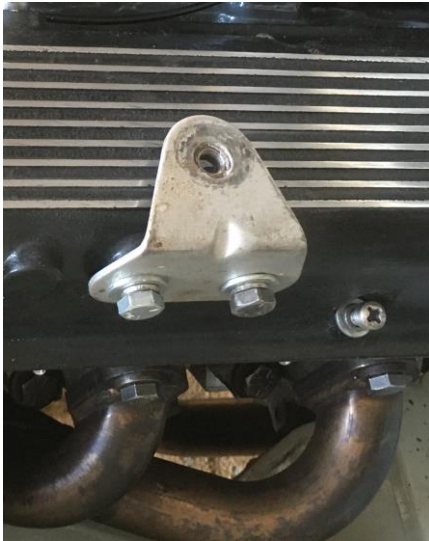
Repositioning the rocker cover bracket

Jim Livingstone had noticed on the rare occasions he had removed the centre bolt in the air filter centre housing that he always experienced difficulty refitting it. He found the cause was misalignment between the air filter and its mounting bracket on the rocker cover caused by the bracket being tightened in the wrong sequence during a previous assembly. The MG designers had recognised the considerable **tolerance stack up*** between the air filter and the rocker cover and had provided elongated holes in the mounting bracket. The consequence of this was if the bracket was reassembled to the rocker cover and prematurely tightened it was likely to be in the wrong position. There is another problem associated with the bracket's position and that is if the bracket is positioned too close to the rocker cover then the air filter bolt can contact the cover and cause minor damage to the ribbing.

1. Remove the air filter (1 bolt) and mounting bracket (2 bolts).
2. Ensure that there are adequate size washers to cover the elongated holes in the bracket.
3. Refit the bracket and loosely secure with its bolts.
4. Refit the air filter with its centre bolt.
5. Engage the centre bolt with the weld nut in the bracket and tighten.
6. Check that there is clearance between the protruding tip of the centre bolt and the rocker cover. Raise the assembly, if necessary, to obtain clearance.
7. Tighten the 2 bolts to secure the bracket to the rocker cover.
8. Repeat the procedure for the air filter installation on the other bank.

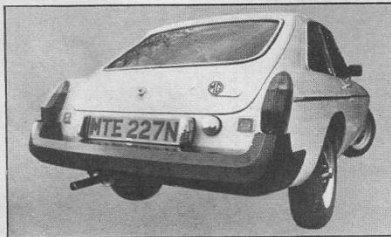
The latest MGB, MGB GT, MGB GT V8 and MG Midget incorporate Bayer's Bayflex integral skin polyurethane foam bumpers front and rear.

Bayflex system. Meeting the US Federal legislation re 5 mph collisions Bayflex was found to be the only material that meets all requirements—is flexible, highly resilient and satisfies the aesthetic demands made on an exterior body part. Bayflex bumpers are the result of the most advanced research and testing and provide the last word in vehicle protection. It's yet one more example of how Bayer technology is helping to build better cars and make the roads a safer place.

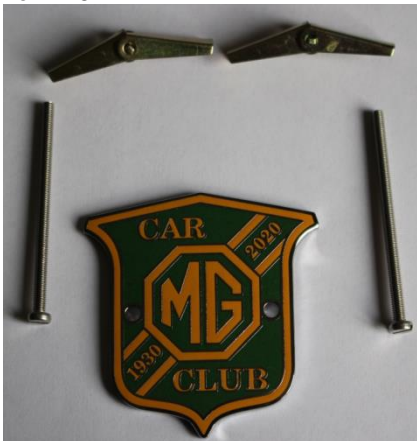
Photo 1: grille badge kit

It is not easy to fit some types of grille badge to an RV8 due to the reduced access at the rear of the grille. Here Marion Quarrington explains how, with some simple tools, it is possible to fit a grille badge without dismantling any of the car. This guide is for the grille badge kit consisting of two butterfly springs with threaded insert, two threaded bolts and the badge, see Photo 1.

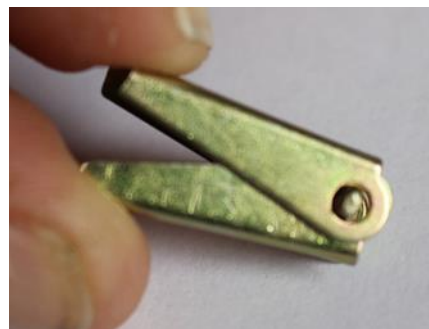
Photo 3: folded butterfly spring

they are almost parallel, (see Photo 3) which will move the spring away from over the insert, see Photo 4. Grip the wings in this position using a suitable tool, and check that the bolt will run smoothly between the wings and into the insert.
