# WELCOME TO THE V8 NEWSLETTER

## Why did the temperature gauge go near the red and lead to a breakdown recovery!

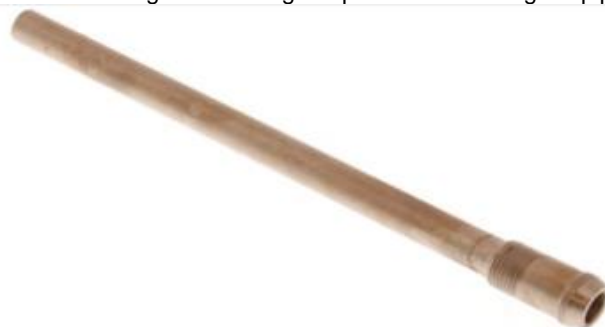
**Heater Feed Pipe** 90611532 – water pump to heater with a swaging near the end for the hose to grip to, is an internal pipe that is screwed into the intake manifold.

A week later I went up to Baldock to collect the car and heard that they had found coolant had been leaking into the "Vee" under the inlet manifold. Searching for the cause of the leak they found the **Heater Feed Pipe** 90611532 between the water pump and heater, which is an internal pipe that is screwed into the intake manifold, was in good condition and was not leaking and causing the problem. The original pipe

can corrode quite badly but mine was a replacement composite stainless steel pipe with a "copper like" look to it and was in good condition.

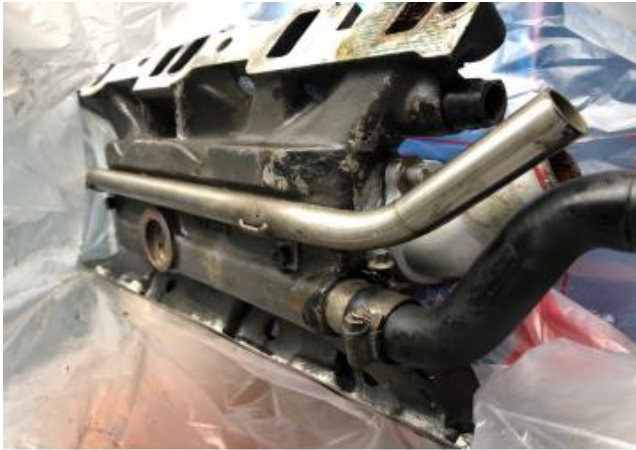
Stainless steel replacement **Bypass Pipe Heater Outlet** 603049 attached to the underside of the intake manifold (Ralph Hardwick)

The **Bypass Pipe Heater Outlet** 603049 attached to the underside of the intake manifold was also in good condition.

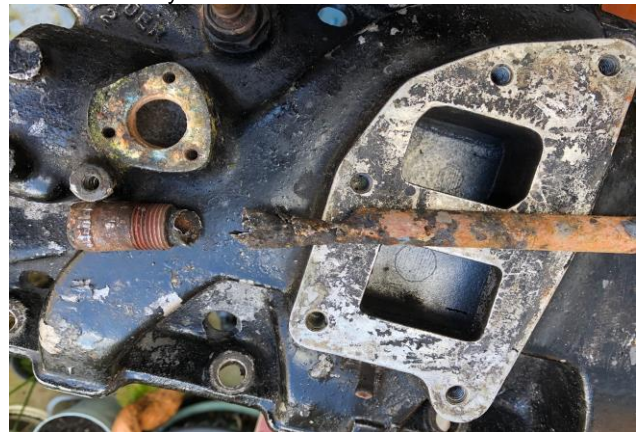
Severely corroded internal **Heater Feed Pipe** 90611532. (Ralph Hardwick)

We then entered Covid lockdown so I decided to venture further. I removed the intake manifold and removed the internal cooling pipe (see photo) which was severely corroded. A replacement was sourced from Rimmers. In the process I had the pair of trousers and intake manifold powder coated in black and grey as it had left the Factory. I cleaned up the 'Otter' switch and cleared the steam pipe. The **Heater Feed Pipe** 90611532, (see image on the previous page) is screwed into the inlet manifold, should not be confused with the **Bypass Pipe** 603049 that runs under the manifold and is attached to it by two screws.

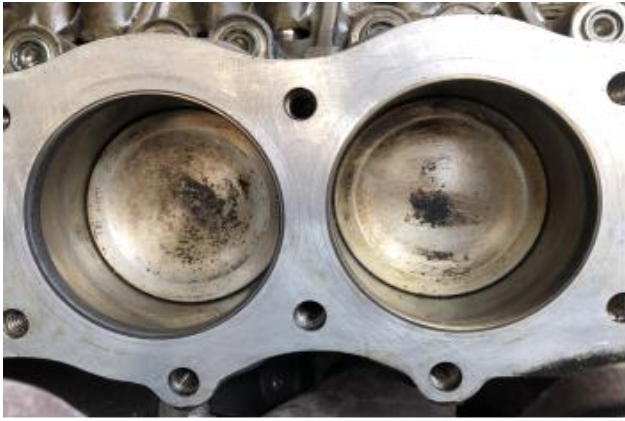
Removing the heads discovered that one of the liners was slightly lower than the block deck height - a slipped liner (Ralph Hardwick)

Still in lockdown I decided that I would remove the cylinder heads to ensure that the passageways were clear. A decision was made to fit some later cylinder heads that I had bought secondhand and I had them refurbished at Powers Performance. When I had removed the heads I discovered that one of the liners was slightly lower than the block deck height - a slipped liner.

The clean piston crowns also indicate that they had been steam cleaned! I removed the engine and gearbox and had Powers Performance fit new 'top hat' liners and rebuild the engine with new HC pistons sourced from Turner Engineering. During the time when the engine was being rebuilt I replaced the heater matrix, replaced the heater valve and also fitted a new replacement stainless bridging pipe from the intake manifold.

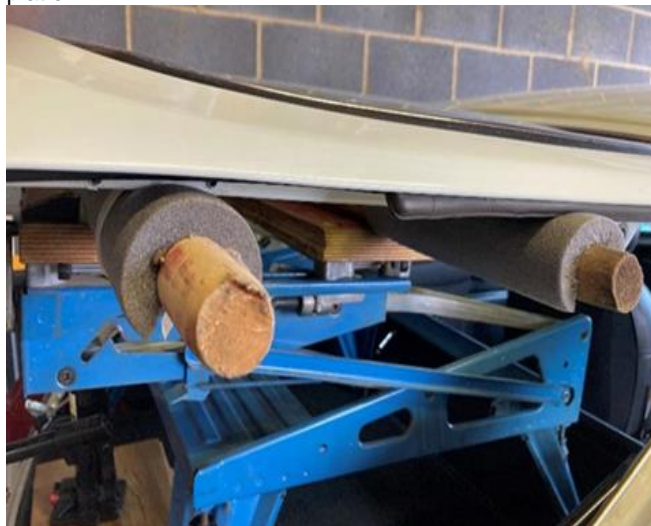
Several schemes were considered to support the tailgate while the hinge screws were removed. The basic requirement is height adjustment combined with a stable non damaging means of support for the tailgate. The problem was resolved by employing the folding properties of a Workmate together with a hydraulic bottle jack to provide the height adjustment. In the event this proved satisfactory provided the jack was positioned under the heavier (glass) end of the Workmate platform.

In essence, the procedure involves adjusting the height of the supporting platform (Workmate and jack) to support the tailgate in a horizontal position followed by removing the tailgate stays and hinge screws. The tailgate can then be slid back to expose the seal retainer and securing screws. The new seal is fitted and the screws replaced while the corners and side extensions are glued in place. The hinge screws are then replaced and the tailgate stays refitted. The closing effort may be increased until the seal has settled but provided that the tailgate adjustment has not been altered sealing should be satisfactory. Adjustment of the tailgate is a rather involved procedure which requires a separate article to address.

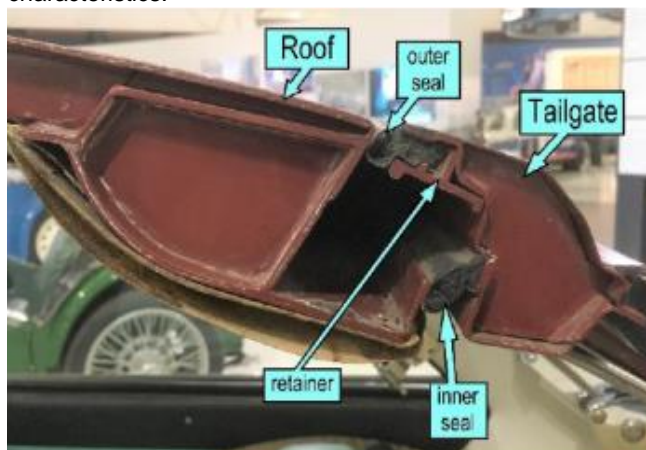
### Details of the tailgate sealing arrangement

The sectioned MGBGT on display at BMH Museum at Gaydon reveals details of the tailgate sealing arrangement which are helpful in understanding how it works. Note that the original inner seal was of foam construction like the outer seal. Commercially available replacements are hollow extrusions which explains the differences in performance characteristics.
