REGISTERS

V8

Condensation in the RV8 VDO Minor Instruments

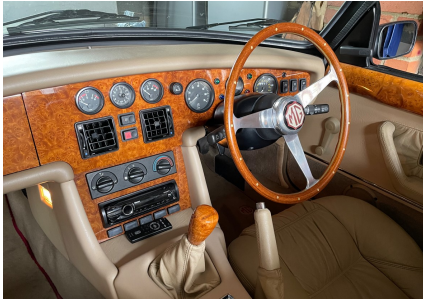
RV8 owner, Steve Hunter posted on the V8BB regarding a problem he'd suffered with his RV8 since he's owned it. The minor VDO instruments, namely the temperature, voltmeter and fuel gauge instruments, which are all plastic sealed units (but not the clock which has a metal casing and a removable lamp) all suffered by misting up with condensation on warm days or when the heater was on. As he had the dash out of his car to repair the vinyl cover on the top of the dash, now was the time to address this annoying habit.

There was no obvious way in which water vapour could easily enter (or more importantly escape) the casings and so Steve's conclusion was that the moisture was trapped within during manufacture, or it was penetrating in some way during ownership. He therefore considered drilling two 1mm holes in the back of the instruments to enable natural ventilation to take place and asked other members for their thoughts.

After further thought, Steve decided to use a small soldering iron to melt two small holes of around 2-3mm diameter in the back of each instrument, hence no swarf. After making the holes, the Instruments were thoroughly dried out and ventilated using warm, dry air. After fitting to the dash and reinstalling the dash (a job which Steve vows never to repeat!) success was finally achieved. In hot and cold conditions there has been no further sign of condensation in any of the instruments.
