REGISTERS

V8

RV8 Battery Change

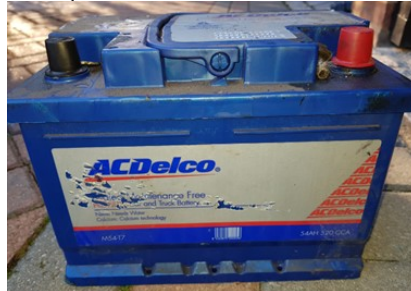
Paul Keeler has been in touch this month regarding the troubles he experienced replacing his battery recently. Paul takes up the story: Changing the battery; what could be easier? Quite a lot actually! Despite being on a CTEK conditioner, the battery finally gave up. Records show

that the old AC Delco item (520 CCA) was fitted in March 2012. Not bad! Two earlier ones were fitted in March 2007 and April 2003.

So, a new Yuasa YBX5069 (650 CCA) was purchased. This battery was 3cm longer and 4.5cm taller than the old AC Delco item. Now the battery isn't particularly easy to get to. Hood down, seat forward, battery cover removed, trim loosened and eased back. The terminals were disconnected, so far, all straightforward. The battery lowermost 'edge' fits under a fixed clamp at the rear of the box; the front 'edge' fits under a bolted clamp. This bolt is totally inaccessible from above the clamp. (The left-hand edge in the picture.) I checked under the car and the bolt is accessible. Great! No... The bolt was turning but not undoing. Could I get a socket or spanner on the head, through a window within the

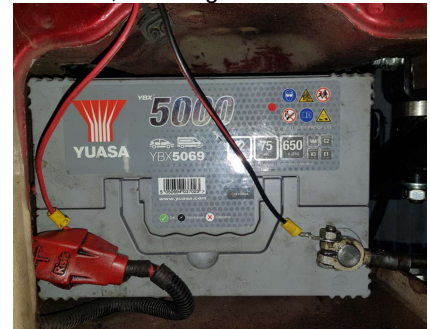
compartment box? No, I could not. So, next move was to jack the car up and remove the rear wheel. More timber blocks to support the car and out came the work lights. The nut was still turning and not undoing. Grrrr... Nothing left but to resort to a nut splitter. Nut duly split, bolt and clamp loosened and the old battery was finally lifted out. The new battery was carefully lowered into place. It just about fits! With Vaseline applied to the terminals and everything tightened up, I'm aware that the front clamp is not yet reinstated. Although the battery is pretty much immovable, I will have another go at this when the weather warms up. In future it's worth lubricating the clamp threads before reassembly and confirming from time to time that it's still free. I'd also source a smaller battery next time, checking the correct CCA.
